UNIVERSIDAD DE INVESTIGACIÓN DE TECNOLOGÍA EXPERIMENTAL YACHAY

IS THE DETERIORATION OF CIVIL CONSTRUCTIONS RELATED TO USING NOT ADEQUATE VOLCANIC MATERIALS? CASE STUDY: IBARRA CITY

Trabajo de integración curricular presentado como requisito para
la obtención del título de Geólogo.

Urququí, julio 2023

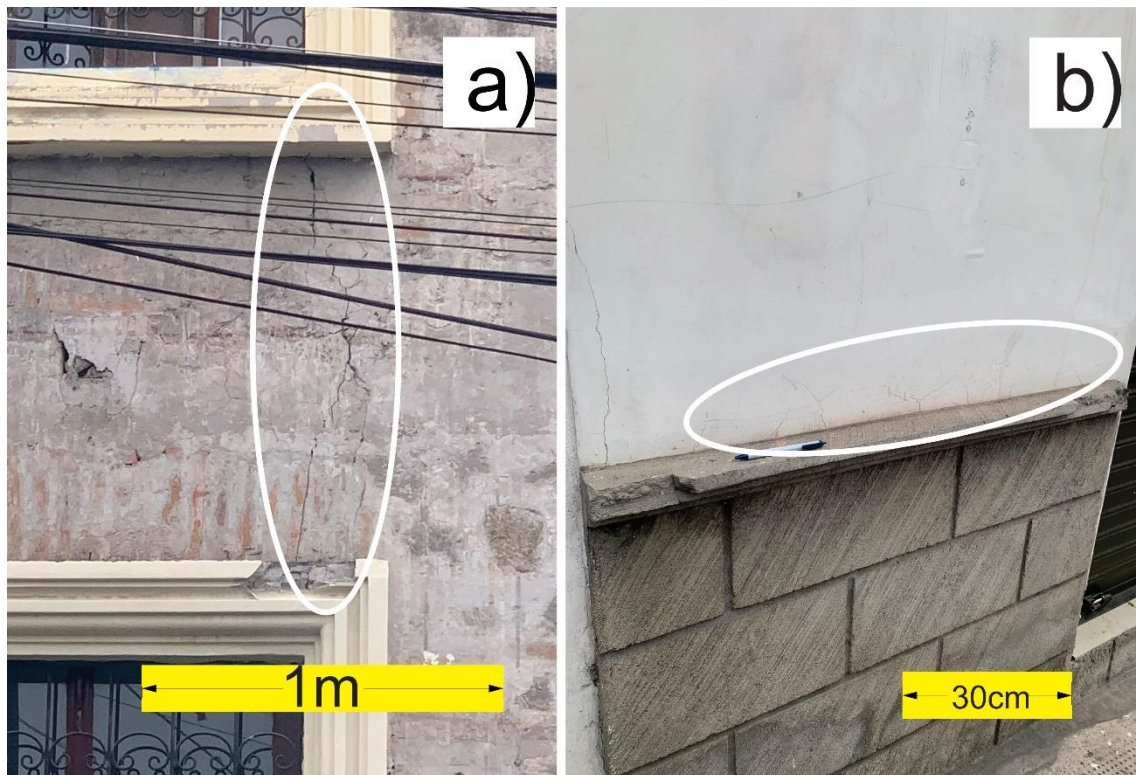
Figure 4. Deterioration by cracks, a) Upper part of a three-floor construction with >1m cracks. Juan Jose Flores street & Vicente Rocafuerte b) Middle part of a concrete wall with microcracks of <1mm. Rafael Troya street & Antonio José de Sucre.

Cracks are defined as a structural discontinuity shown as an opening displacement between opposite walls due to a stress component exceeding its strength component due to, in most cases, externally applied loads (Chitte & Sonawane, 2018). These are generally preceded by a deformation originated by an external factor. This type of deterioration falls into the category of physical deterioration and is highly dependent on the hydraulic capabilities of the building materials. Cracks (Fig. 4a), usually start with minor imperfections, also known as fissures, that are exposed mainly on the material's surface. Cracks can be caused by various phenomena such as freeze-thaw cycles, alkali-aggregate expansion and the desiccation shrinkage of concrete (Terada & Kurumatani, 2010).

Concrete cracking is typical and easily repairable as long as there is no major underlying problem. However, when these occur over and over, it is necessary to conduct an in-depth study of the material's resistance and the stress to which the structure is subjected (Lundin et al., 1996). They can appear in different shapes and sizes, the largest being those that have been subjected to a greater stress, however, it should be considered that those of smaller size, micro-cracks (Fig. 4b), are produced by the same stresses and are naturally followed by a fracture.

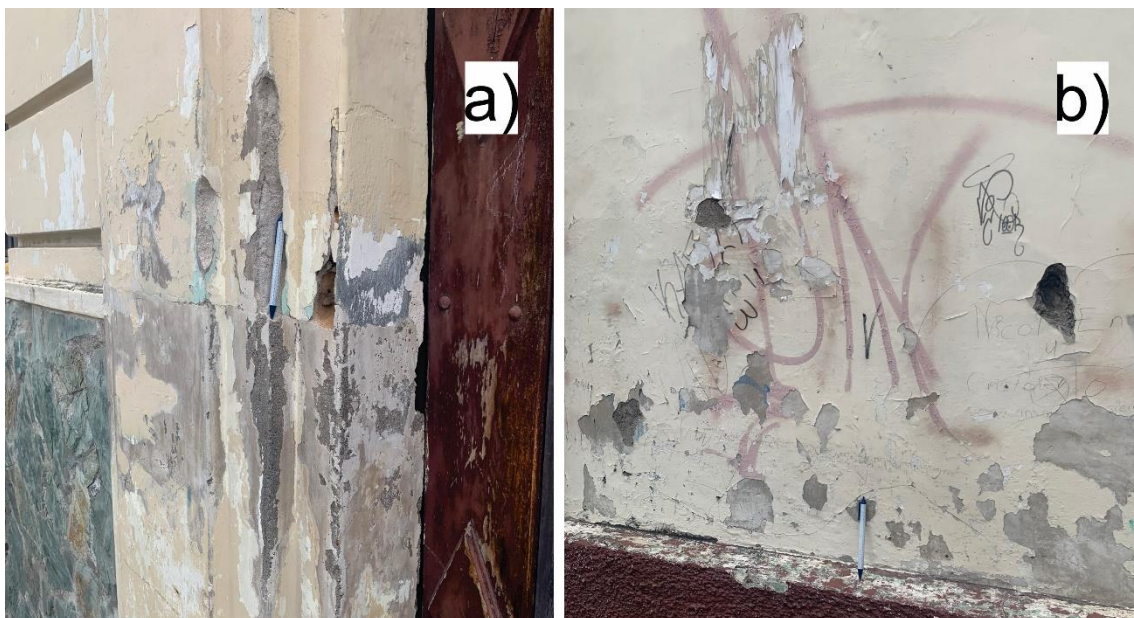
Figure 5. Detachment cause by blistering, a) Concrete detachment in a wall of a local shopping building in the historical center of the Ibarra city, Simon Bolivar avenue & Jose Mejia Lequerica, b) Detachment in paint coat in the lower middle part of a house in the historical center of the city, Antonio José de Sucre avenue & Jose Mejia Lequerica.

One of the most common forms of deterioration in the external layer of the walls is detachment; this often affects the paint coating of the houses and the concrete surfaces producing peeling or blistering. Blisters originate from fluid pressures underneath the coating, which pulls it away from the surface; this is always preceded by peeling. Blisters can also be the leading cause of bursting, delamination and scaling. Following Agyekum & Salgin (2017), blisters are correlated with dampness increase in buildings, and they usually depend very little on the quality of the materials used. These are generally found to be hollow, but can also be found filled with water as soon as the blistering conditions

are maintained. On painting coats (Fig. 5b), this failure is caused by abnormal conditions in which the affected constructions are built. These can be rainwater leaking through cracks or moisture originating within the buildings (Browne, 1953). Meanwhile, this phenomenon can also be developed in concrete structures with drastic changes in the daily temperature (Hailesilassie & Partl, 2012). However, other factors as the fluctuation of the pressure inside blisters can also influence (to a lower degree) the blisters' growth in concrete (Fig. 5a).

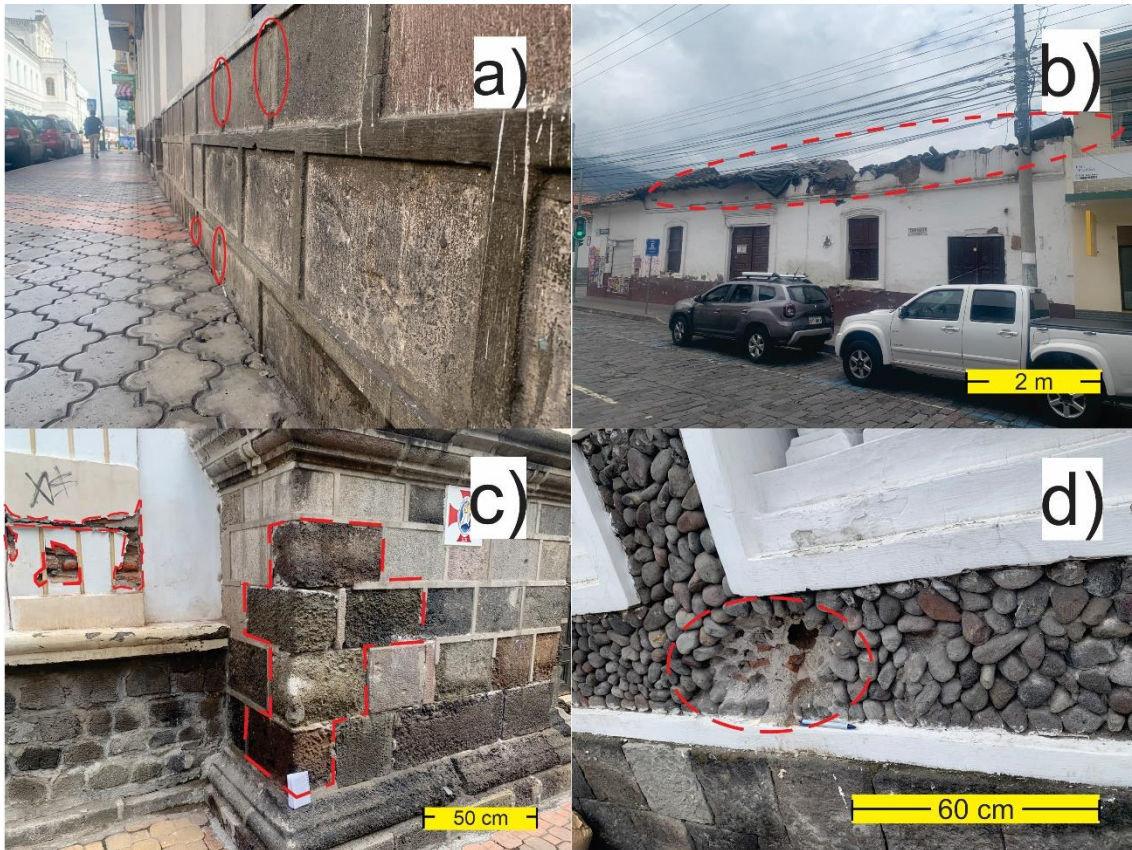
This type of deterioration is characterized by the loss of material influenced by diverse agents of physical origin, including erosion and alveolization. In many cases, this can also be a consequence of cracking or detachment, making this type of deterioration one of the most common and observable in the environment. Alveolization, also known as honeycomb weathering (Fig. 6c), is a form of degradation characterized by the mechanical intervention of water and wind to shape deeply eroded cavities on rocks. As Moreno et al. (2019) reported, alveolization and high alveolization primarily affect stone reinforcements on the base of the walls. On the other hand, erosion can be described as the process that produces materials to wear out due to natural agents like water or wind. The difference between this and alveolization is that erosion does not create a specific pattern on rocks. It only removes soil, rock or any dissolved material and relocates these so they can be redeposited (Fig. 6b).

Figure 6. Features induced by material loss in the historical center of Ibarra, a) Mechanical damage, Simon Bolivar & Miguel Oviedo str., b) Erosion, Vicente Rocafuerte & Miguel de Oviedo str., c) Alveolization, Episcopal Chapel, Pedro Moncayo str., d) Missing part, Simon Bolivar & Eusebio Borrero str.

Mechanical damage is also considered in this section (Fig. 6a). Even though there is a limited understanding of the main drivers, it can be purported to be segments of rock that have gone through a strong level of abrasion or impact damage. They can be human induced in many cases, but the quality of materials and environmental factors also impact these. Generally, moisture has been widely suggested as one of the main precursors to rock breakdown, associated with weathering, regolith production and/or erosion (Eppes & Keanini, 2017). The types of deterioration previously mentioned can lead to gaps (or missing parts) in civil structures (Fig. 6d). Gaps usually take more time to happen but are strongly dependent on the level of abrasion the structure has been subjected to.

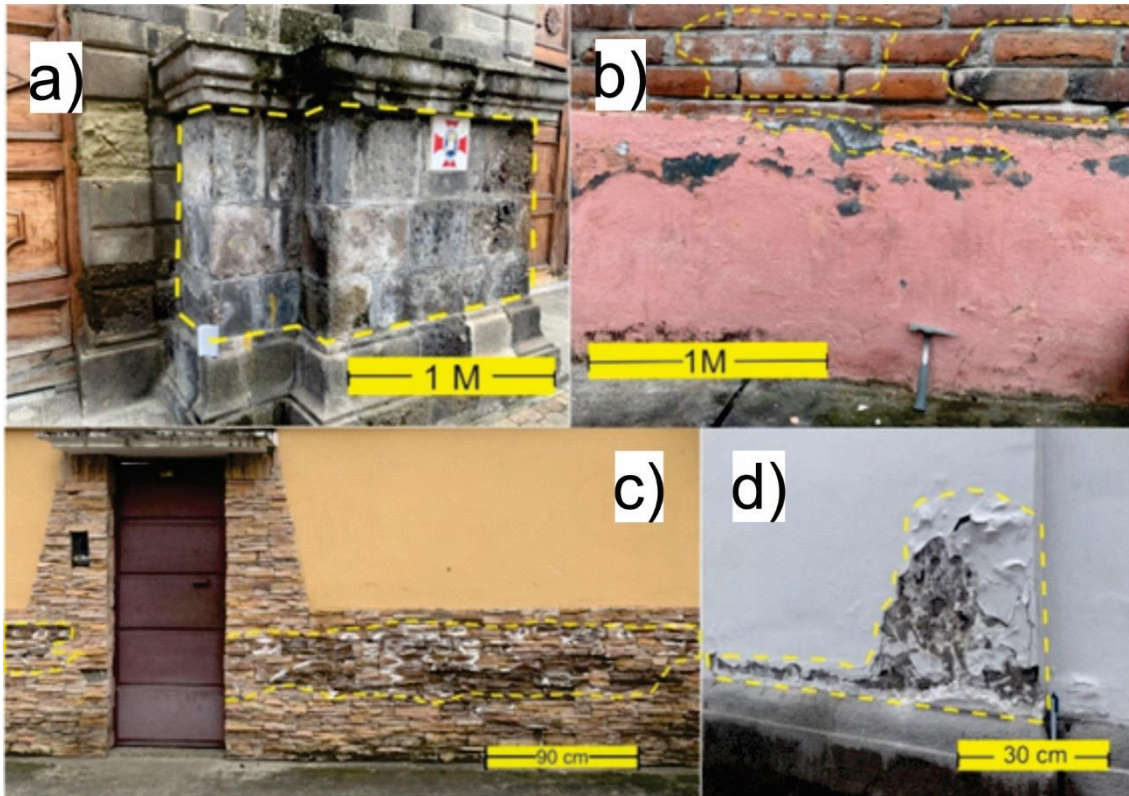
This is one of the most observed types of deterioration in homes in Ibarra City, both outside and inside. Efflorescence is a surface deposit of salts that usually affect constructions or historical monuments. This growth can occur in different types of materials (brick, concrete, paint, etc.; Fig. 7), and is produced when a wall, enriched to some primary salt, is subjected to humidity from the environment, which moves through the substrate dissolving these mineral salts and forming crystals when they dry (Zehnder & Arnold, 1989). Alternatively, when this salt growth occurs deep within the pores of a solid matrix, it is known as subflorescence. This latter can be, at times, very destructive since it can produce a physical disruption in the physical coherence of the matrix, causing its rupture (Dow & Glasser, 2003). Despite this, efflorescence on buildings is mainly analyzed because the sampling process has been non-intrusive and only superficial samples have been considered.

Figure 7. Efflorescence in different materials in Ibarra City, a) Carved igneous rocks, Catholic Cathedral of Ibarra, b) Bricks, Atahualpa ave. & Tobías Mena, c) Sedimentary carved rocks, Jacinto Egas ave. & Tobías Mena d) Concrete, Pedro Vicente Maldonado ave. & Juan Jose Flores.

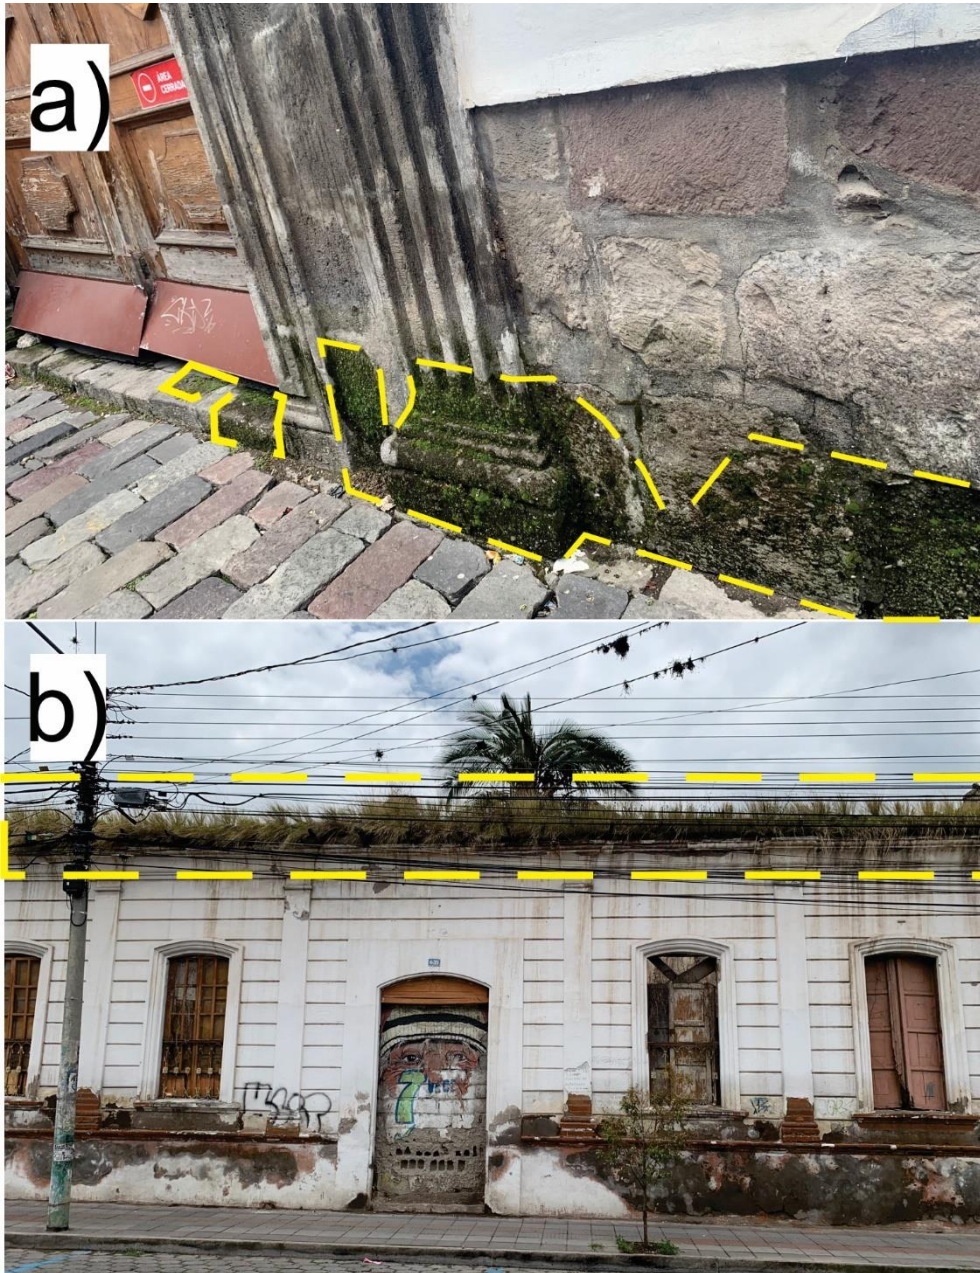
Figure 8. Deterioration by biological colonization in the historical center of Ibarra, a) plant growth in the bottom part of a concrete structure, Catholic Cathedral of Ibarra b) severe deterioration on a house ceiling due to root growth, Pedro Vicente Maldonado & Miguel Oviedo.

The biological colonization is one of the most curious cases on which weathering can show up in the environment. Although the previous weathering types are very important factors in the deterioration of concrete, biological activity also plays a predominant role due to its interactions with the materials (Fig. 8). The presence of macro and
