**UNIVERSIDAD DE INVESTIGACIÓN DE
TECNOLOGÍA EXPERIMENTAL YACHAY**

**TÍTULO: “Characterization of Haloclasty to reduce the
deterioration of buildings in Urcuquí and near Villages,
Ecuador.”**

Trabajo de integración curricular presentado como requisito para la
obtención del título de Geóloga.

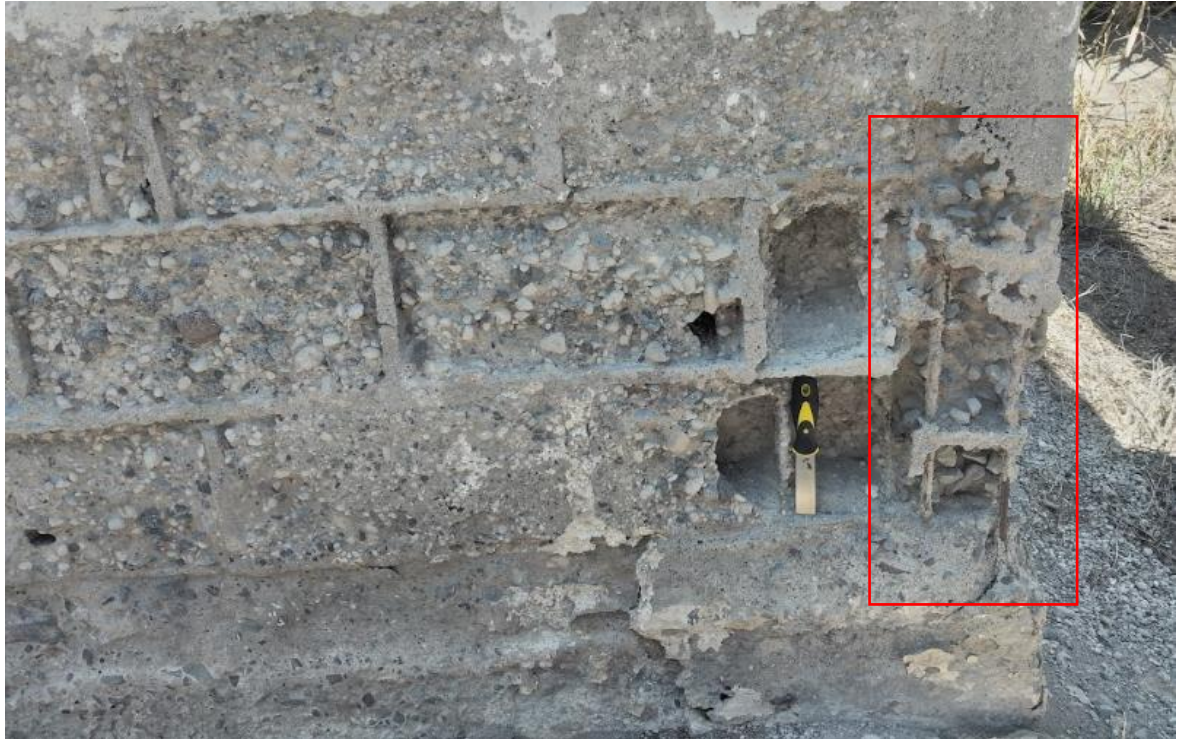
Figure 3. *The building's infrastructure appears to have a significant amount of corrosion. The concrete blocks are already breaking apart, and the iron bars are exposed, increasing the likelihood of a potential collapse in the future. The photo was captured in an abandoned building located in Tapiapamba (See location in Figure 1).*

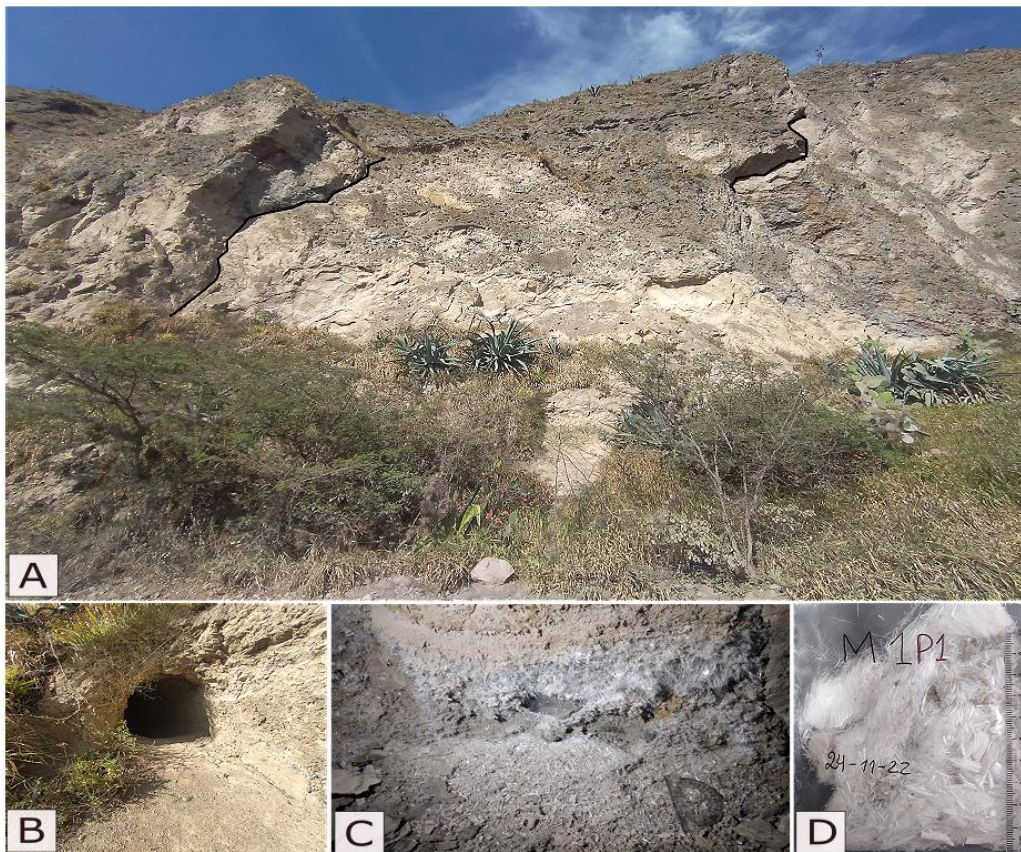
The outcrop (Figure 7A) is close to the Hoja Blanca station and adjacent to the ancient Urcuquí-Ibarra viaduct. The coordinates of the location where a natural mineral (sample M1P1) was sampled are shared in Figure 1 and Table 1. It depicts the displacement of volcanic material with expanded fractures (black lines) caused by the slope's instability. The height of this outcrop is approximately 70 meters. The clasts appear to have angular to subangular shapes, indicating that they were transported with medium-level energy and had a fine to coarse grain size. The initial sampling was made in an anthropogenic channel (Figure 7B). This channel was supposed to transport water but must be completed for unknown reasons. Possible natural salts are growing in the wet soil (Figure 7C). The minerals found in this location have an elongated and white fibrous structure (Figure 7D). On the other hand, it is well known that construction materials are extracted from mountains; hence, a salt sample at this location is required to identify what salt types are naturally crystallizing. The objective is to ascertain the specific kinds of salt that naturally develop into crystals.

Figure 7. Outcrop with cracks near the Ambí River (See location in Figure 1) (A). Artificial channel (B). Crystallized salts in the ground (C). M1P1 Sample taken in the channel(D)

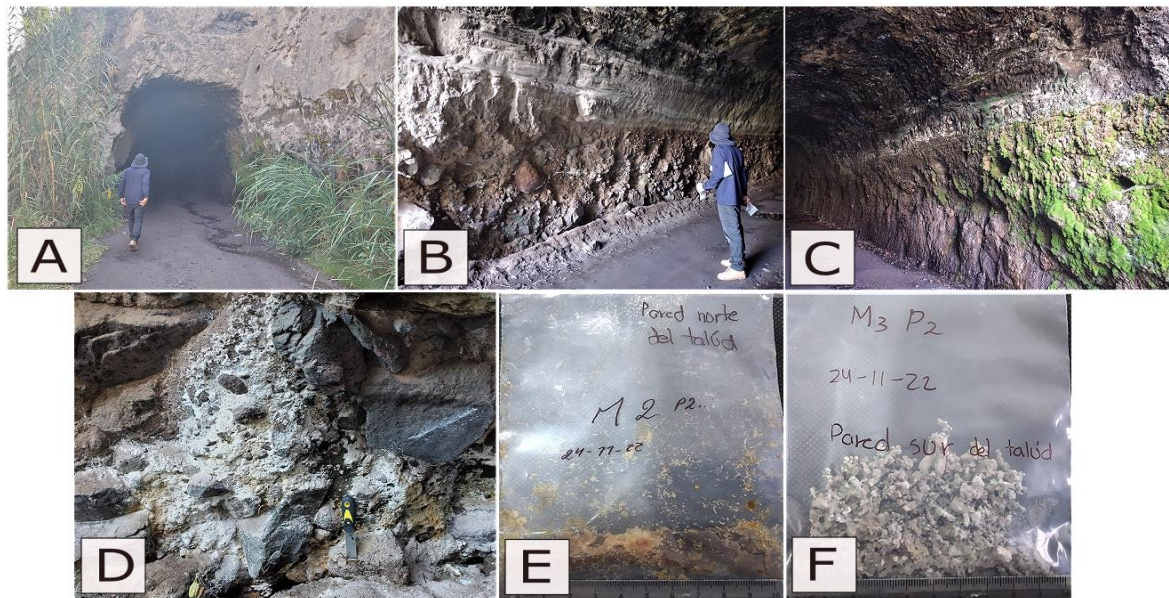
In this location (Figure 8A), two samples were collected in two different scenarios to know their composition. These outcrops are in an anthropogenic tunnel 100 meters from the first stand. Figure 1 and Table 1 show the site's location where two natural mineral samples (M2P2, M3P2) were taken. Sample M2P2 from the north wall (Figure 8B) and M3P2 from the south wall (Figure 8C). M2P2 presents minerals with a smooth texture and resembles fine dust (Figure 8D). Furthermore, it has white lamination layers in the outcrop's center but a conglomerate stratum with subangular clasts towards the base. M3P2 shows minerals growing as little green trees on the south side; however, due to their hardness, this sample was difficult to collect (Figure 8F). This wall contains a natural water source that keeps the wall moist. Aside from the two salt samples collected there, a piece of rock from this cave will be tested with HCl to determine how it reacts. The project's results section will include this piece's reaction to HCl.

Figure 8. Anthropogenic tunnel in Hoja Blanca – Imbaya via (See location on Figure 1) (A). North wall of the tunnel (B). South wall of the tunnel (C). Minerals in the north wall(D). Sample M2P2 from the north (E). Sample M3P3 from the south (F).

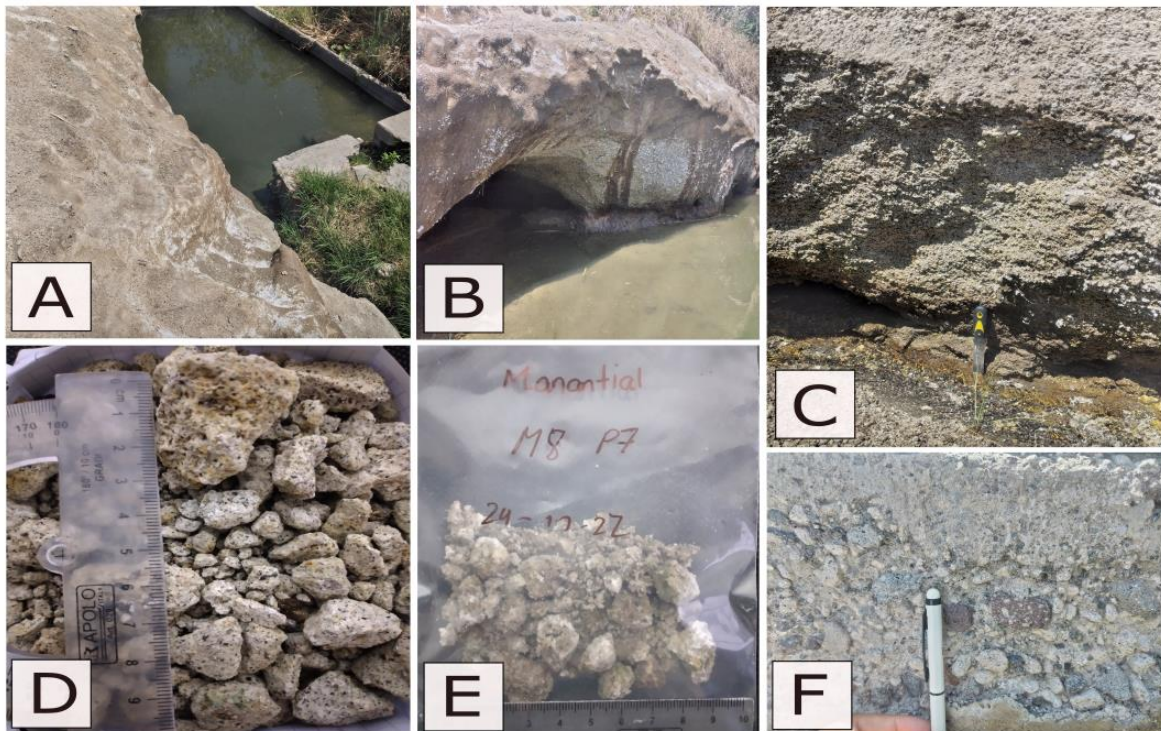
The coordinates of the location where the natural mineral sample (M8P7) was collected are displayed in Figure 1 and Table 1. The following outcrop is several meters from the road (Figure 9A). In this place, possible salt crystals grow on the soil surface before reaching the spring water (Figure 9B). Sample M8P7 belongs to the outcrop near the spring water since the minerals are growing there (Figure 9C). The sample was extracted in pieces with 0.5 - 3 cm where the salt was growing in the rock (Figure 9D, 9E). This mineral's crystals are white to transparent in color and clump together to create an agglomeration. The outcrop has volcanic material known as pumice rock which is presented in a fence that surrounds the area to keep the water in (Figure 9F). Here is evidence of the implementation of volcanic material, such as pumice, in construction areas since it is found in concrete blocks. Due to pumice density, which makes it not heavy, it is well-recognized that this material is helpful for construction.

Figure 9. Spring water with volcanic material (See location in Figure 1) (A). Possible salt in situ growing in the ground (B). Water flowing through volcanic material (C). Mineral sample collected (D). The volcanic material sample is taken M8.P7 (E). Volcanic material is used with concrete to retain water (F).

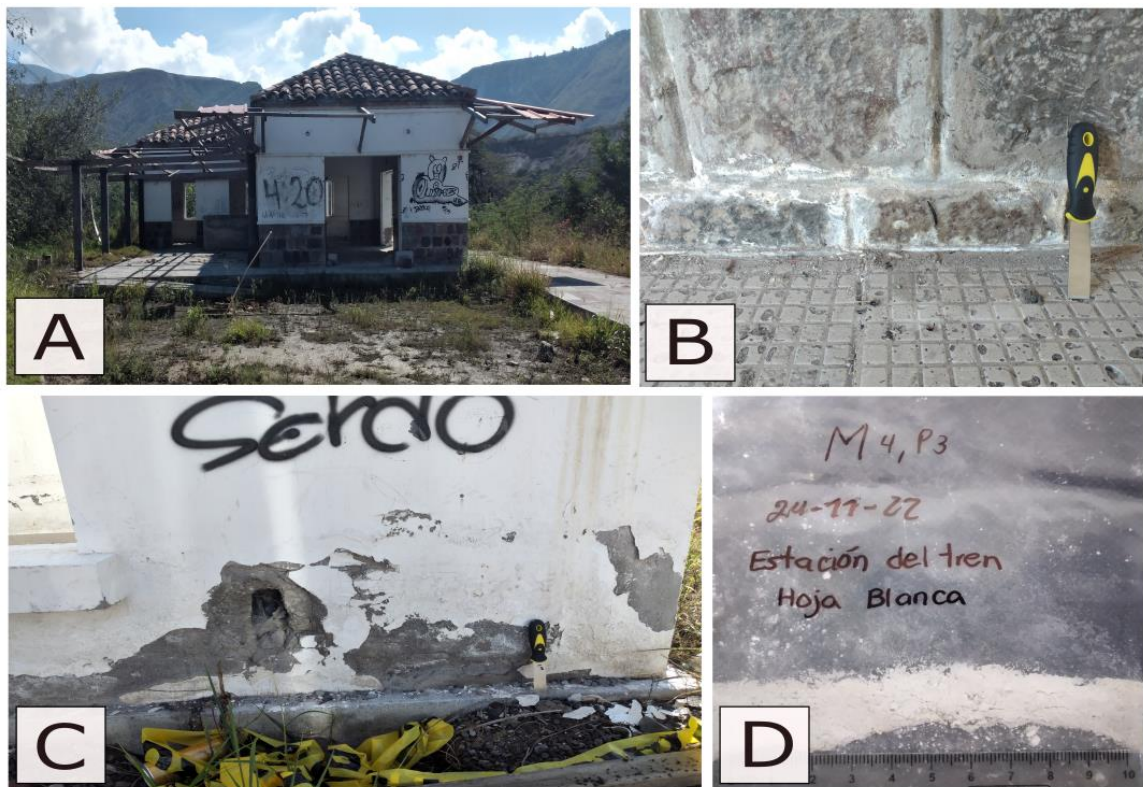
For many years, the Hoja Blanca Station has been abandoned (Figure 10A). As a result of the abandonment, the roof has crumbled through the years, resulting in ongoing damage from the sun and rain. The coordinates of the location where a mineral (sample M4P3) was sampled are shared in Figure 1 and Table 1. Possible salt crystals grow in the cement joints near the wall's bottom (Figure 10B). The inside wall has minor damage, but the external wall is deteriorating (Figure 10C). One of the principal construction materials is lava bricks at the base of the building bonded with a mortar mixture. The concrete block is a secondary construction material, which also presents deterioration. The sample M4P3 (Figure 10D) comes from the internal wall where the crystals are shown in the mortar mixture. All the physical conditions of the buildings are of great importance since they will help to study each case.

Figure 10. Hoja Blanca Train Station (See location in Figure 1) (A). The internal wall presents salt crystallization (B). Abandoned and deteriorate building (C). M4P3 Sample taken from the inner wall (D).

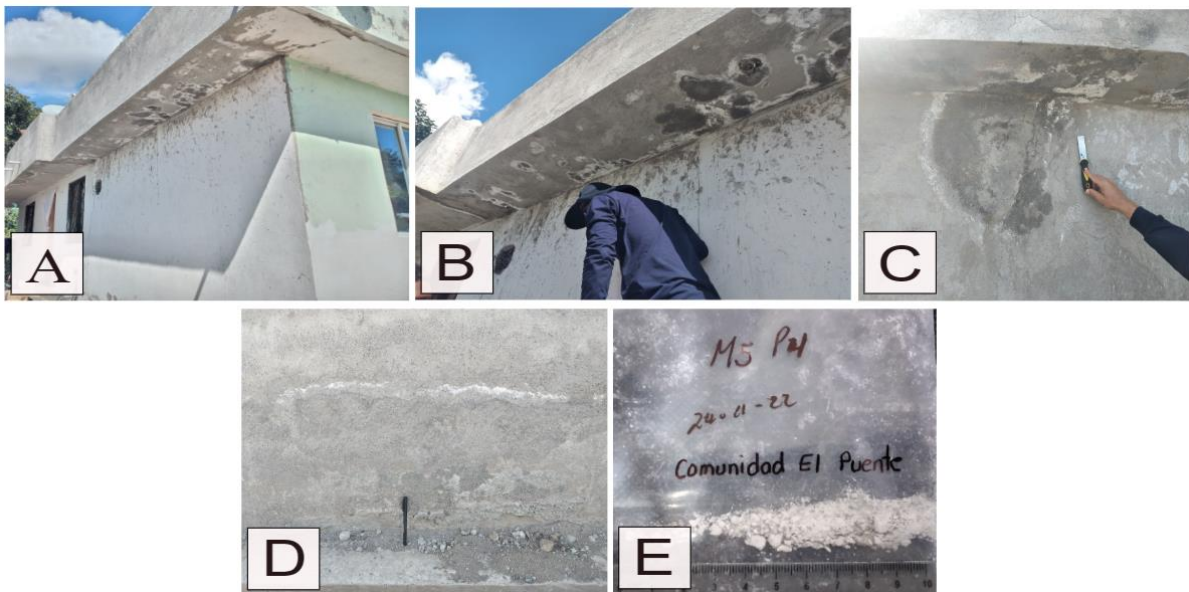
Take a sample from a house in El Puente Community. Figure 1 and Table 1 show the location of the site where the mineral sample was taken (M5P4). On the left side of the house analyzed (Figure 11A), a white patch (possible salt crystals) is forming on the wall with considerable size (Figure 11B), which is where the M5P4 sample was obtained (Figure 11E). The second floor has no roof; thus, the soil is not protected from heat and rain. Consequently, the filtering of water likely is what is causing crystals to develop on the roof (Figure 11C). On the other hand, concrete blocks are one of the primary building materials used in this home. Additionally, the house's walls are not covered with plaster but a sand mixture. The owner has noted the presence of several white spots on the walls, and rainwater is standing in several places on the second floor. He believes humidity causes those white spots created by the percolating water; nevertheless, he is unaware that the white areas are possibly salt crystals growing in buildings. On the other hand, salt crystals increase at the bottom of the wall (Figure 11D), indicating the soil's capillary absorption. Compared to the top of the wall, the degradation is more significant near the base. They are considering that the concrete blocks present a little detachment of material that covers the concrete blocks. Some homes in the small community of El Puente Community have varying degrees of deterioration.

Figure 11. House in El Puente Community with possibly salt crystals (See location on Figure 1) (A). Identifying the existence of crystals in construction (B). Taking the mineral sample from the wall (C). Crystals at the base of the wall(D). Sample M5P4 taken (E).

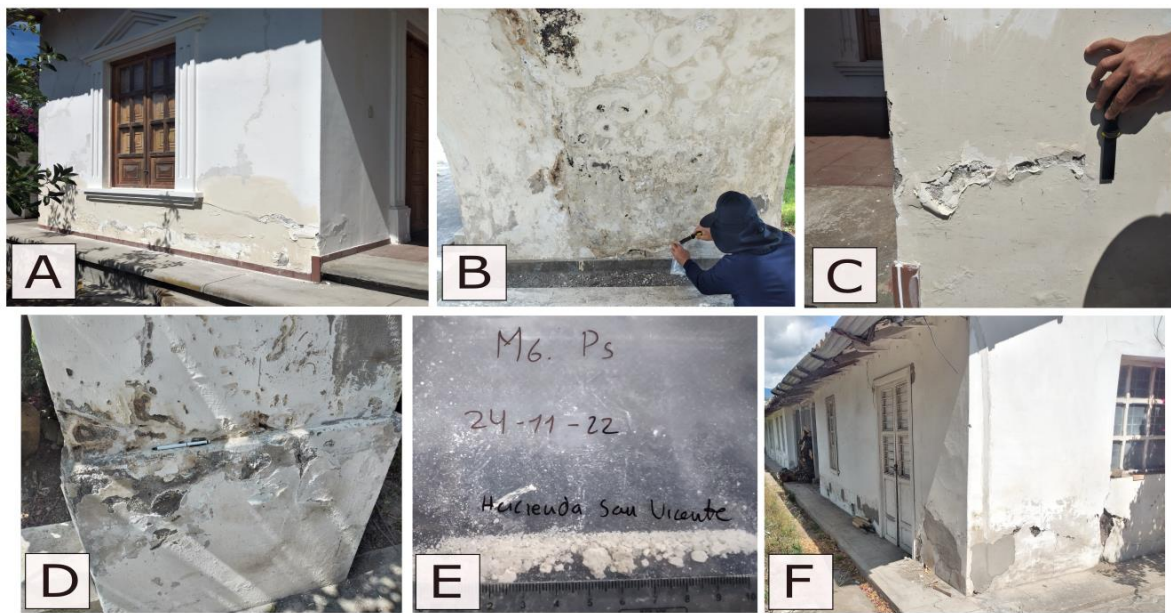
There are abandoned farms near Yachay Tech University with powerful indications of possible salt crystal damage. One is San Vicente Farm, which has several buildings with minerals growing on walls (Figure 12A). Figure 1 and Table 1 show the location of the site where the mineral sample was taken (M6P5). The sample comes from a house wall and a concrete bridge containing crystals (Figure 1B). Those crystals were removed from the wall with a spatula and a zip-top bag. Crystals of the minerals are white and have a lumpy texture. It is known that crystal growth causes the paint on the wall to expand because those minerals develop between the concrete block and the color (Figure 12C, 12D). Moreover, crystals may be seen in several pillars around the house (Figure 12D) because of the high level of weathering. Besides, another building on the property has cracks and cement patches, typical when deterioration begins (Figure 12F). The degradation level is high for paint conservation since it is one of the first materials to decay due to its expansion caused by crystals of minerals.

Figure 12. Deterioration in a San Vicente Farmhouse wall (See location on Figure 1) (A). Concrete bridge with superficial salt deterioration (B). The place where the sample was taken (C). Concrete wall with the presence of salt crystals (D). Salt sample M6P5 (E). House with fractures in the wall and fixed with cement mixture (F).

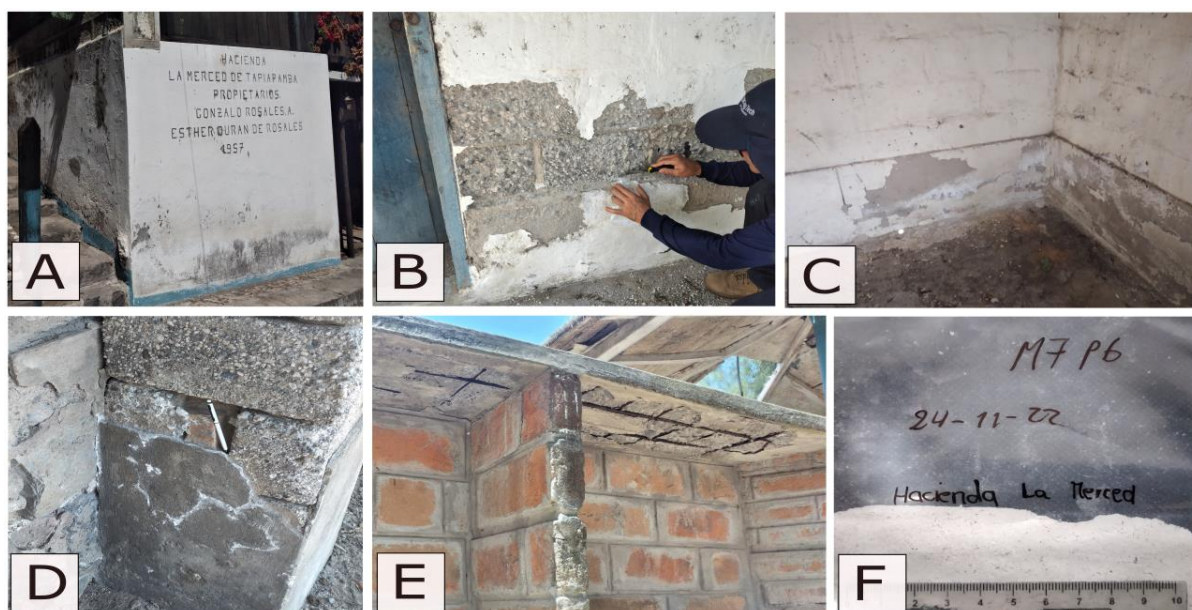
La Merced Tapiapamba Farm is another abandoned building near the Yachay University campus (Figure 13A). Figure 1 and Table 1 show the location of the site where the mineral sample was taken (M7P6). This farm was built in 1957, having been 65 years to this day. Dates are necessary to analyze the deterioration level throughout the years. Several structures around the sampling area belong to the farm, presenting a certain level of degradation too. Examining the constructions, all these are constantly deteriorating due to weathering and lack of maintenance. The primary building materials are concrete blocks (Figure 13B) and bricks. Most of the structures are exposed to the agents of erosion, such as rainwater, wind, and sun, causing material cracking. Furthermore, crystals grow primarily at the bottom of the wall (Figure 13C), where the sample M7P6 comes from (Figure 13F). Those crystals were taken by scraping the wall with a spatula and safe into a zip-top bag. Their physical appearance presents a smooth texture and white color. It is worth mentioning that crystallization occurs mainly in the mortar mixture that covers the concrete block giving some patterns to analyze (Figure 13D). In addition, iron bars are exposed to the environment, so they may start to oxidize and eventually cause the structure to collapse (Figure 13E).

Figure 13. La Merced Farm construction from 1957 (See location in Figure 1) (A). The sample was taken in a porous material (B). White crystals were identified in the wall of an abandoned house (C). Concrete block pillars with salt crystals (D). Iron is revealed beneath a concrete table (E). Salt sample M7P6

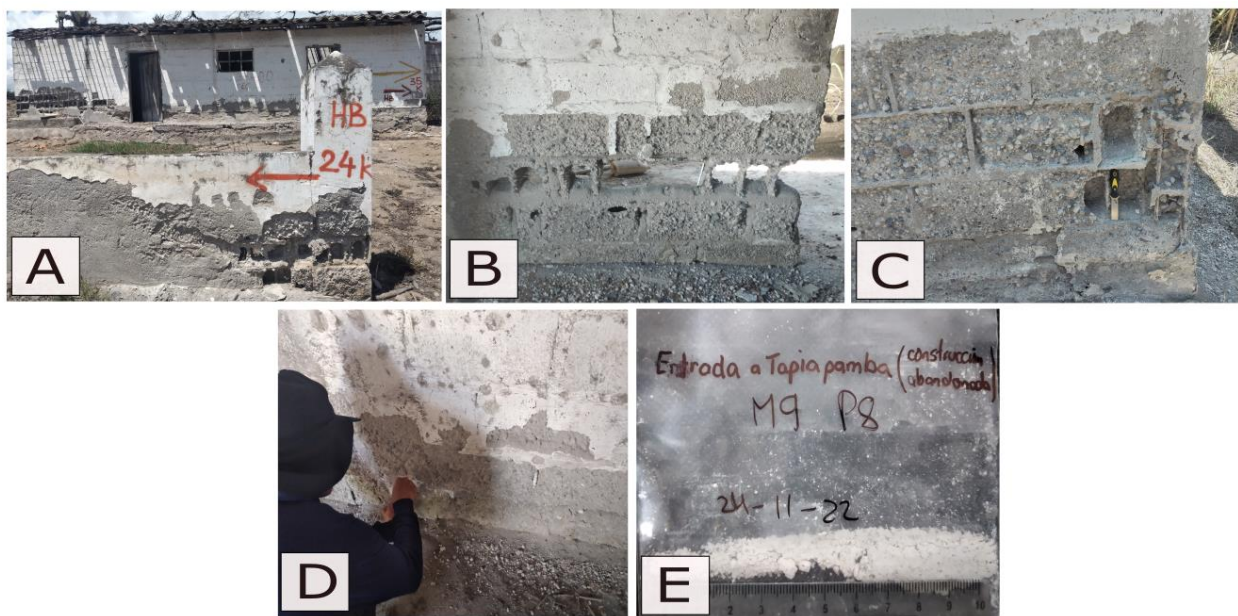
The state of this structure is one of abandonment and continuous decay (Figure 14A). The most affected areas are the lower part due to the soil humidity and the presence of minerals. The deterioration level here is increasing since it does not have constant maintenance (Figure 14B). Figure 1 and Table 1 show the location of the site where the mineral sample was taken (M9P8). Inside the house, one of the walls indicates a high level of degeneration since there is a big hole at the wall base. Similarly, the exterior side of the house presents damage to walls and pillars since the iron bars are already exposed (Figure 14C). The mineral sample M9P8 comes from the inside wall of the house (Figure 14D). These minerals have a smooth texture and white color (Figure 14E). This house's construction elements include concrete blocks with white paint and a damaged tile roof. The degree of deterioration in the building components puts this structure at risk of collapsing.

Figure 14. Abandoned construction in Tapiapamba (See location in Figure 1) (A). Concrete block deteriorated (B). Iron exposed in concrete block construction (C). Sample-taking process (D). Salt sample M9P8(E).

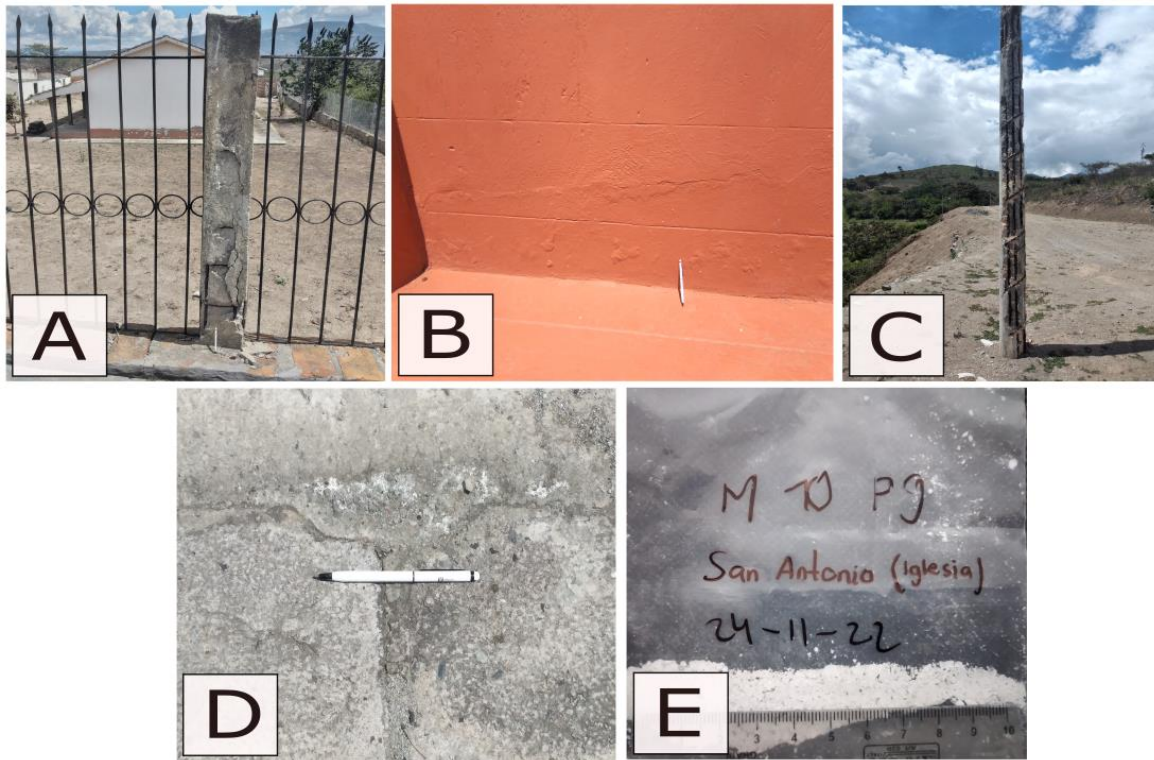
Around the San Antonio church, pillars have certain deterioration levels where the iron is already exposed; these pillars enclose a plot, and others are lamp posts (Figure 15-C). Figure 1 and Table 1 show the location of the site where the mineral sample was taken (M10P9). These pillars may crumble with time due to the degradation of the building materials. Touch-up paint was recently applied to the church walls, but since crystals are developing within, the color has expanded or inflated (Figure 15B). Additionally, a crack can be seen where they painted, and this paint expansion is worsening near the bottom of the wall. However, due to crystal accumulation, paving stones are also susceptible to degradation in front of walls (Figure 15D). To determine the type of mineral present, the sample M10P9 was obtained from a wall at this location (Figure 15E). These crystals have a smooth texture and white color. Those crystals were collected by scraping the wall with a spatula and putting them in a zip-top bag.

Figure 15. In the San Antonio Community (See location in Figure 1), there is a concrete column that features exposed iron (A)(C). The paint on the wall has expanded due to crystal growth within the surface (B). Crystals of minerals growing on the floor (D). Sample M10P9 taken from church (E).

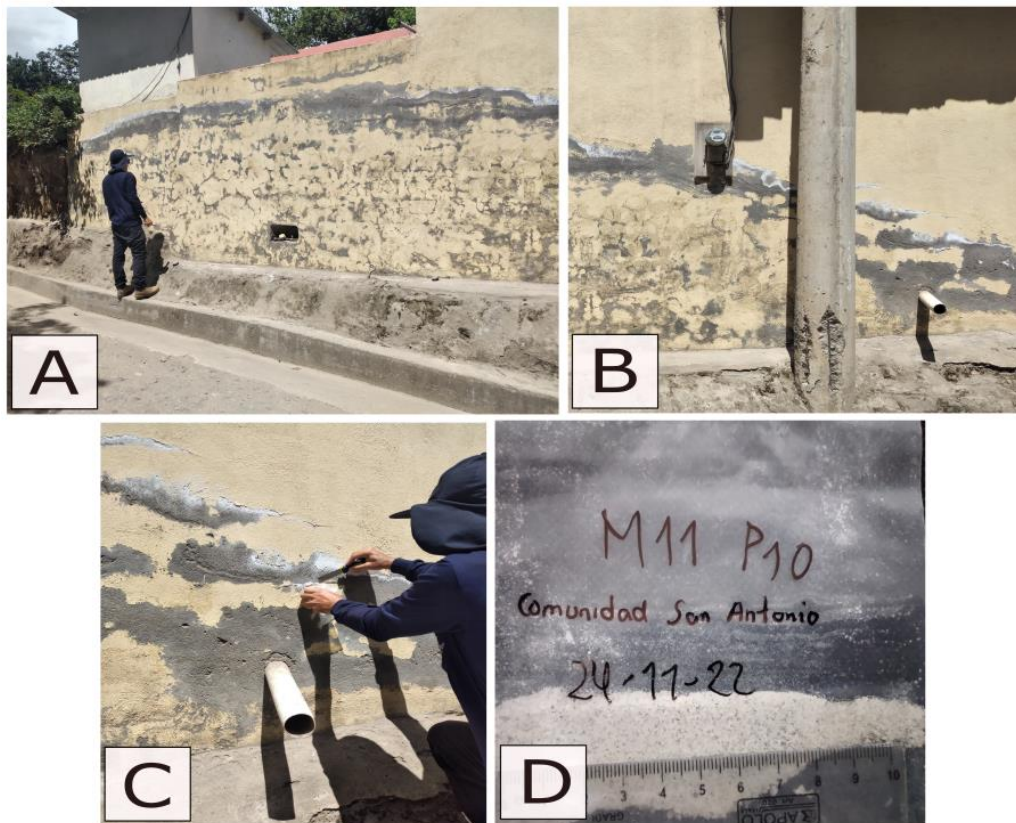
Another common scenario around the villages is the next. Crystals are also present in walls and lampposts of the San Antonio neighborhood (Figure 16A-B). Figure 1 and Table 1 show the location of the site where the mineral sample was taken (M11P10). The iron bars in the lamppost are exposed to the environment, which is crucial to note since oxidation may occur in the future; consequently, it could collapse. The building materials used in the retaining wall analyzed appear to be made of concrete. Crystals or white zones, in this instance, are near the top of the wall, visible from the street. The presence of crystals descends to a drainage pipe, creating the impression that the water penetration is the leading cause of the crystal's formation (Figure 16C). To contrast the argument expressed, a sample must be taken here. The M11P10 sample will be examined to determine the mineral type found. These crystals are white and have a smooth texture (Figure 16D). To collect the crystals, one should scrape the wall using a spatula and store them in a zip-top bag for later use in the lab. Although the wall has some tiny crystals growing, the deterioration level is insignificant.

Figure 16. House wall with crystals in the San Antonio community (See location in Figure 1) (A). A deteriorated light pole with exposed iron bars (B). Obtaining a mineral sample from the wall near the drainage (C). Sample M11P10 obtained (D).

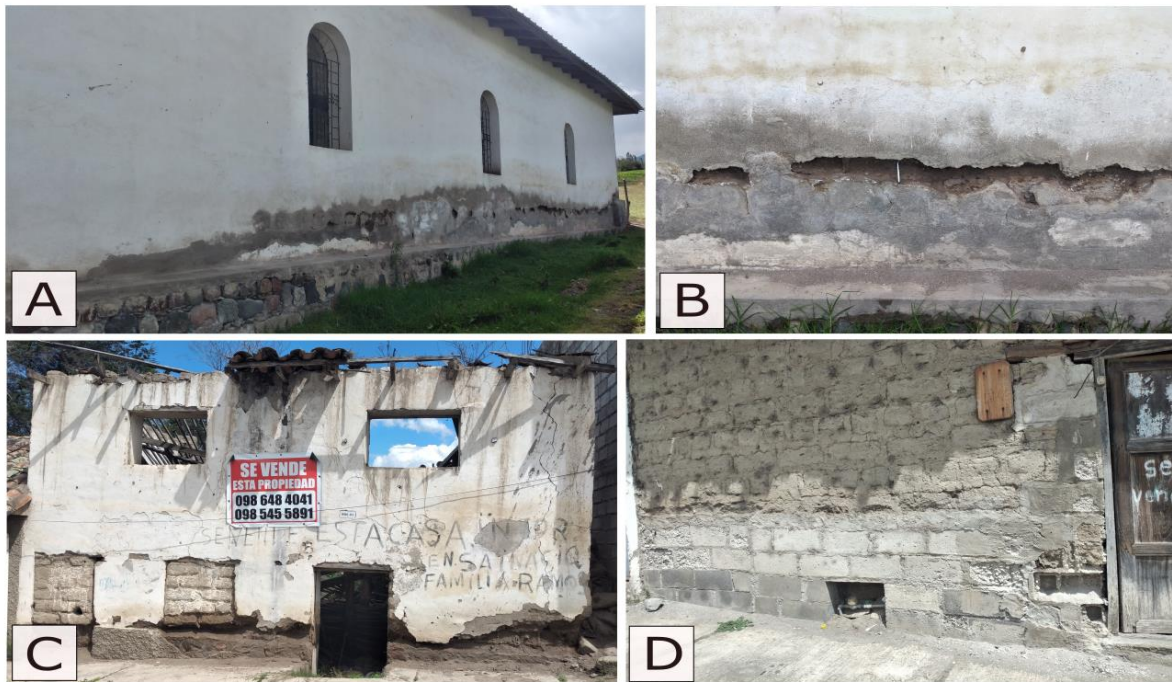
Both the newest and oldest buildings are being deteriorated due to the detachment of the building material caused by physical weathering. The San Ignacio village has a high level of deterioration in an ancient church structure. Figures 17A–B show the old church and the damage caused near the base of the wall. Similar to Figure 17B, Figure 17C depicts an ancient structure with comparable damage at the bottom of the wall. This building will be demolished since all that is left of it is one wall. Concrete blocks were used to construct those buildings, and compressed earth blocks were used to create these two buildings. Any porous material exposed to water over time may experience various forms of physical weathering. In another case, concrete blocks were installed in an old house, where the damage was found (Figure 17D), trying to mitigate the effects of the deterioration. However, the most recent materials used have experienced a detachment process that has resulted in almost 15% of lost material.

Figure 17. Church wall with exterior degradation (A). The degree of degradation of the wall (B). Old house with significant degradation (C). The combination of construction materials and their degradation (D).

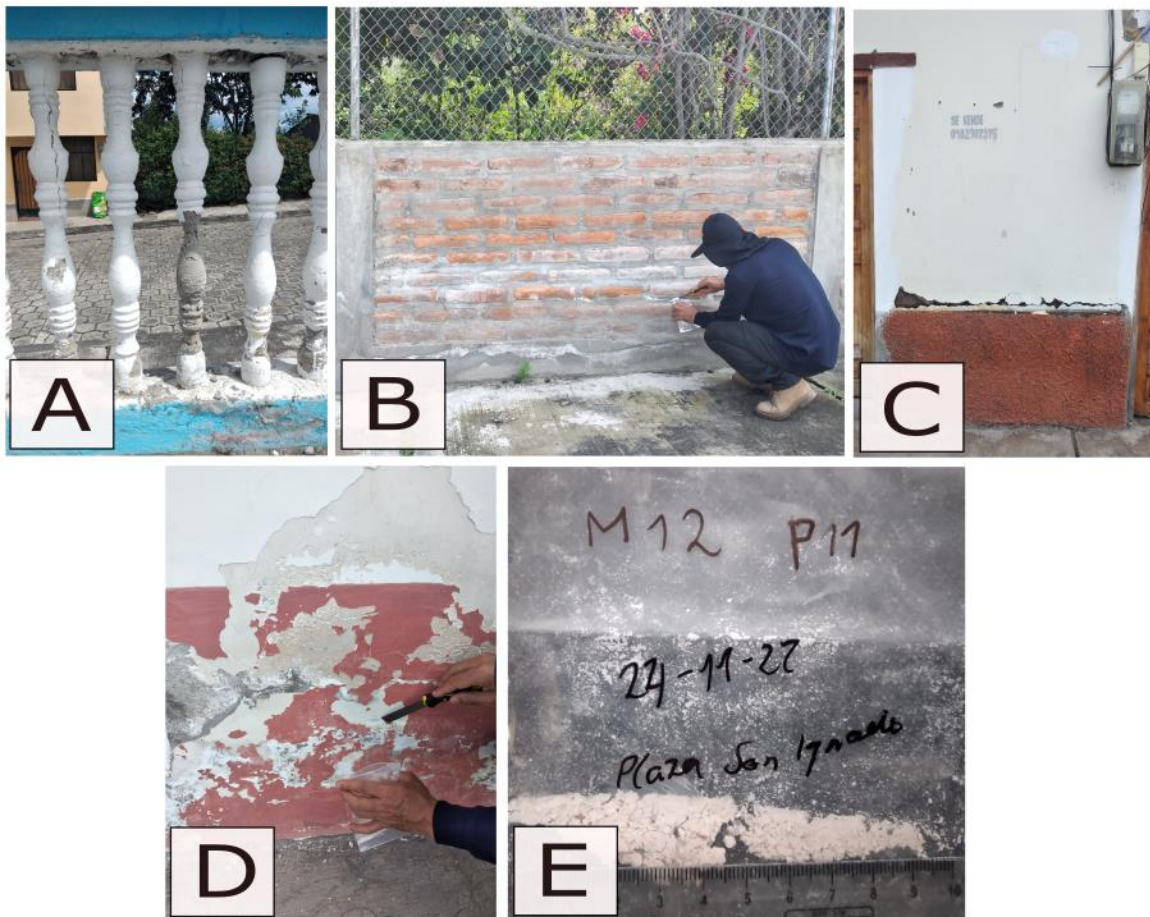
The San Ignacio Plaza has damaged railings that are losing material due to deterioration processes (Figure 18A). Figure 1 and Table 1 show the location of the site where the mineral sample was taken (M12P11). The base of the walls also exhibits signs of building decay. In this location, the walls have moderate wall deterioration (Figures 18D-C). The M12P11 sample was taken from a brick wall (Figure 18B) where crystals cover part of the wall. The physical appearance of the minerals is white smooth (Figure 18E). These crystals were collected by scraping off the wall with a spatula and put in a zip-top bag. On the other hand, concrete and clay blocks are the most often used building materials in this zone, and both have certain degrees of degradation. Because public infrastructures represent most areas where weathering occurs, repairing them incurs significant expenditures. Having crystal samples in historic structures can help us determine what mineral types are presented.

Figure 18. Deteriorated handrails in the San Ignacio Plaza (See location in Figure 1) (A). The sample was taken from a brick wall (B). Base wall with deterioration-caused fractures (C)(D). The sample was taken M12P11

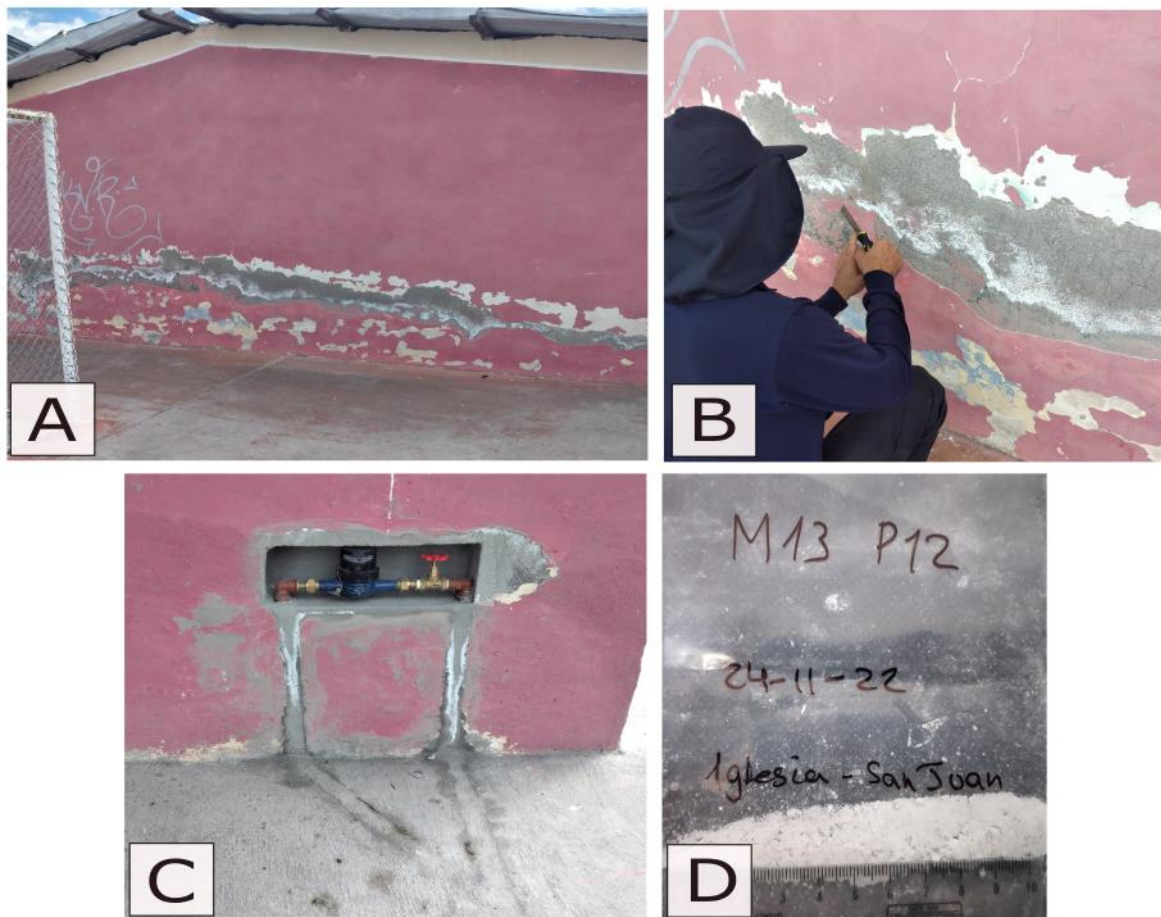
Figure 19. San Juan church wall with salt crystals (See location in Figure 1) (A). The sample is taken from the wall base (B). Salt crystals are forming along the cement-covered pipe (C). Sample salt collected (D)

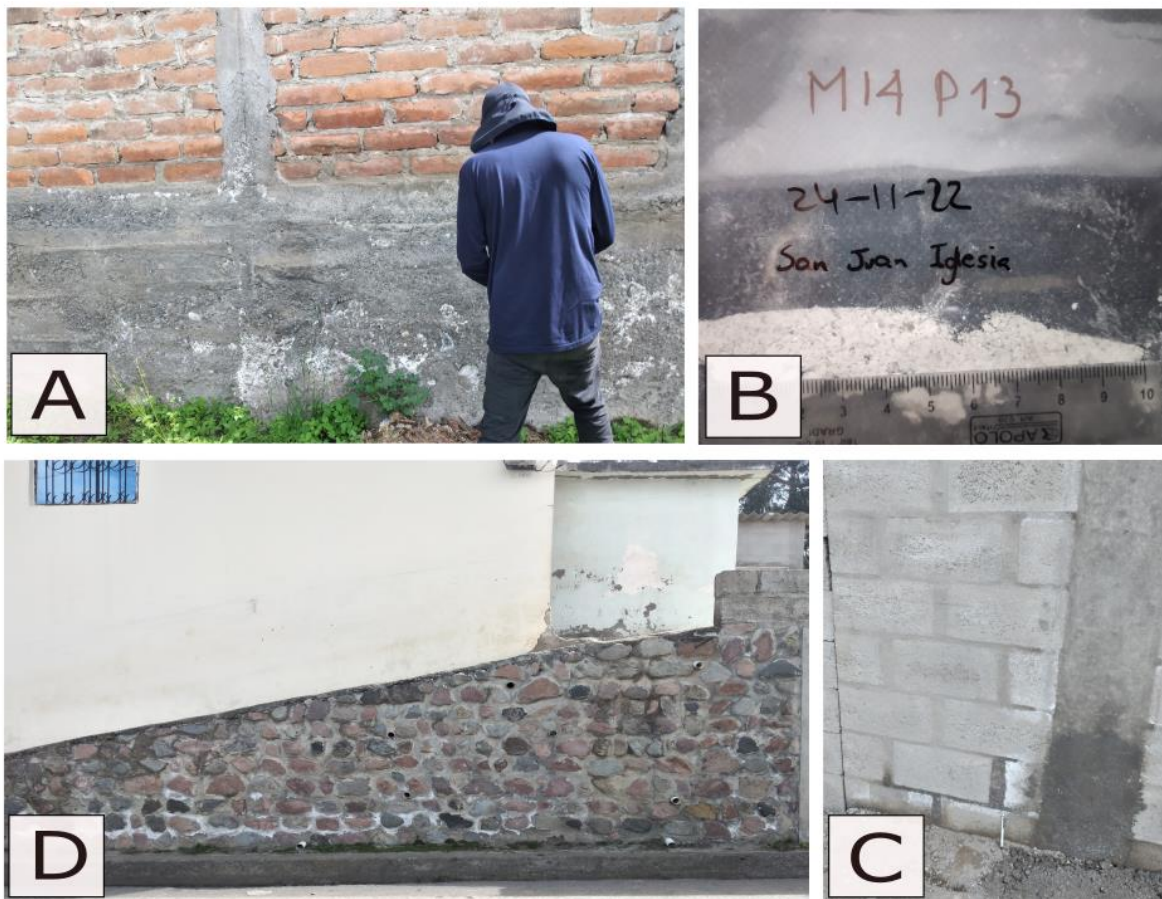
Figure 20. Taking crystals from a wall (A). The sample was taken M14P13 (B). White crystals are present at the base of a rock wall (C). Crystals are seen in a freshly built wall (D)

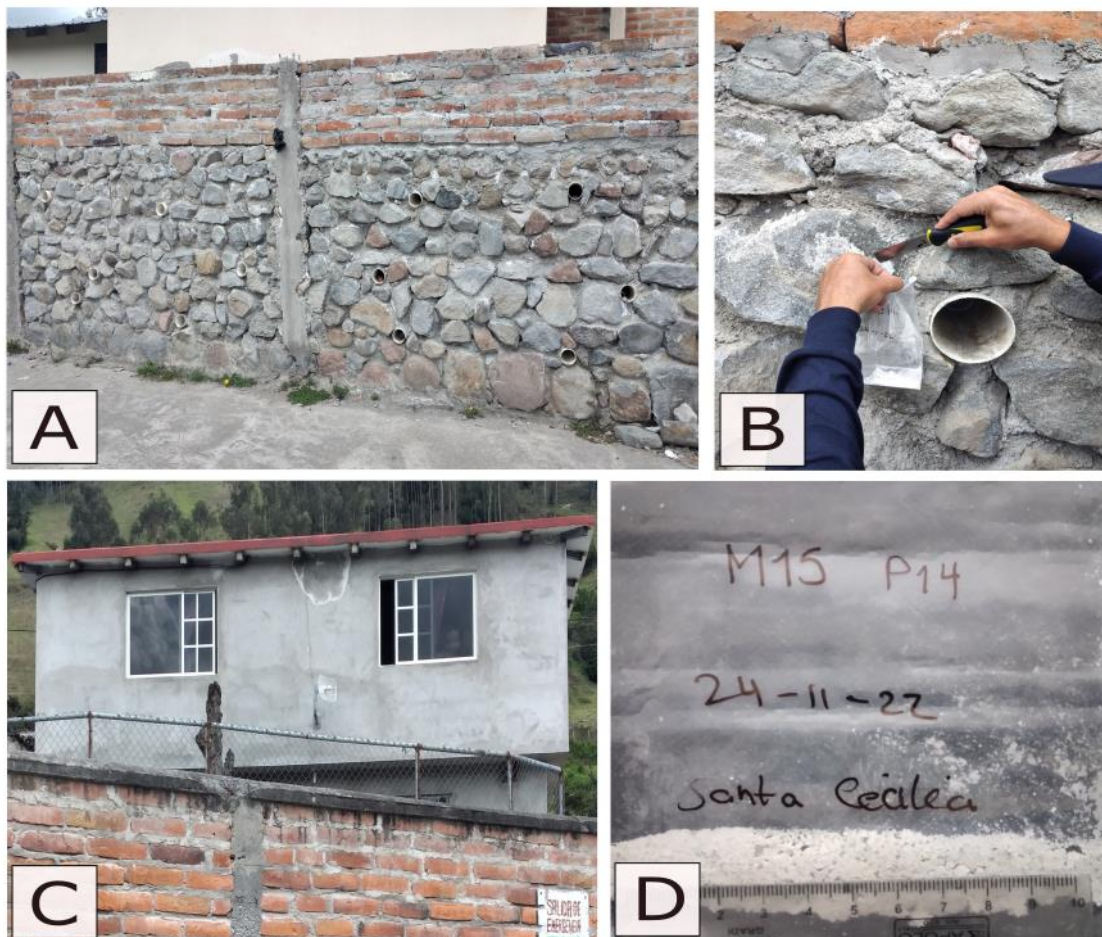
Figure 21. White minerals are present in lava brick walls in Santa Cecilia Community (See location in Figure 1) (A). Collecting crystals from the wall (B). A white splotch on a new house's second floor (C). Sample M15P14 taken (D).

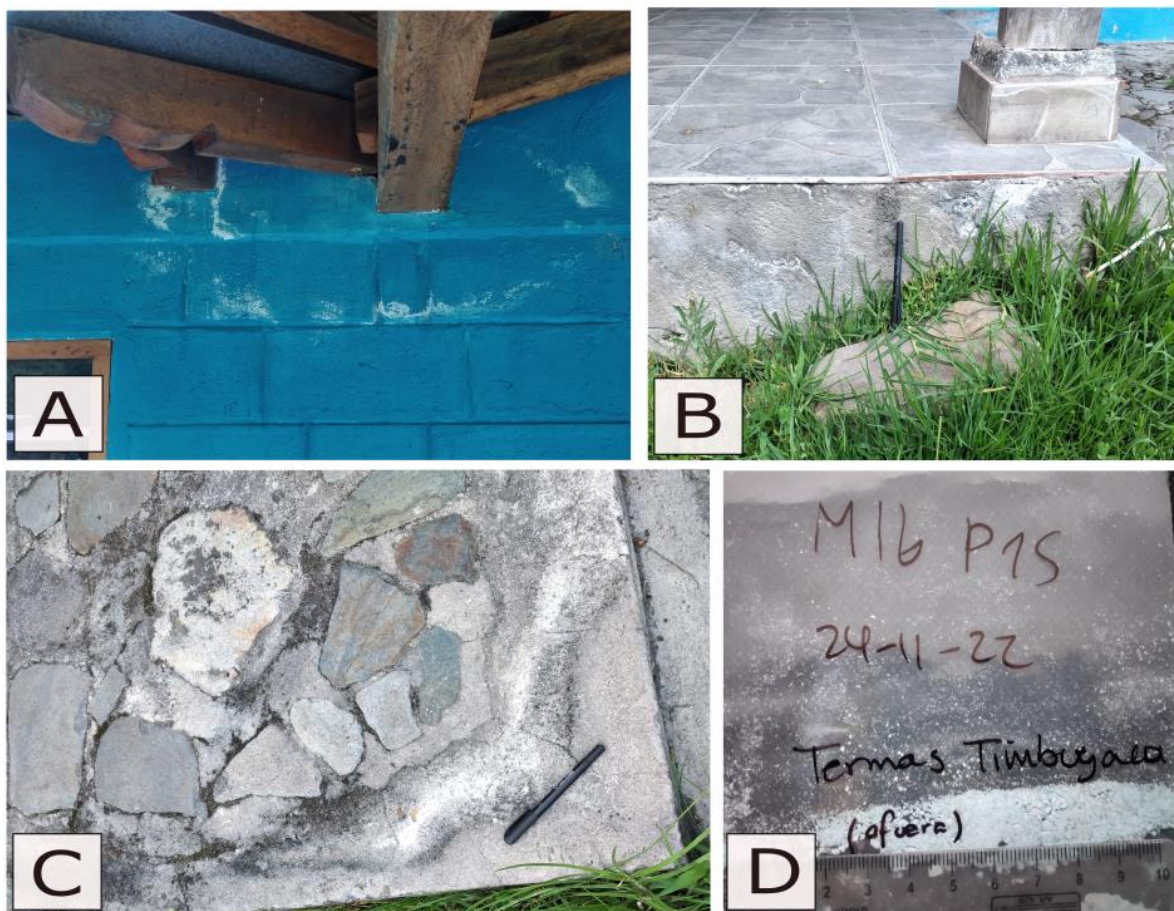
Figure 22. Crystals grow in the upper part of the wall in Timbuyacu Community (See location in Figure 1) (A). White minerals are presented on the floor (B). Crystals develop around volcanic rocks in the soil (C). The sample taken from the walls was analyzed (D).

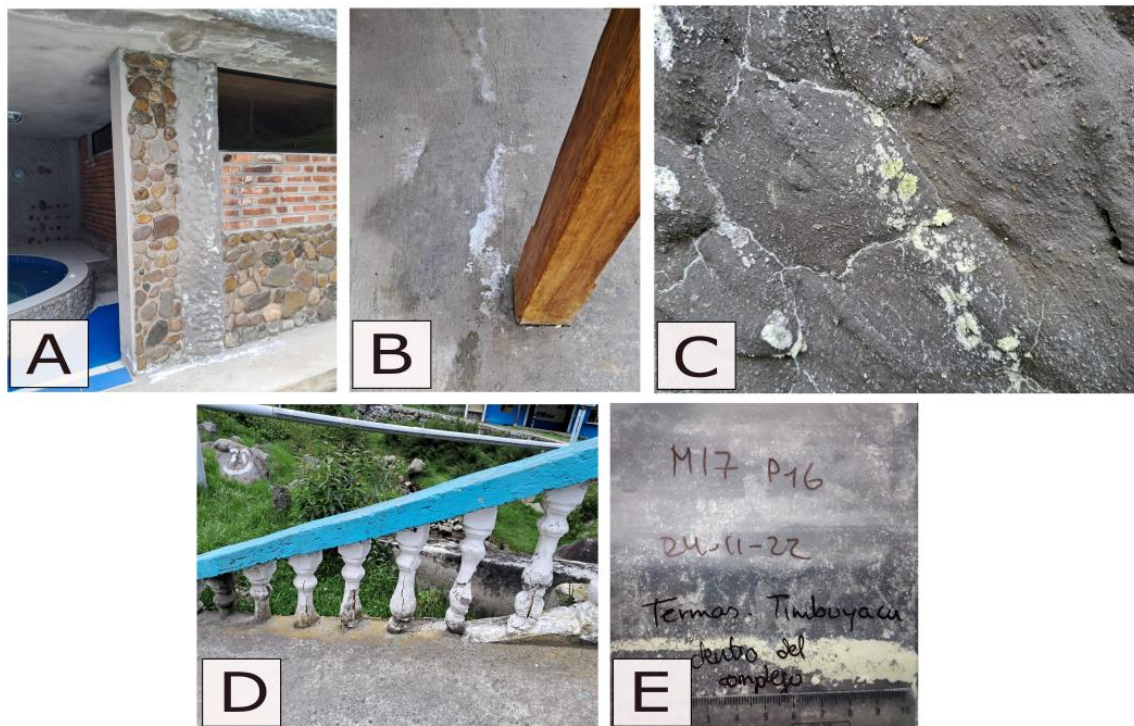
Figure 23. Timbuyacu Resort walls with salt crystals (See location in Figure 1) (A), Salts are growing in the soil (B), Cement railing pillars deteriorated (C), and Sample (M17P16) was taken from this resort.

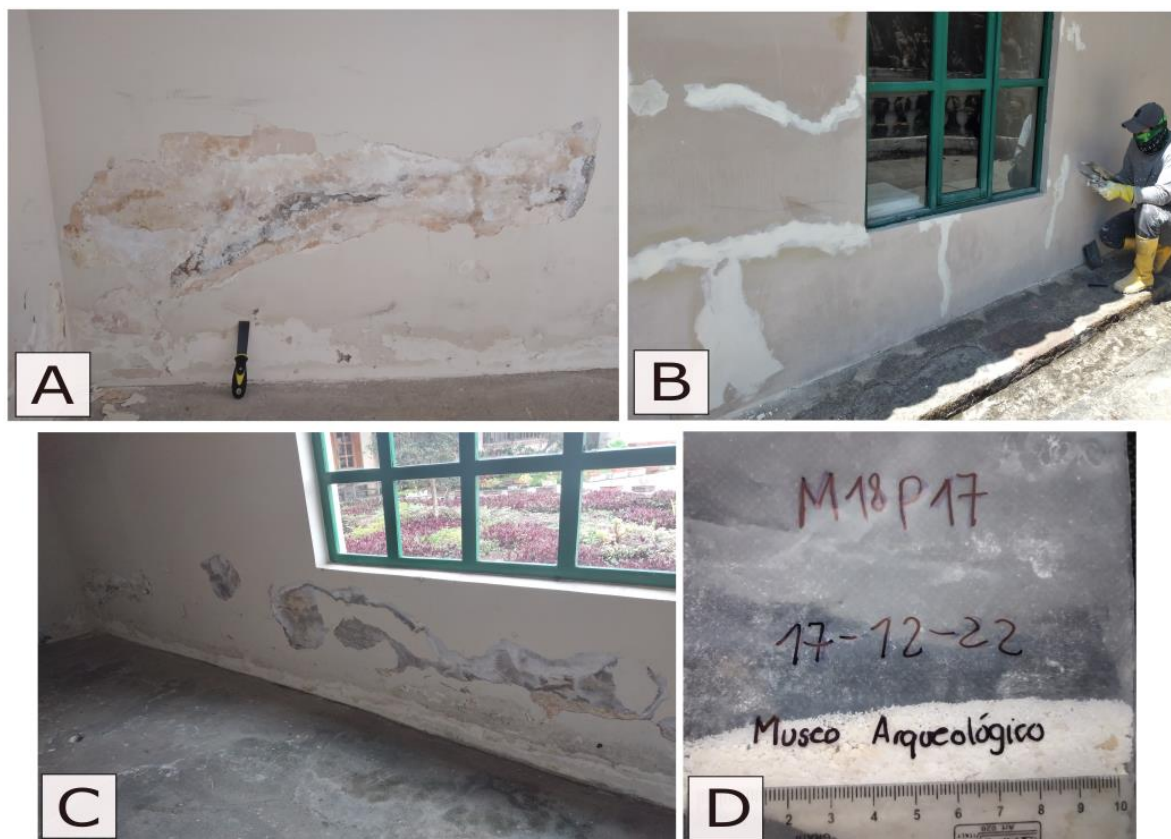
Figure 24. Outer wall with white crystals in San Eloy (See location on Figure 1) (A). Reparation of the wall in the Archaeological Museum (B). Overview of the wall with deterioration (C). A sample M18P17 taken from the external wall (D)

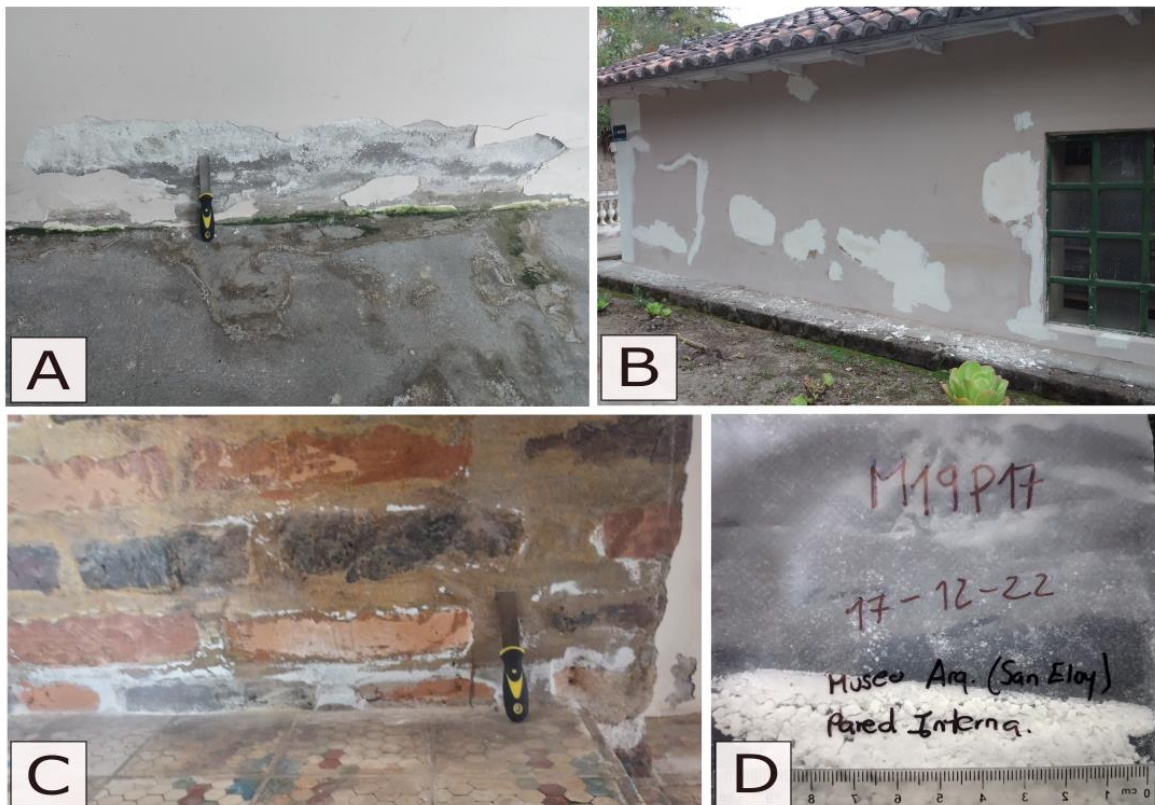
Figure 25. Inner wall with salt crystals in San Eloy (See location on Figure 1) (A). Reparation of the external wall in the Archaeological Museum (B). Clay blocks with salt crystals (C). Sample M19P17 was taken from the analyzed wall.
