**UNIVERSIDAD DE INVESTIGACIÓN DE
TECNOLOGÍA EXPERIMENTAL YACHAY**

**TÍTULO: “Characterization of Haloclasty to reduce the
deterioration of buildings in Urcuquí and near Villages,
Ecuador.”**

Trabajo de integración curricular presentado como requisito para la
obtención del título de Geóloga.

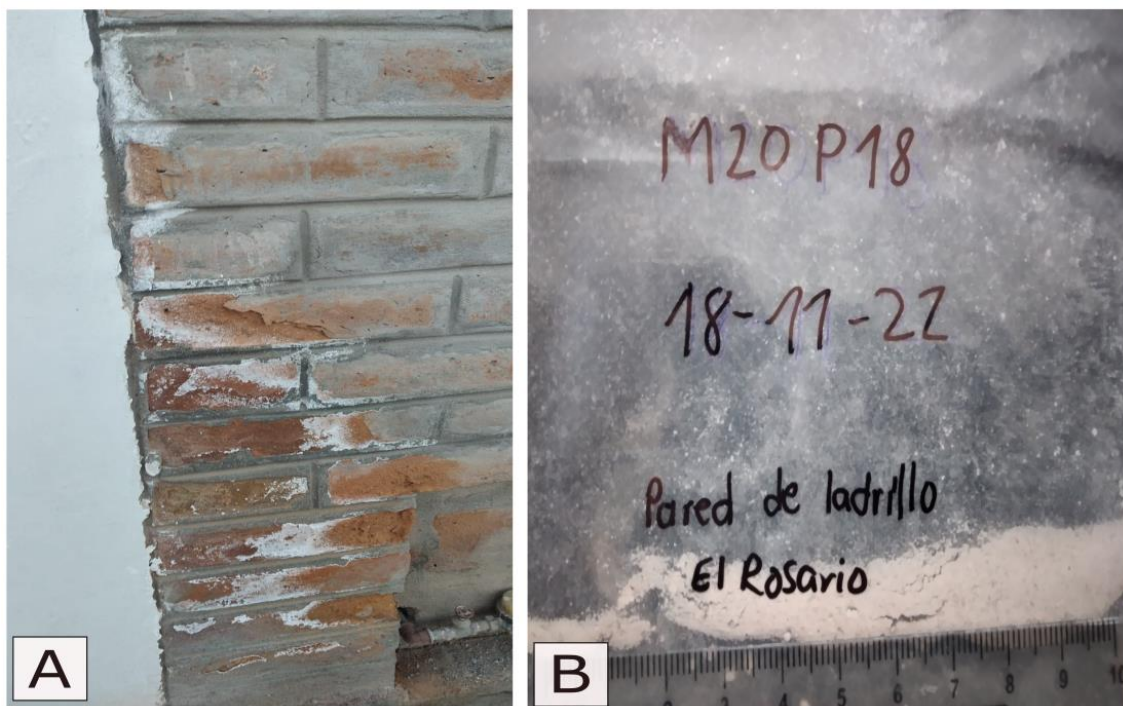
Figure 26. Brick wall with degradation and white minerals growing in El Rosario neighborhood (See location on Figure 1) (A). Sample taken from the wall analyzed (B).

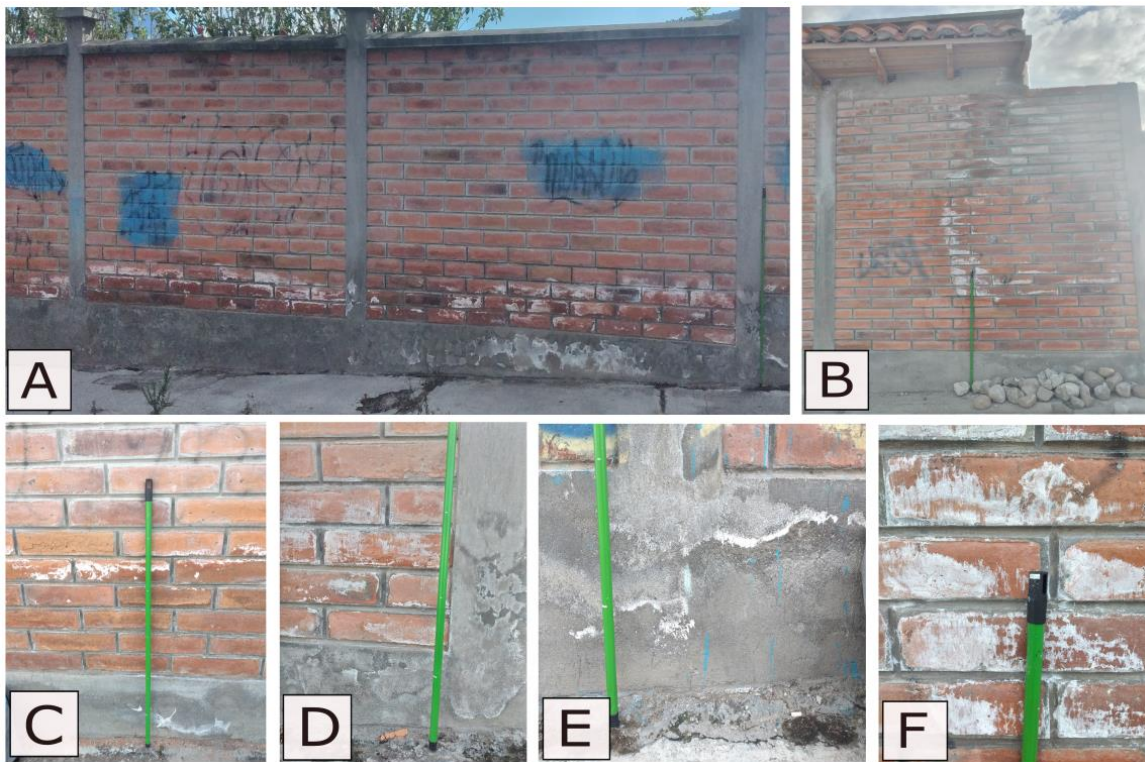
Figure 27. Clay Wall with a low degree of deterioration in Urcuquí (See location in Figure 1) (A). Crystals grow at the top of the wall (B). White crystals develop at specific C, D, E, and F levels.

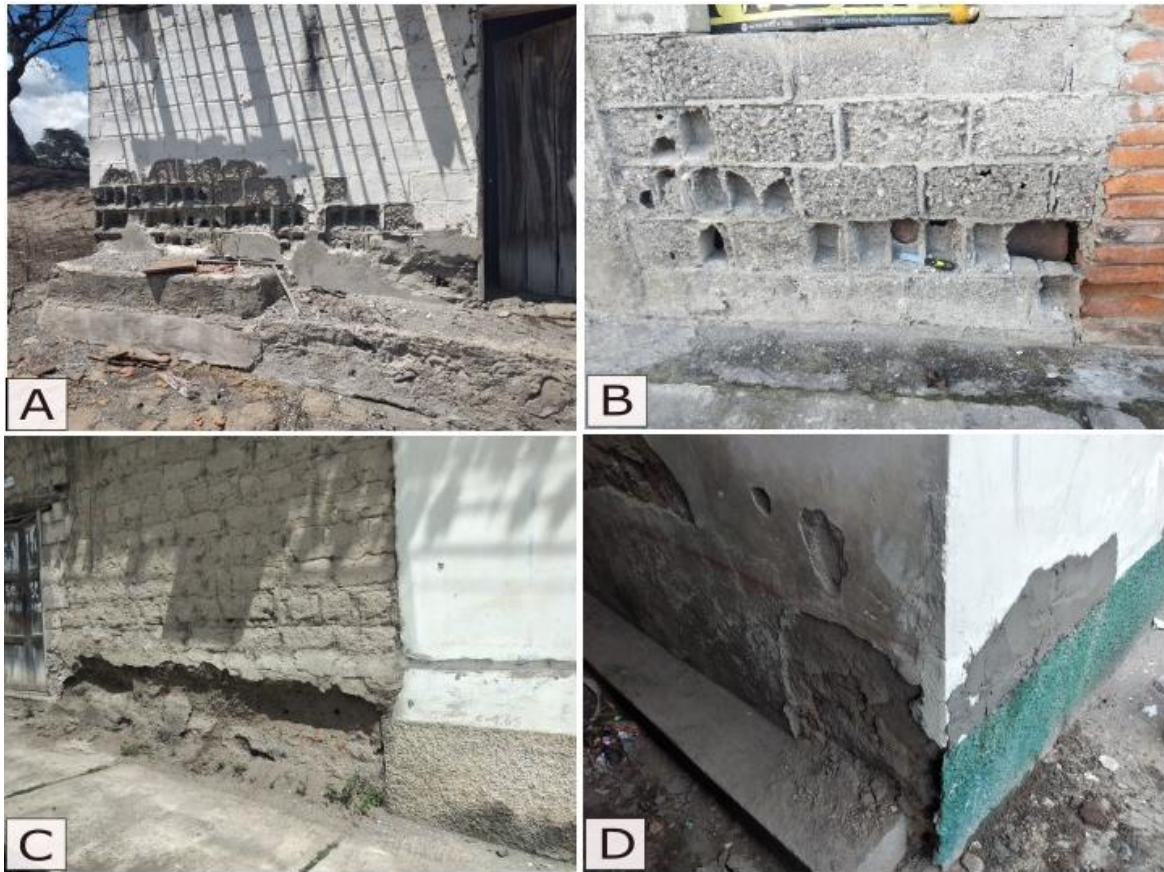
Figure 33. Constructions with deterioration at the base of the walls. Concrete blocks exposed to weathering with high levels of damage (A) (B). There are some missing blocks on a house wall in Urcuquí town, which was damaged by weathering (B)(C). The wall underwent recent repairs, with cement patches applied to cover holes that resulted from deterioration (D).

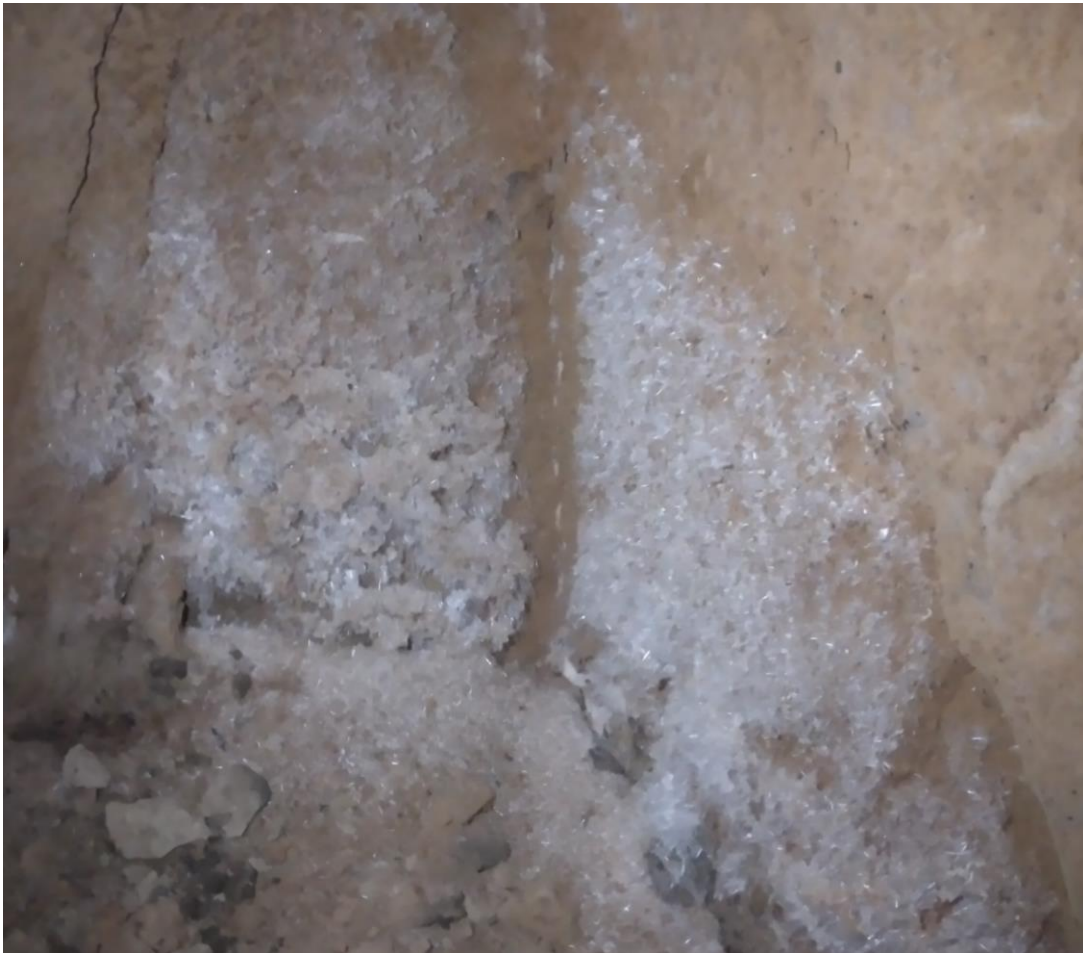
Image 2. It has been observed that the base of the wall in La Merced Hacienda is experiencing some form of deterioration.

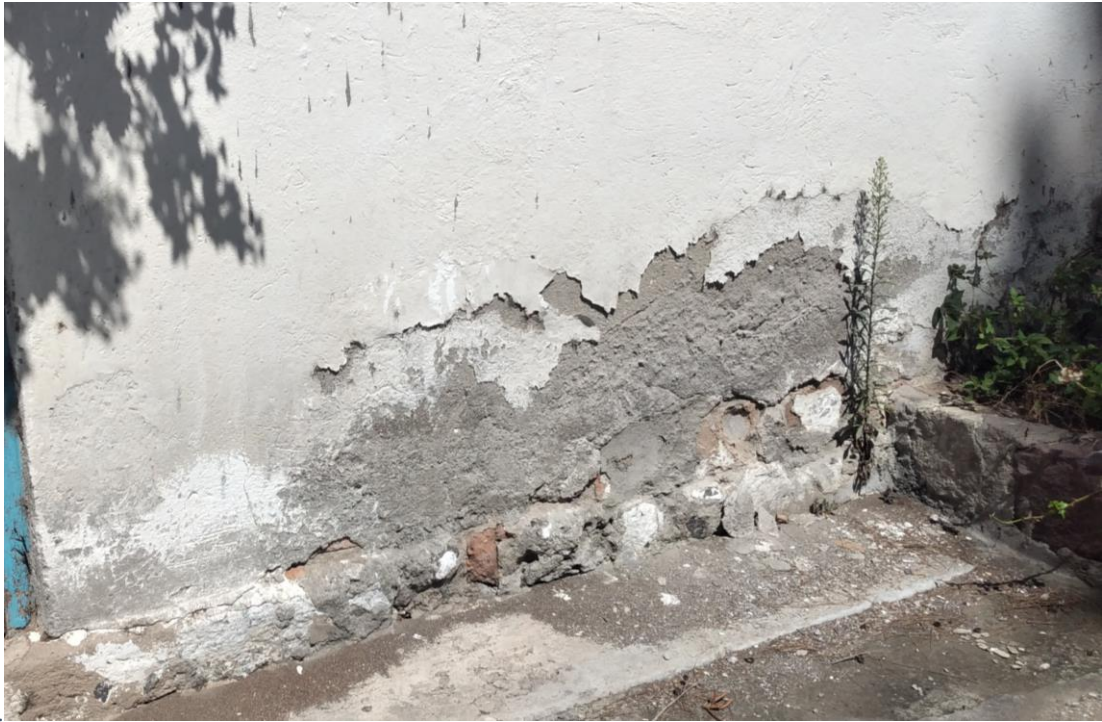
Image 3. Building under weathering agents shows the degradation of building materials.

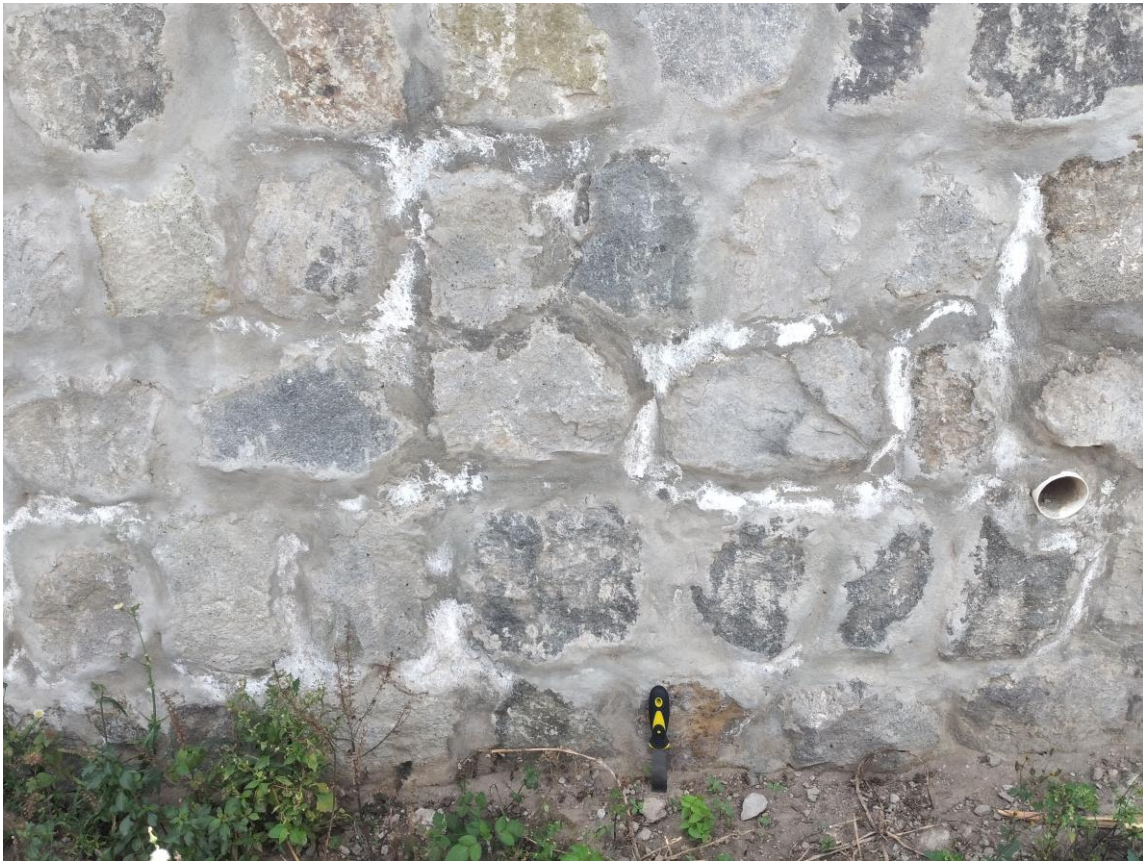
Image 5. The wetness at the wall base allows salt growth (white spots).

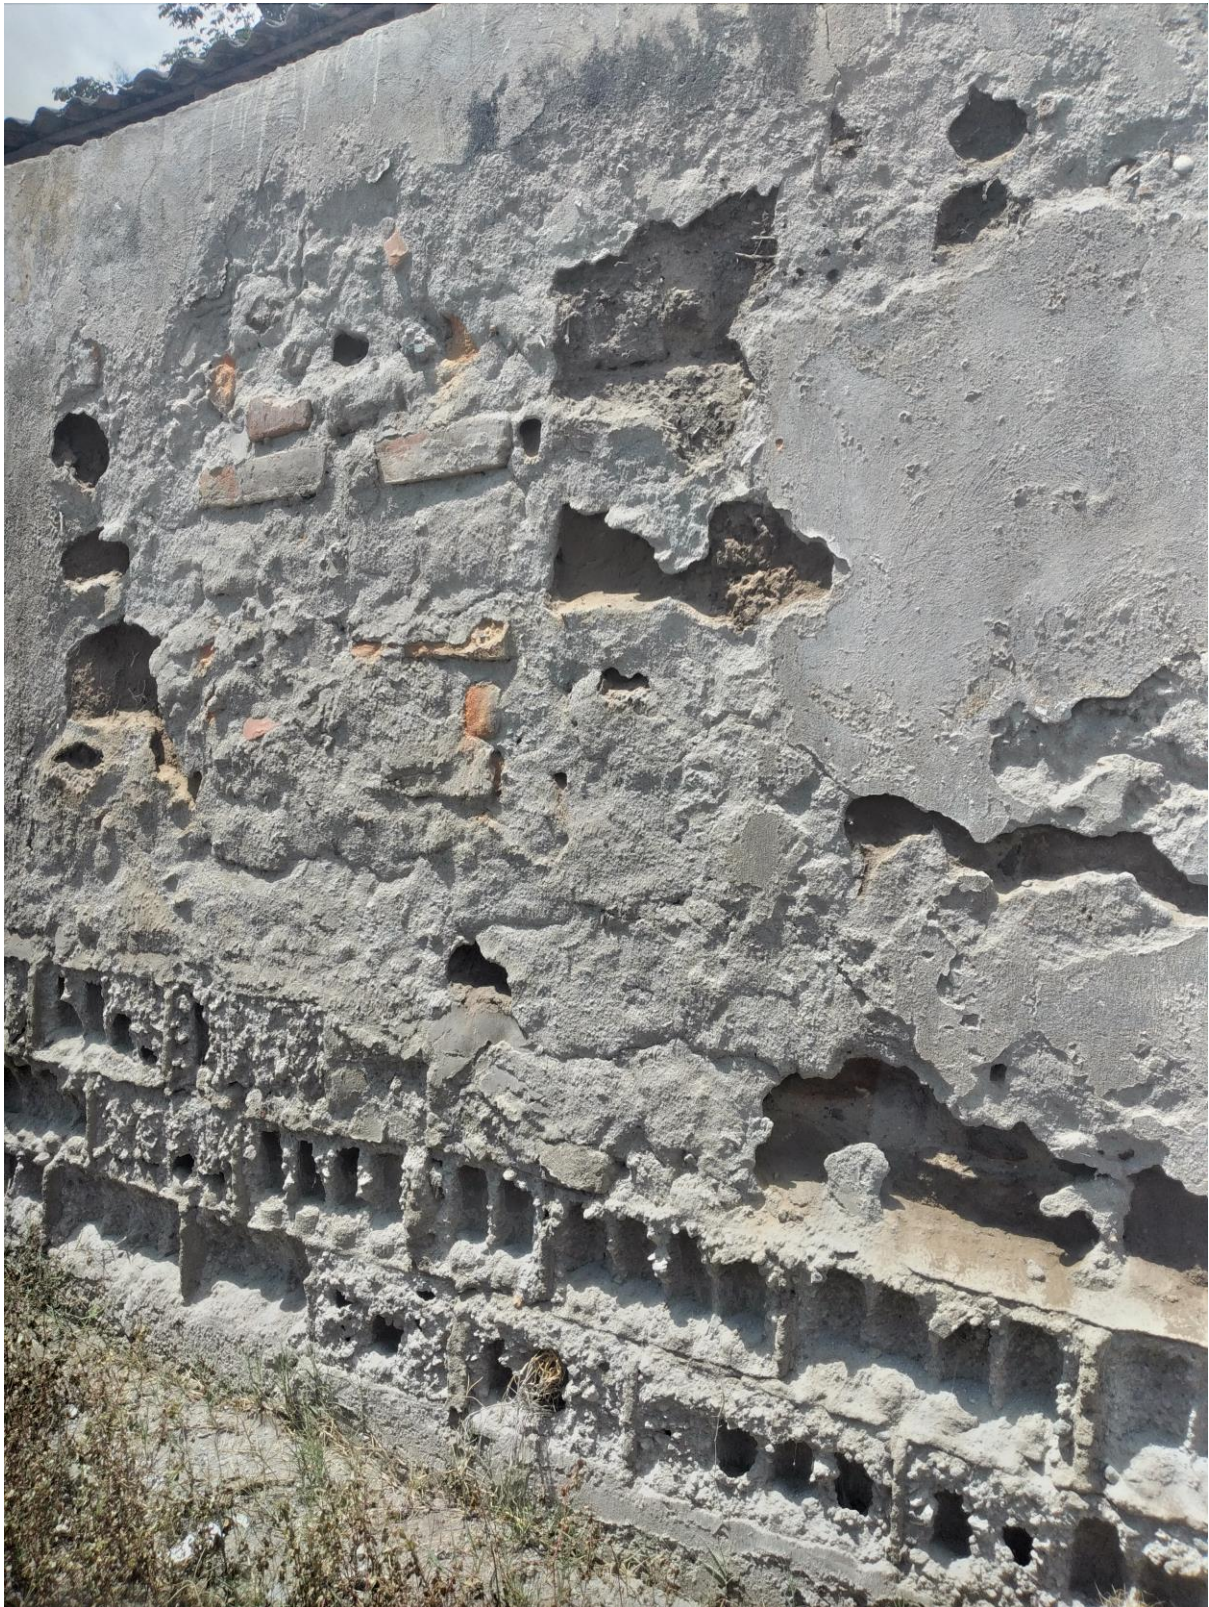
Image 8. Filtration of water could lead to the degradation of paint, forming salt crystals at the bottom of the wall.

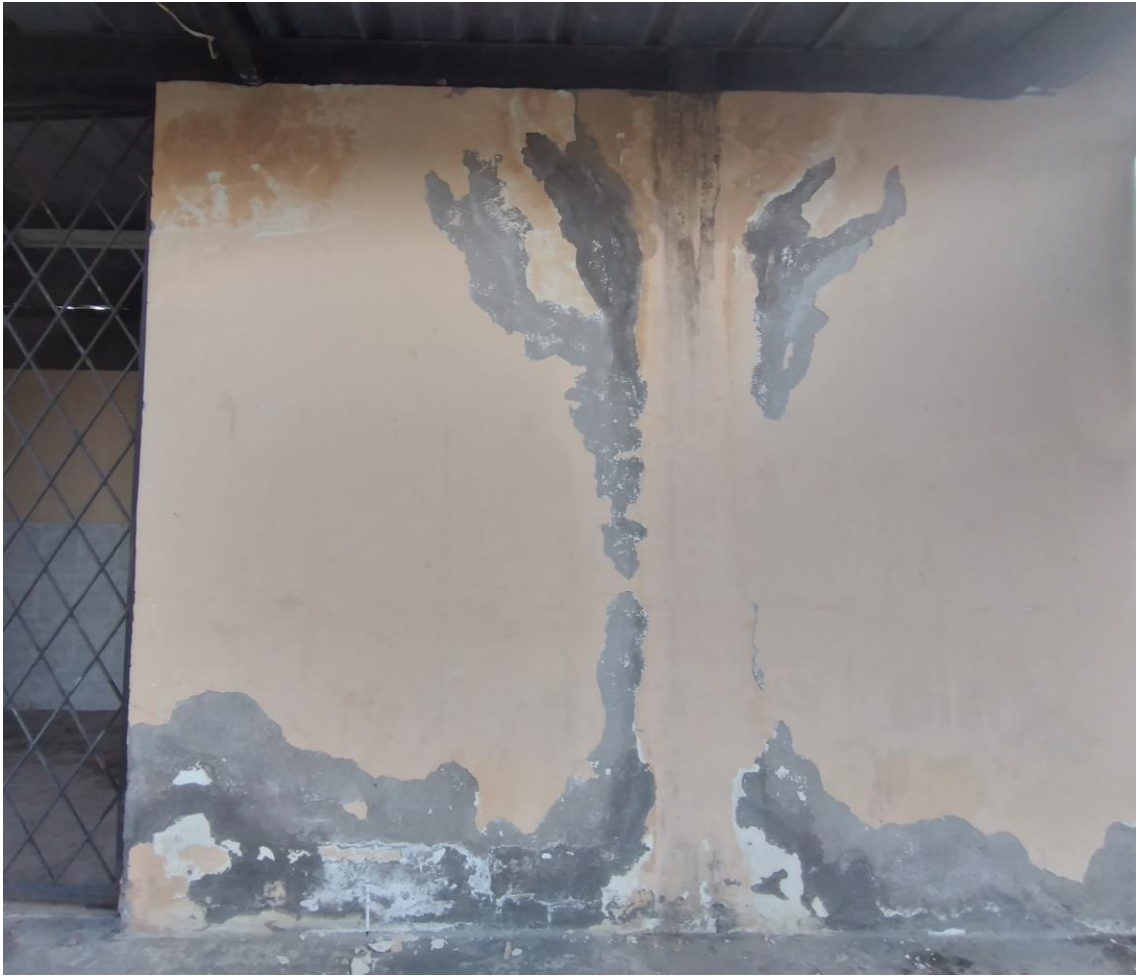
Image 9. The white and black spots on the wall indicate the presence of water filtration, wetness, and CO2.
