**UNIVERSIDAD DE INVESTIGACIÓN DE
TECNOLOGÍA EXPERIMENTAL YACHAY**

**TÍTULO: Incidence of Physical Weathering by Salt Growing
Deterioration Process Associated to the Aggregates Employed in
the Architectural Structures of the Riobamba City**

Trabajo de integración curricular presentado como requisito para la
obtención del título de Geólogo.

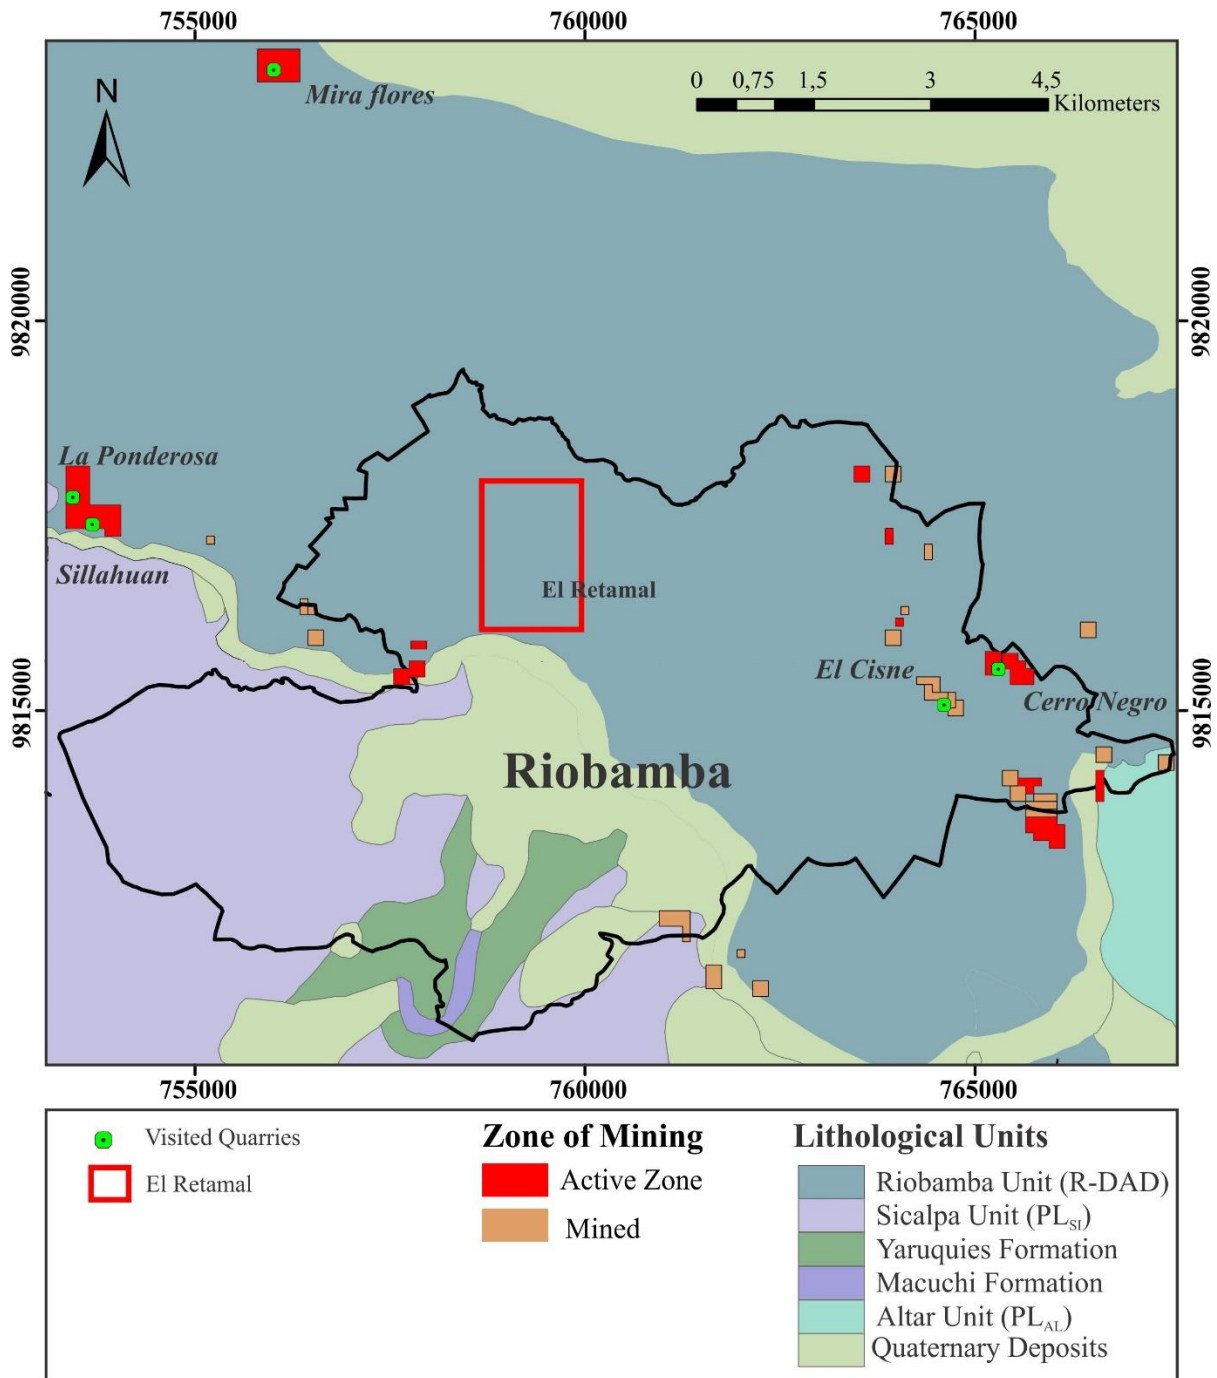
Figure 2. Geological Map of Riobamba City. This map shows the special distribution of the different geological units presents in the city. The Riobamba Unit R-DAD is the predominant and emerges the north and east of the city, the rest emerges at the south-west. The red and orange rectangles show the areas designed for mining y the municipality of Riobamba through the time. From these, red rectangles show the zones that still working. The map also shows the specific location of each quarry visited by the development of this project IGM (2012).

In addition, During the 13,14, and 15 of December of 2022 was carried out different filed trips toward the different quarries in Riobamba city (Figure 2). However, only was possible to visit the quarries located in the west, northwest and east, because the quarries in the south are closed and the access is restricted. In the quarries visited was verified their lithology, the way of mining and, the final products that spends (Annex.3).

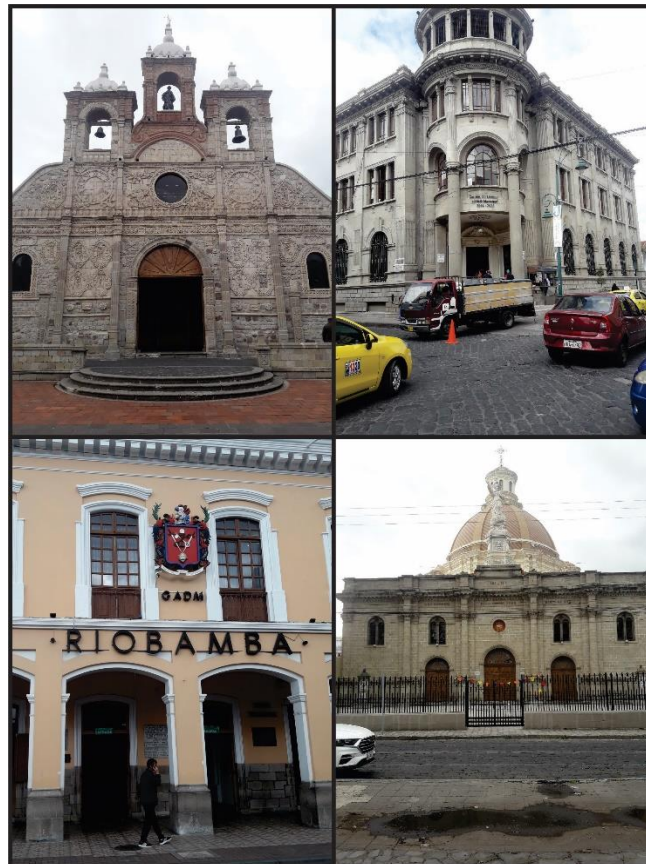
Figure 3. Historical Heritage Buildings of Riobamba city. La Catedral church, Edificio del Correo, Municipio de la ciudad de Riobamba and La Basilica church. Architectural structures of Gothic stile (Author).

Are consider as historical heritage buildings to which that have an historical value for the society and must be protected and conserved for the future generations (Vecco, 2010). In concordance with Lemache (2017) the heritage buildings in Riobamba are Gothic or Romanesque style, influenced by the Italian, Anglo-Saxon, and French architecture (Figure 3). These structures were built employing volcanic blocks, bricks, wood, and rammed earth. In Riobamba there are 435 structures recognized as historical heritage buildings which are located specially in the historical center of the city. (RIOBAMBA – Ministerio de Cultura y Patrimonio, 2022).

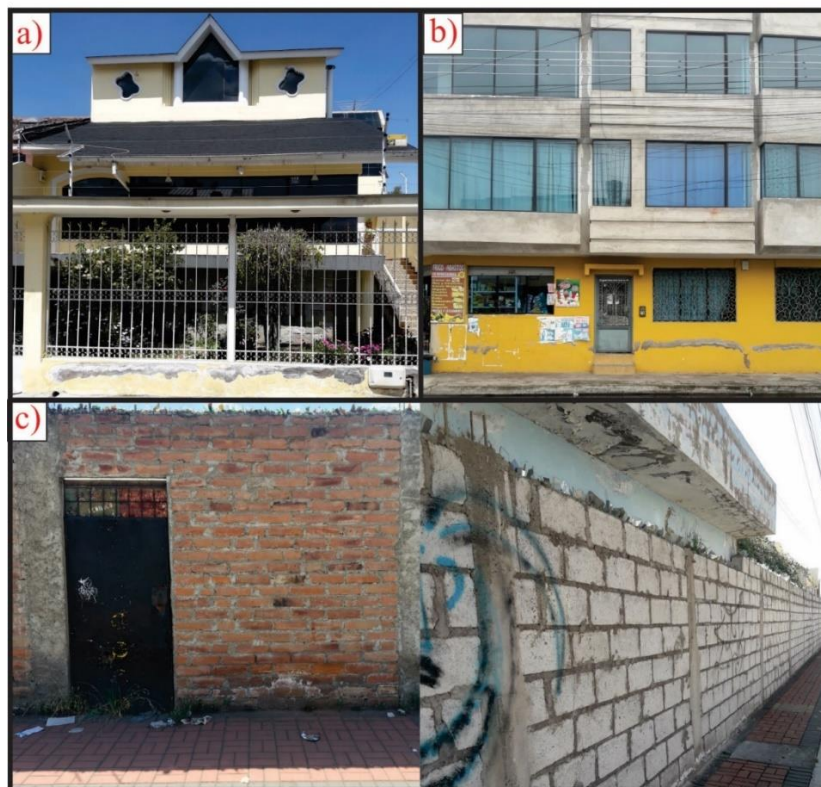
Figure 4. Republican Buildings in Riobamba city. The figure shows the typical republican buildings and its classification according to the ending of the building. a) shows a typical republican building built in base of concrete, bricks, iron, and aggregates. Likewise, a) is a white work building because the walls are cover by a white plaster and painted b) this picture shows a building where the ground floor corresponds a white work. However, the upper floors are designed as gray work building due to, the endings correspond a wall cover by mortar without protection against the environment. Finally, both walls showed in c) there are two different black work building because bricks (terracotta, concrete) and columns does not have any protection (mortar, paint) against the environment (Author).

- White work buildings: If the buildings are composed by concrete or terracotta bricks walls covered by a film of mortar followed by a shell of plaster, or paintwork, or both [Figure 4a)].
- Gray work buildings: If the buildings are composed by concrete or terracotta bricks walls covered by a film of mortar [Figure 4b)].
- Black work buildings: If the buildings are composed by concrete or terracotta bricks walls exposed directly to the environment [Figure 4c)].

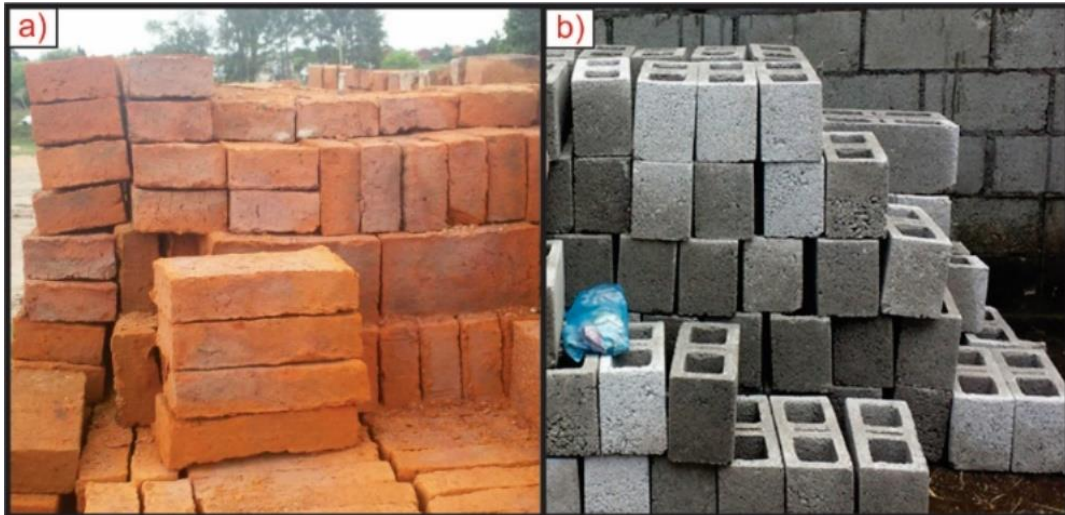
Figure 5. *Terracotta and Concrete Bricks. a) shows the form of terracotta bricks employed to build the different infrastructure in Riobamba city. b) shows the form how concrete brick is exposed to be expended (Gavilanes & Santellan, 2016).*

Concrete bricks correspond to great resistance compression blocks composed by Portland cement, sand and water, forming a past that is placed in molds with dimensions of 15x20x40 cm, its shape corresponds to hollow blocks inside without a plane of 15 x 40 cm. The paste solidifies in a minimum time of 28 days when it reaches its maximum resistance and obtaining its characteristic gray color (Figure 5b). The sand employed in this is extracted from the quarries of the city specially from Cerro Negro. In Riobamba there are many craft factories which spends this kind of bricks. (Romero & Chuquimarca, 2011).

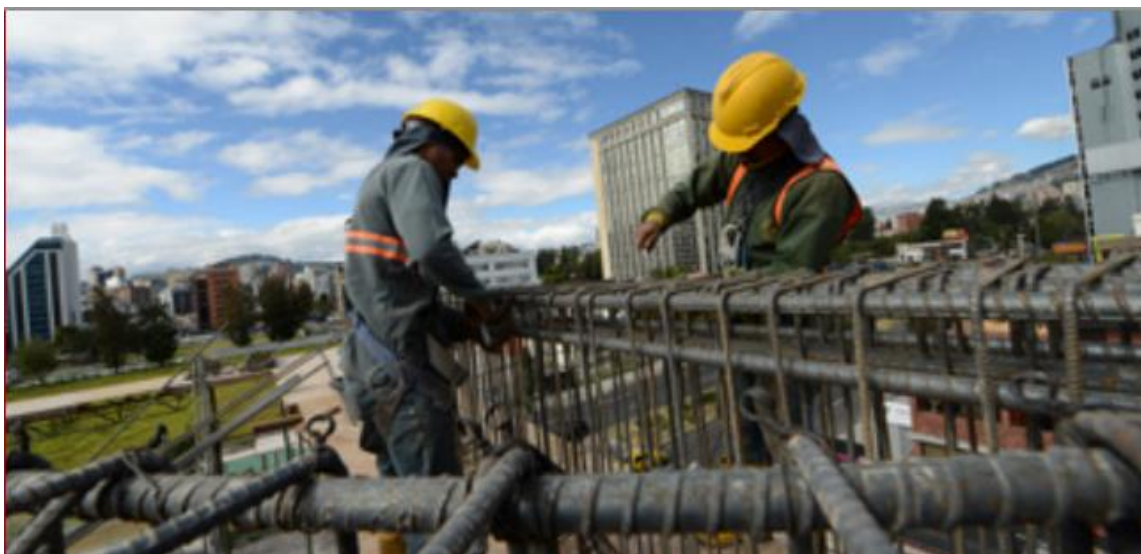
Figure 6. *Iron Rods. Iron rods structures employed to enforce slabs and columns. These structures are directly cover by concrete (Adelca, 2020).*

Iron rods: These consist in large iron cylinders which diameter varies in a range between 8 to 40 mm, according to the needs of the building. Iron rods are employed in the reinforcement of structures that could be concrete columns or slabs (Figure 6). The biggest distributor of Iron rods in Ecuador is Adelca company (Adelca, 2020).

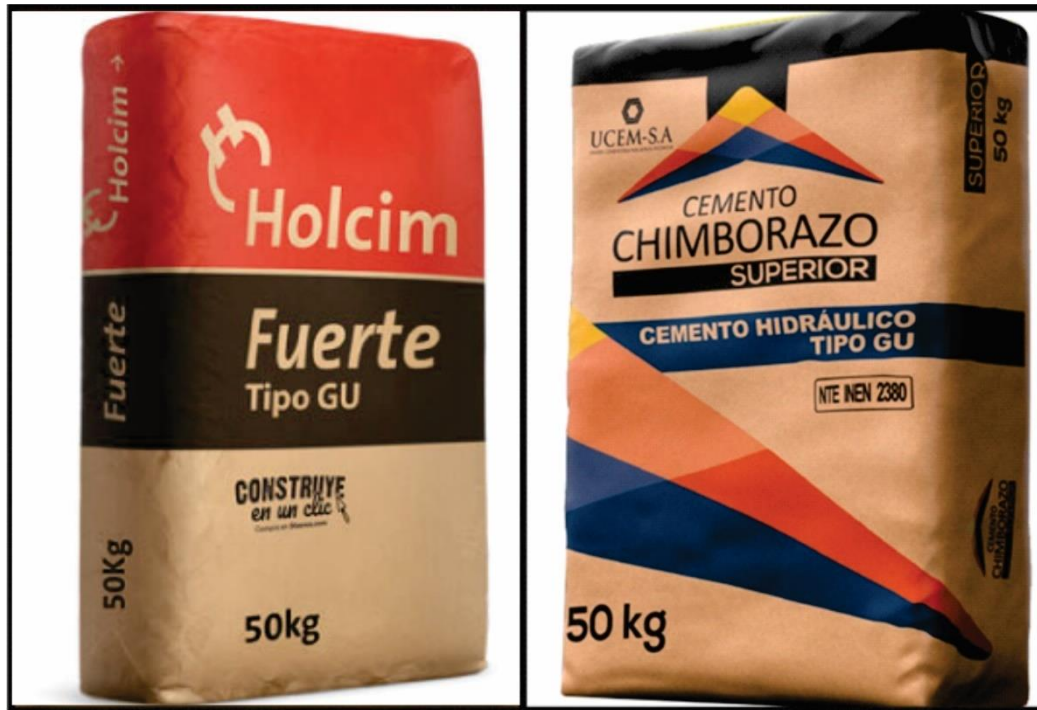
Figure 7. Holcim and Chimborazo Cement. The figure shows the typical presentation of the 50kg bag of Hydraulic Cement Type GU from the most important companies Holcim and Cemento Chimborazo. According with the normative of construction of Ecuador the GU type cement must be employed in general for buildings that does not need special specifications.

Cement: According to Instituto Ecuatoriano de Normalización in the NTE INEN 2380 (2011), the cement employed in general for buildings, that does not need special specifications, corresponds to hydraulic cement of GU type. This is a kind of Portland cement that reacts with water to form solid mass. Portland cement according the American Concrete Institute “is the product obtained by pulverizing clinker, consisting of hydraulic calcium silicates to which

some calcium sulfate has usually been provided as an inter-ground addition” (American Concrete Institute, 2022.). The chemical composition of the Portland cement is expressed in form of oxides CaO, SiO₂, Al₂O₃, Fe₂O₃, where could be included other materials, but in a very low proportion (Orna, 2019). In Riobamba the most important companies that spend hydraulic cement UG type corresponds to: Cemento Chimborazo, and Holcim Ecuador (Figure 7).

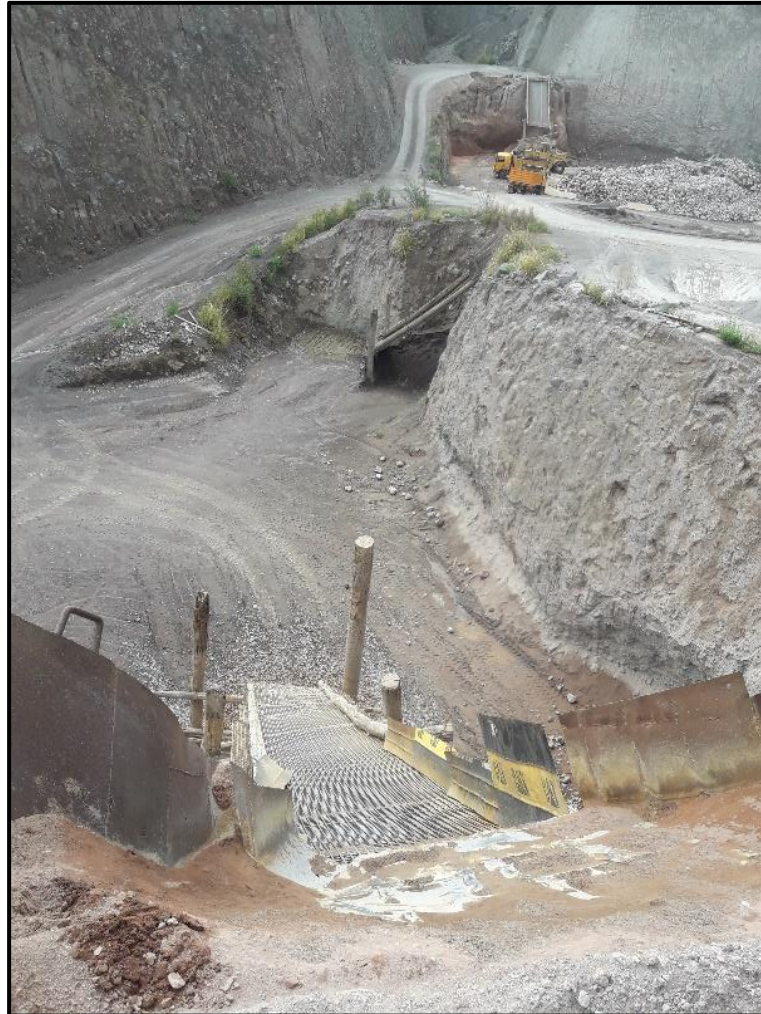
Figure 8. Mira Flores Quarry. The figure shows a typical quarry in Riobamba city. This quarry corresponds to Mira Flores and it is located at the north of the city in the Panamericana E-35 highway. In the background of the image, it is possible to see how heavy machinery mined the material from the deposit. This material posteriorly is sifted to be expended at the citizens (Author).

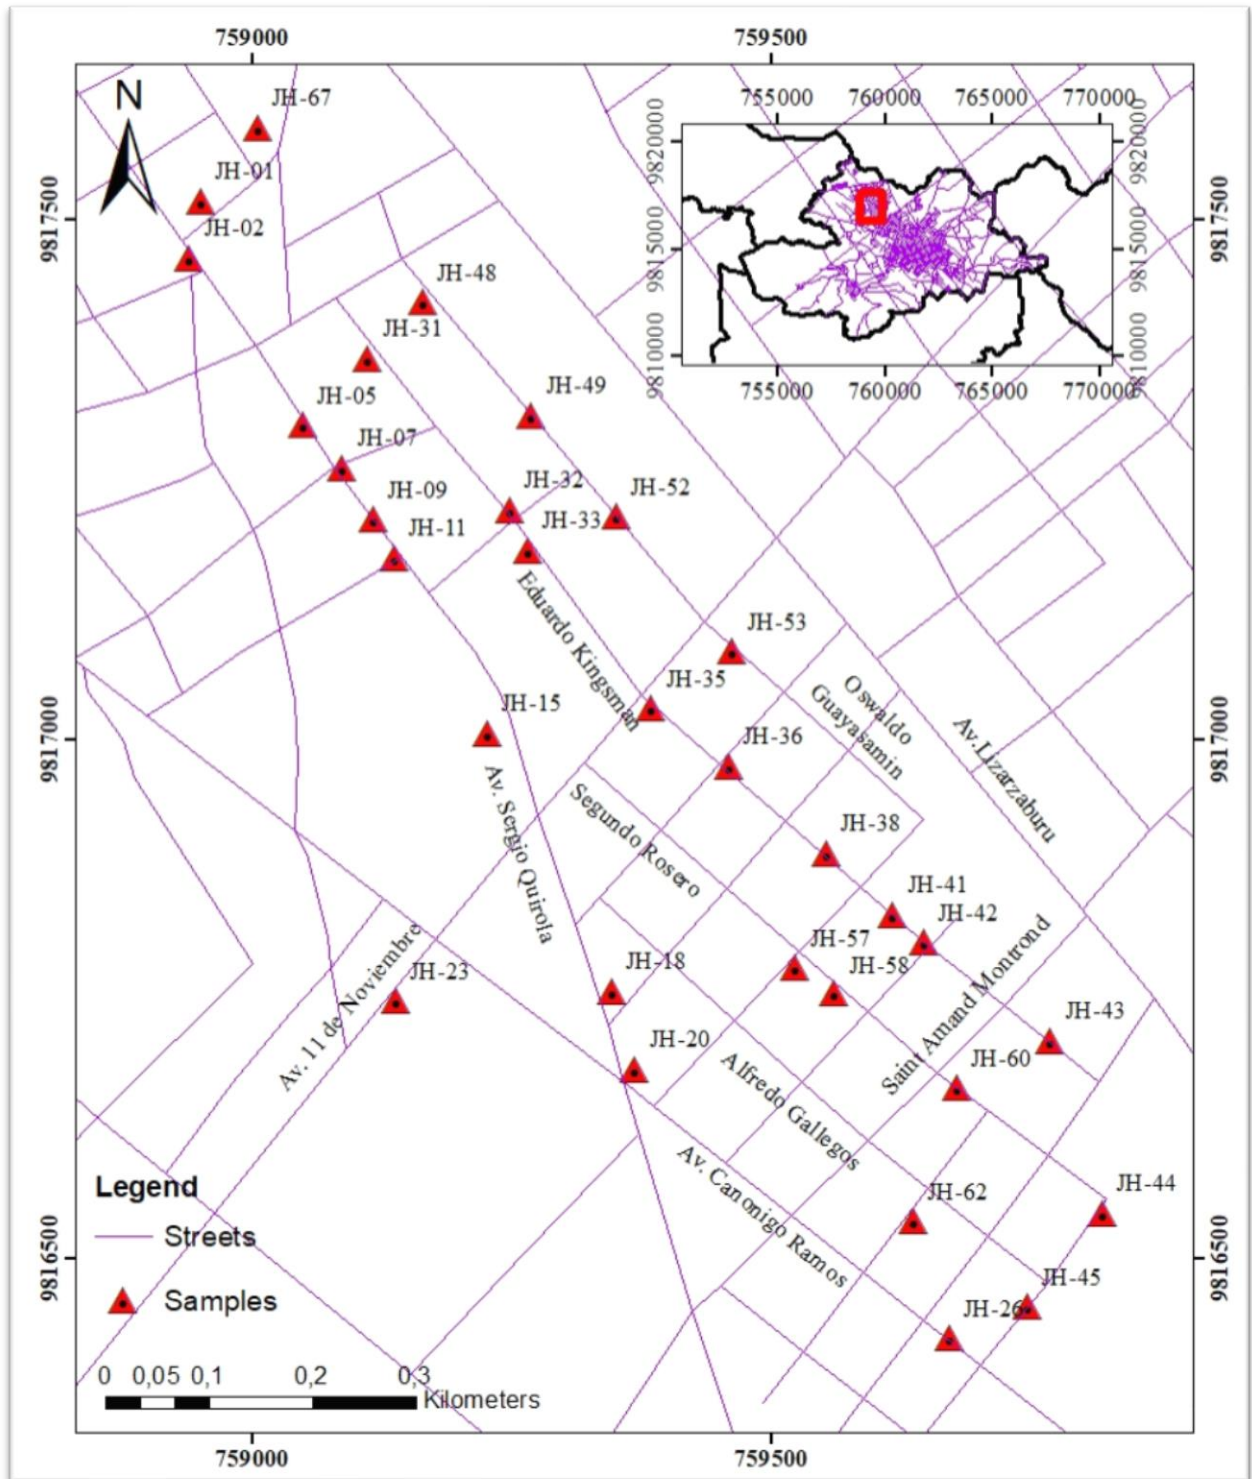
Figure 9. Study Zone. The map shows the northwest part of Riobamba city known as El Retamal. The red triangles show the points where the different samples were taken. The principal streets and avenues travelled corresponds to: Av. Sergio Quirola, Av. 11 de Noviembre and, Oswaldo Guayasamin, Eduardo Kingsman, Segundo Rosero Alfredo Gallegos streets (Author).

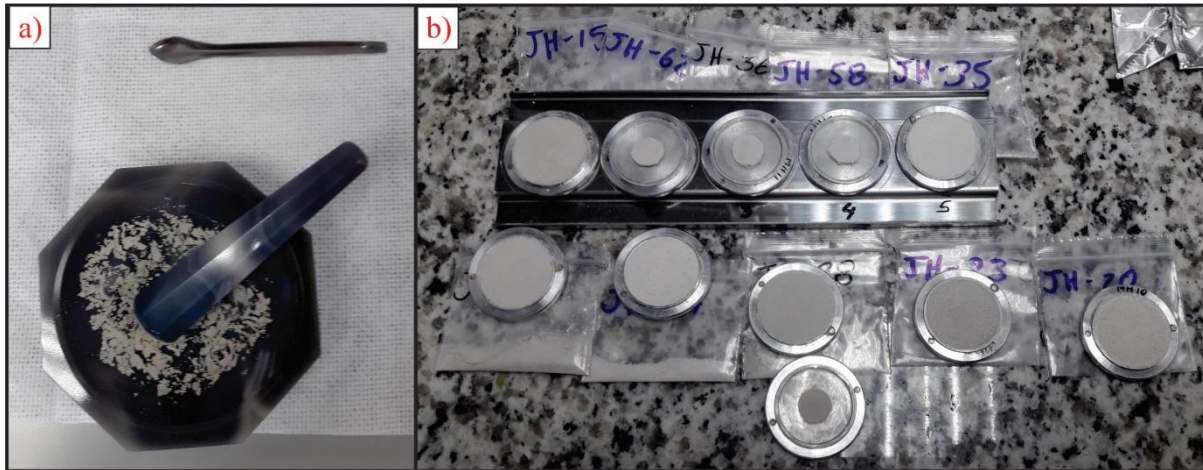
Figure 10. Sample processing: The pictures show the different steps necessary to the samples turns adequate for the XRD analysis. The picture (a) shows the pulverization of the sample, while (b) shows the correct way to emplaces the samples in the molds (Author).

The preparation of the 32 samples consists in the manual pulverization of each sample until obtain particles as fine as possible employing a mortar [Figure 10 a)]. The samples must become in a silt grain size (Figure 10a). Posterior, the pulverized sample is placed in molds designed specifically by the XR-D analysis avoid any fissure in the surface of the sample how is showed in the (Figure 10b). Finally, the molds are placed in the XR-D analyzer and the parameters for the analyses are adjusted (Figure 11).

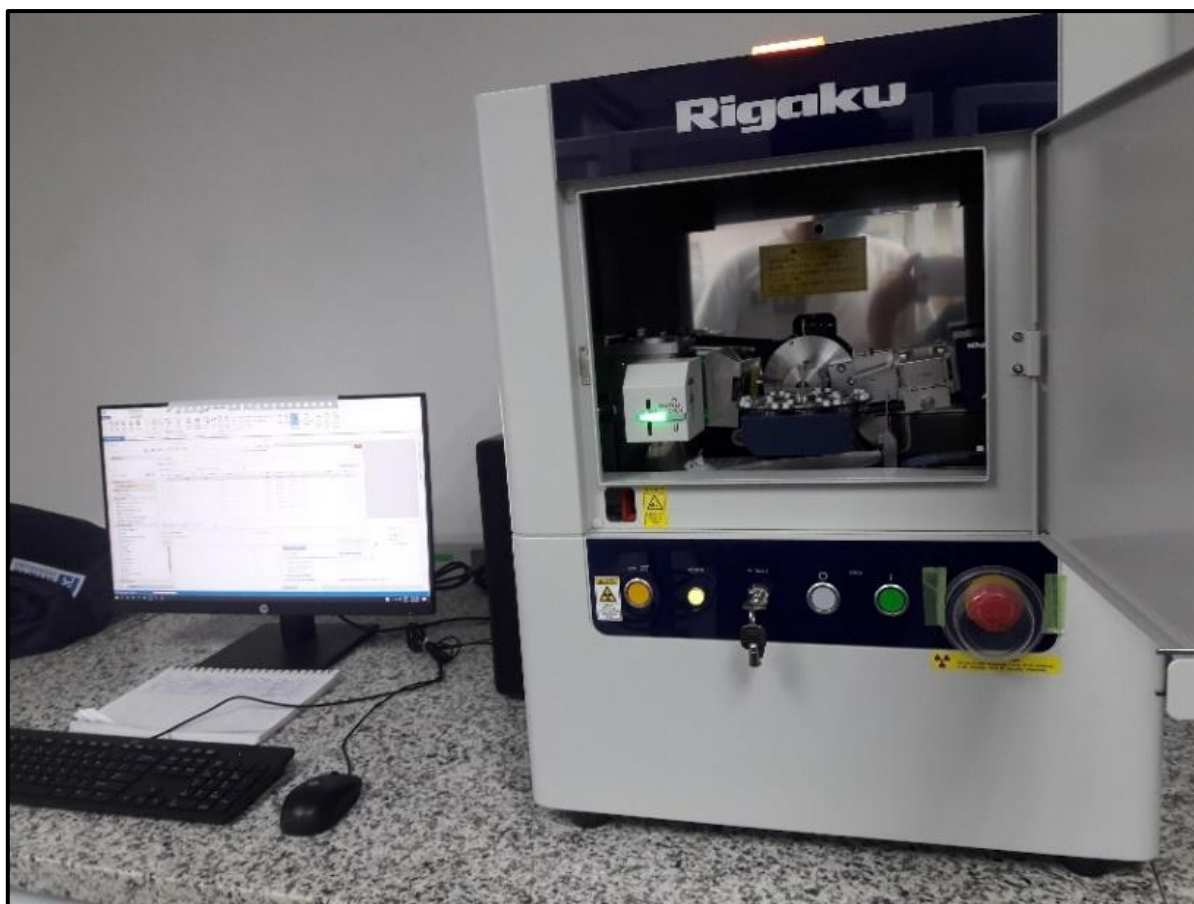
Figure 11. XR-D analyzer from the Yachay Tech university. The samples are scanning in the machine located at the right. Posteriorly, the data is digitalized and saved in the computer located to the left (Author).

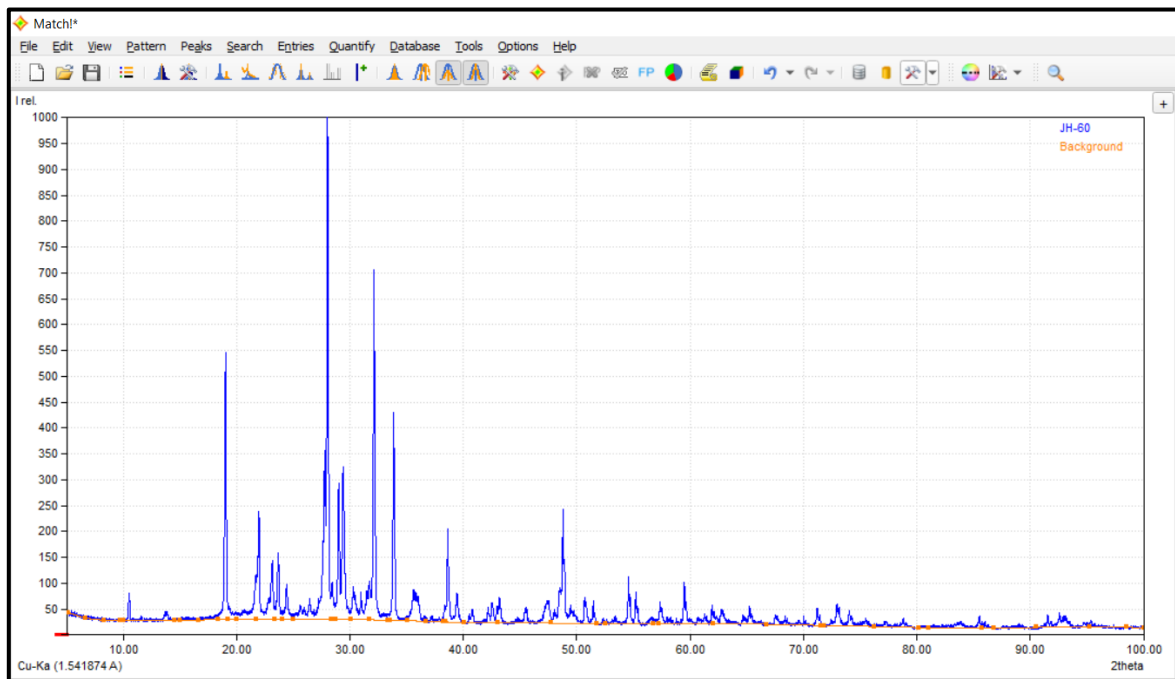
Figure 12. Interference Figure. The blue line represents the interference figure obtained as data from the XRD analyzer. This figure is processed by the software Match! To identify the different mineral phases present in the sample (Author).

Nowadays, to solve this equation is used the software Match!, which give a result in form of figure know as interference figure. This interference figure is compared whit an extended data base that contains the standard interference figure specific for each mineral phase. In addition, Match! give the probability of the presence of a specific mineral phase, and a qualitative value in percentage form of this phase in relationship of the whole sample (Abdulrazzak & Alkiam, 2019).

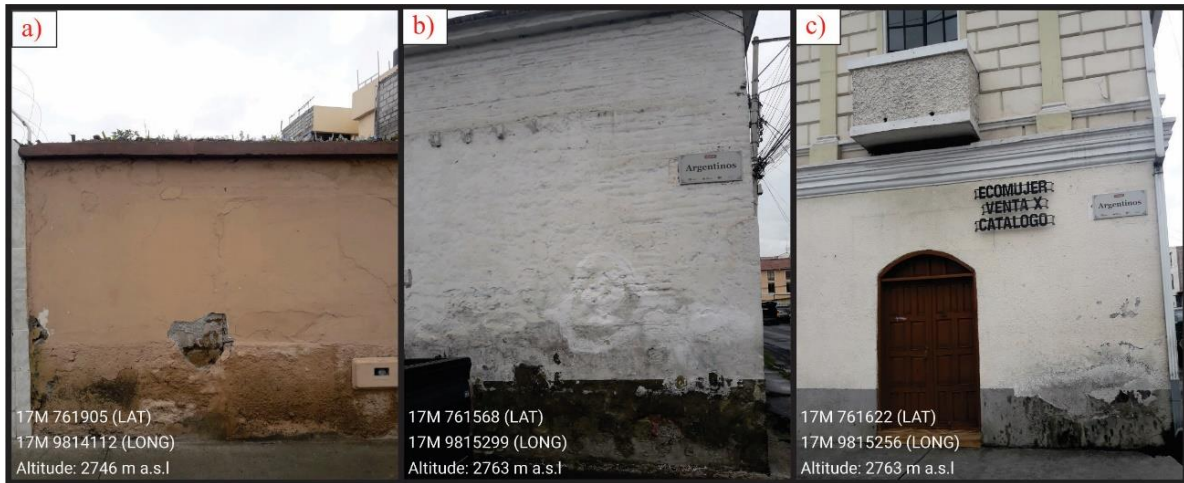
Figure 13. Historical Heritage Buildings of Riobamba City. The figure shows three different kind of historical heritage buildings which were covered or fixed by modern mortar. In these three buildings the salt growing process is limited to the zones covered by modern mortars. The picture a) shows a big hole where the mortar has been removed exposing the rammed earth, inside the wall, to the environment. In the picture b) the deterioration is associated at the mortar surrounding the volcanic rocks arranged in the base of the wall. Finally, picture c) shows slat growing affection in the façade of the building (Author).

In republican buildings, the deterioration problem corresponds to a cyclic process that manifest itself in the form of efflorescence and/or in form of alveolar erosion. This kind of deterioration represent an aesthetic problem, due to, the salts growing ruins the facades of the buildings. Likewise, this ruins the internal walls, associating with the buildings deteriorated and careless aspect, and forced the owners to spend money periodically.

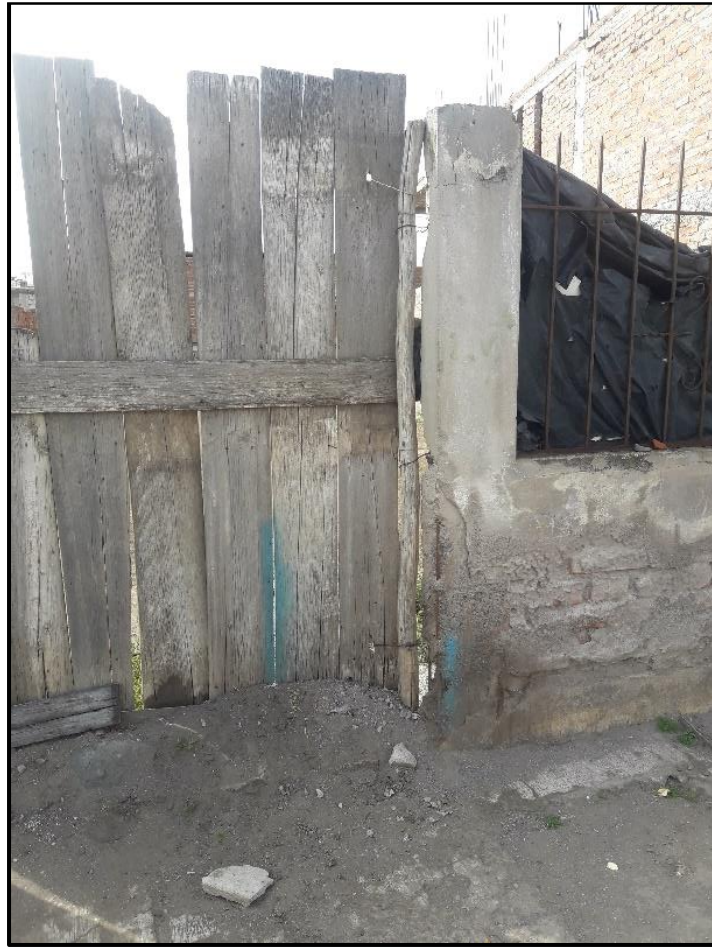
Figure 14. Several Cases of Salt Growing. The figure shows a several cases of slat growing where the mortar that cover the walls and the concrete that covers the iron rods have been removed. Likewise, the iron rods exposed in the lower part of the column show signs of oxidation. Even though the iron rods are exposed, no flexion of the concrete column is seen (Author).

The corrosion in iron metals is the result of action to hydrated oxides that increasing the iron original volume. In general iron materials are dep in structures as a consequence its interaction with water is restricted. However, in case both stay in contact, the stress produced by the iron expansion is enough to produce cracks in the surrounding material (Torraca, 2005) (Figure 14).

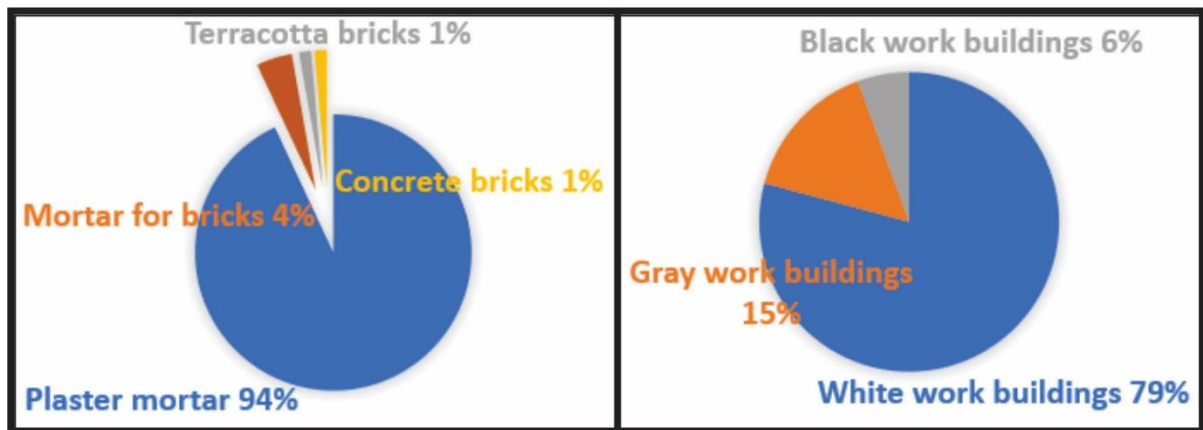
Figure 15. Salt Growing Incidence in Republican Buildings. The left figure shows the relationship between the salt growing phenomenon with the different mortars and bricks employed in civil architecture. The right figure shows the incidence of salt growing according the three kinds of republican building (Author).

From the observations the level of deterioration associated with salt growing is intermedium because this only affects the aesthetic appearance of the buildings. This forces to owners to spend money to repair and/or maintain the good facades aspect of their homes. Fortunately, this phenomenon does not represent a structural problem for the structures.

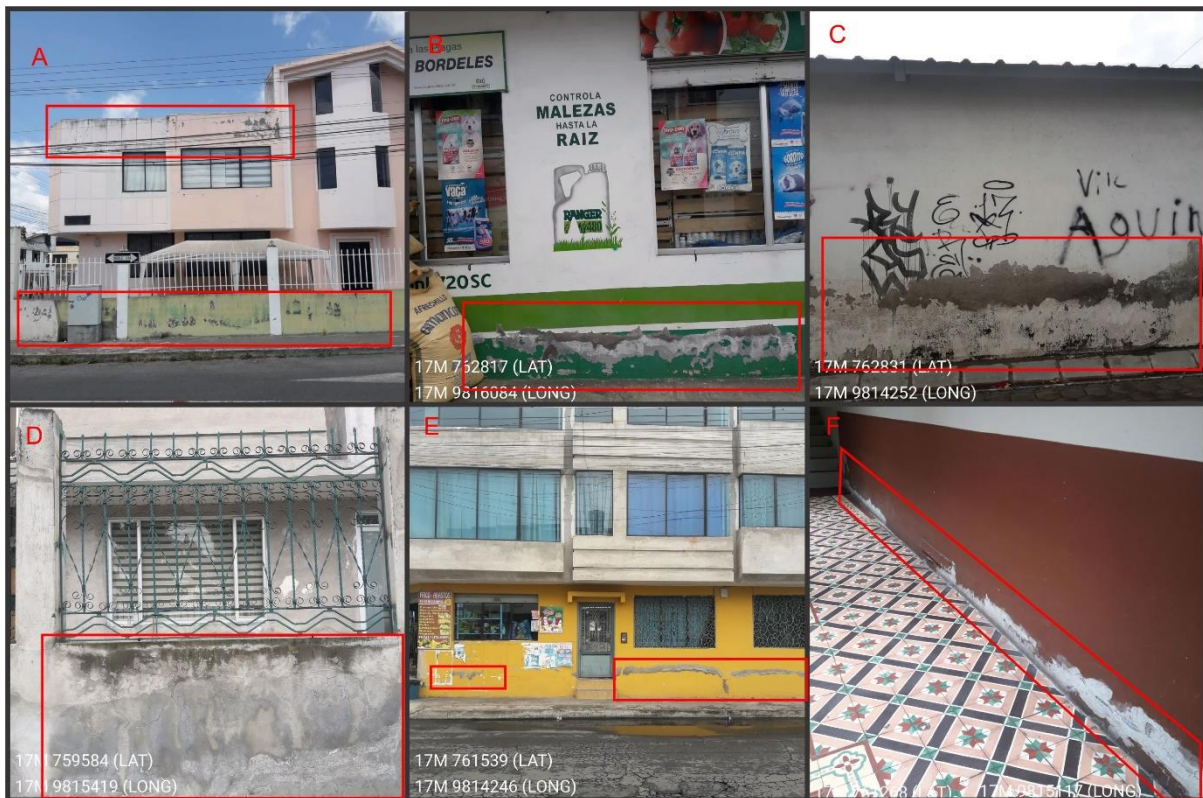
Figure 16.. Distribution of the Problematic around the Riobamba city. This figure represents six different republican buildings located in different parts of the city where the salt growing deterioration is present especially in façades, but it is also inside the buildings. The pictures A, B, C, and the ground floor of picture E represent white work buildings affected by salt growing producing the deterioration of the facades. Picture D shows how salt growing process affects gray work buildings. Finally, F shows that salt growing also occurs in the internal walls of the buildings (Author).

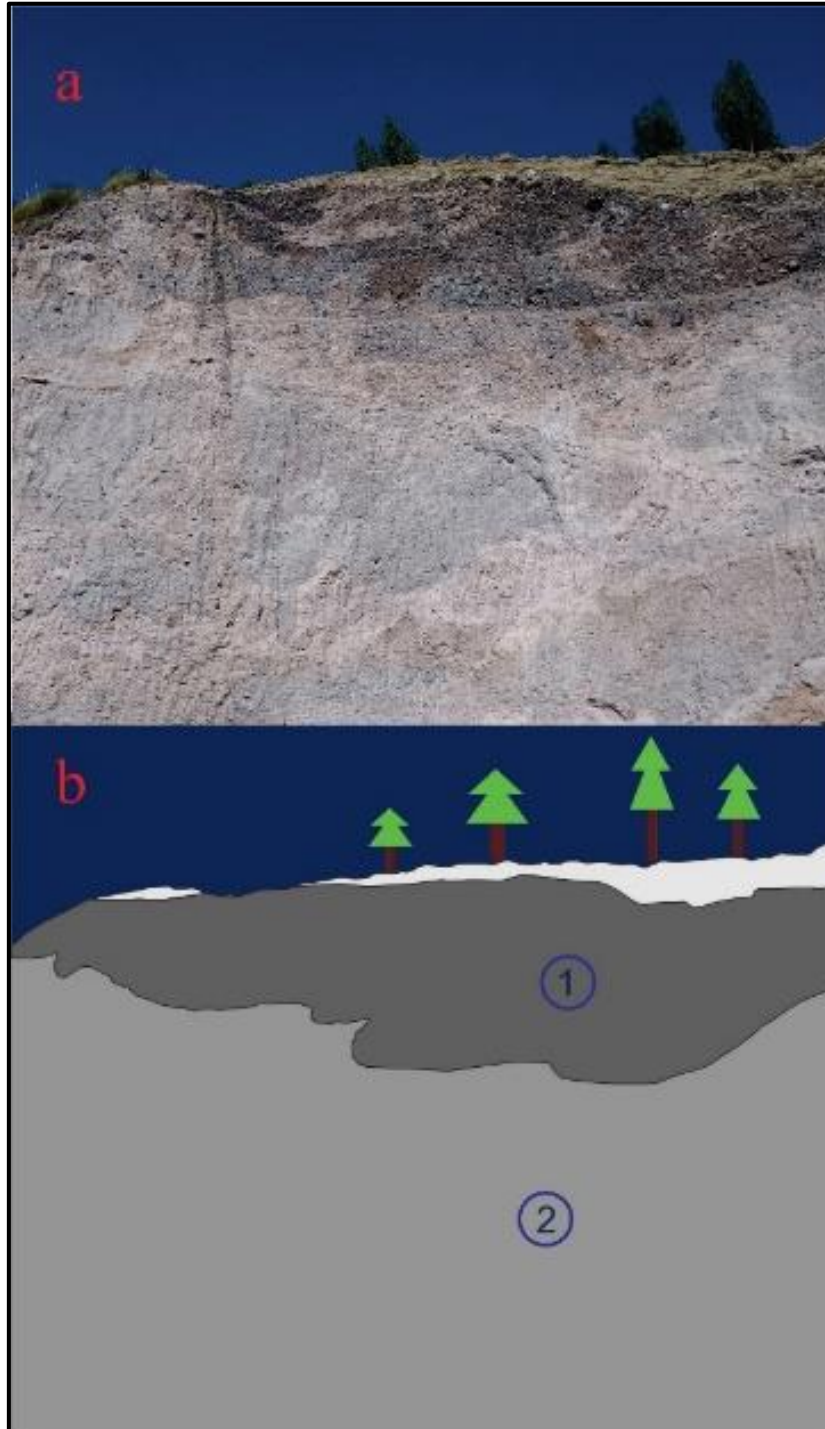
Figure 17. Spatial Distribution of the Facies that Conforms the R-DAD. This corresponds mined slope from the Sillahuan quarry locates at the west of the city. The deposit reaches up 50 m. This is composed of two facies, the Mf (2) in the bottom with the Bf (1) over this. The Mf shows light colors corresponding a matrix supported massive deposit. On the other hand, the Bf show more dark colors, although this is a matrix supported deposit too, here it is possible to appreciate clasts of different size (Author).

deposit reaches a high of 50 m. The Mf deposited in the bottom shows light colors, and reaches an approximate high of 40 m. The Bf shows dark colors and reaches an approximate high of 10 m. In the top is deposited a paleo-soil of yellow color.

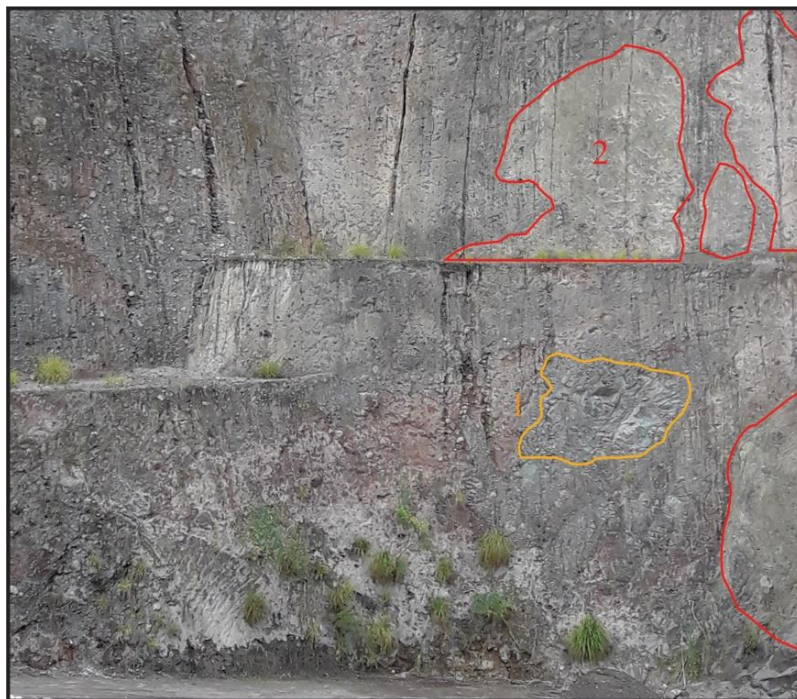
Figure 18. Mixed Facies Mf. The Mf shown in the figure belongs to a mined slope from the Mira Flores quarry located in the north of the city. Here the Mf reaches up 22 m. Inside this deposit is contained diaclosed rocks of around 1.5 m in size (1). Likewise, it is possible to distinguish some intrusions that correspond to yellow pipes. These pipes reach up to 3 m of thickens (2) (Author).

In the quarries the mixed facie consists of deposits of light colors which reach a thickness of up to 40 m (Figure 18). However, the distribution of this facie varies in each quarry and sometimes it is impossible to distinguish between the Mf and Bf. This is a massive deposit that presents many colors such as: yellow, beige, red and gray. It is matrix-supported, and poorly sorted. The matrix is composed of silty to fine sand. The clasts are sub-angular, their sizes vary from 10 to 25 cm, and parents low sphericity. It is common to find diaclosed bombs, these bombs are gray color, sub angular, around 1 m size (Figure 18). Finally, some deposits show the presence of pipes. These pipes reach a thickness of up to 4 m, and are yellow color, matrix-supported, and poorly sorted. The matrix is composed of silty yellow material. The clasts are gray and sub-angular of 5 to 15 mm.

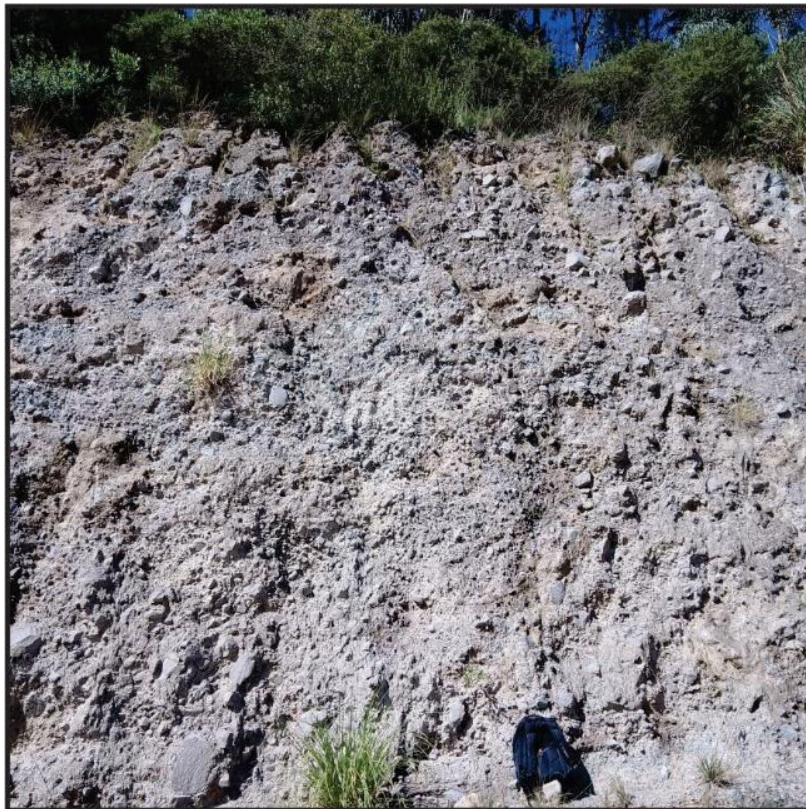
Figure 19. Block Facies Bf. The Bf shown in the figure belongs to a mined slope from the Cerro Negro quarry located in the east of the city. Here the Mf reaches up to 22 m. this consist of a matrix-supported massive deposit poorly sorted. The clast size varies from 3 to 45 cm (Author).

In many quarries, the block facie is distributed randomly and is difficult to distinguish. However, in this quarry, the Bf is in the upper part and reaches up to 8 m. The deposit is gray color, massive, matrix-supported, and poorly sorted. The matrix is composed of light brown material of fine to medium grain size. The clasts correspond to andesites whose size varies from 3 to 45 cm. These are gray in color, angular, and low-sphericity. Some clast shows red color (Figure 19).

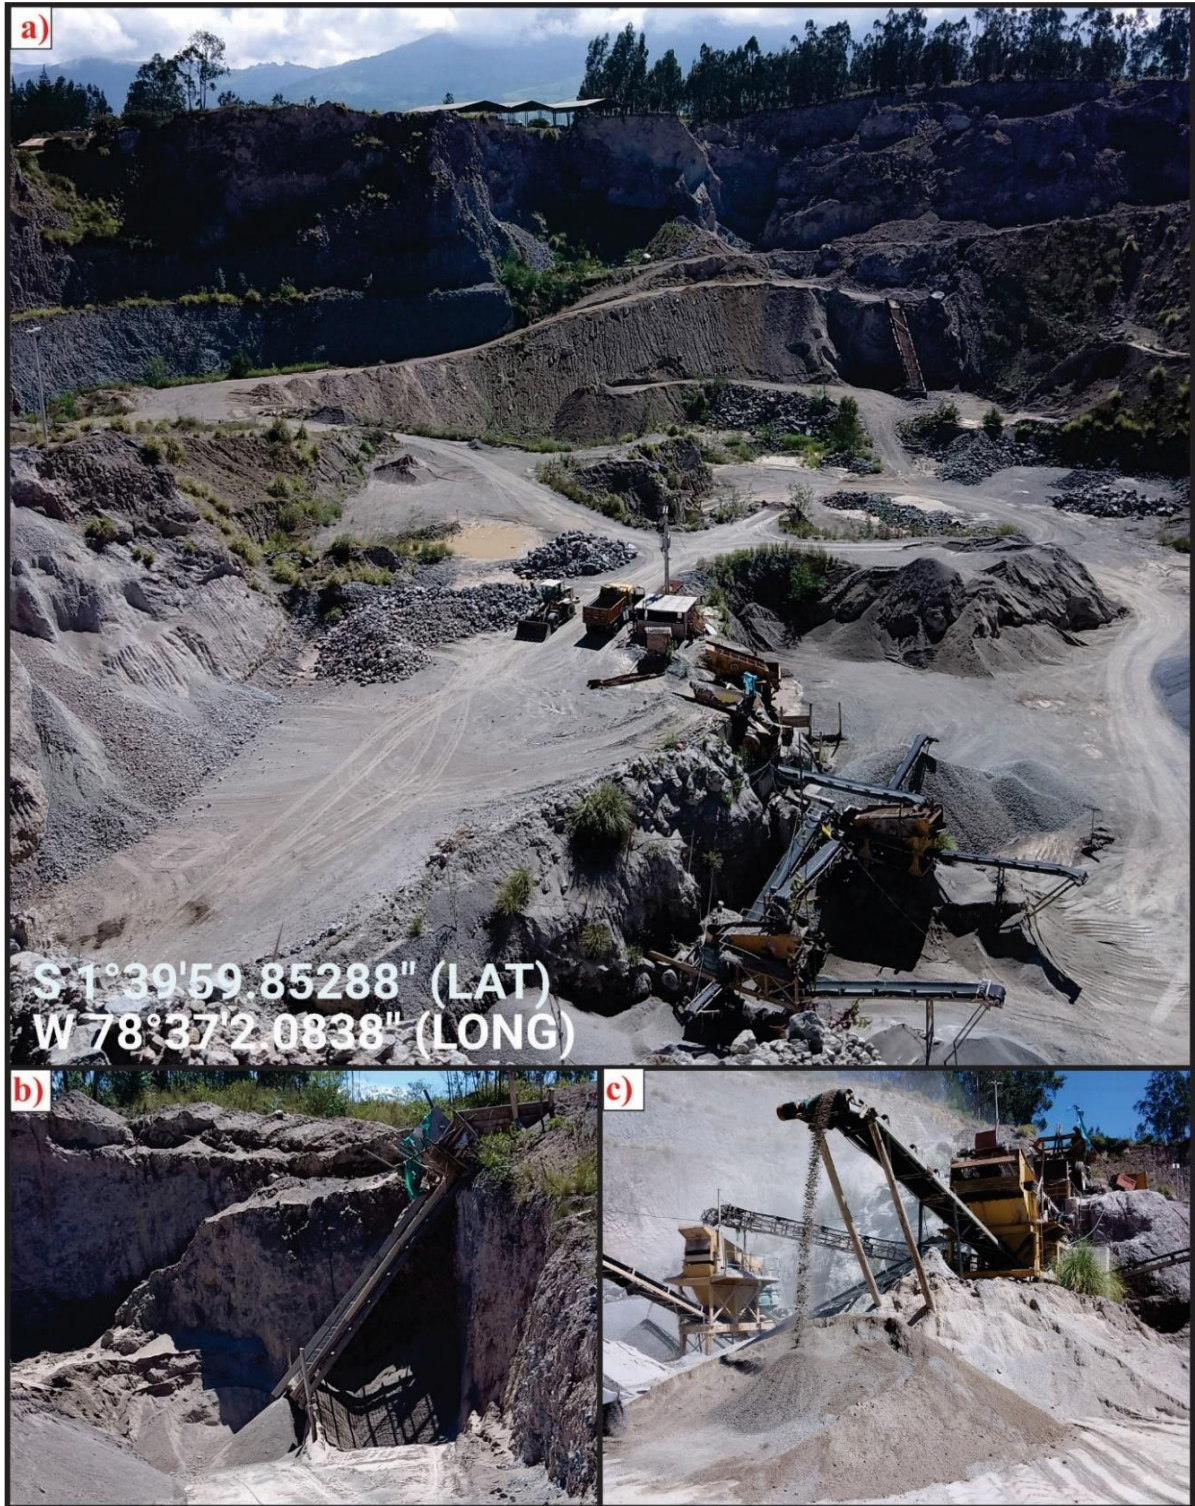
Figure 20. Cerro Negro Quarry. This corresponds to one of the oldest quarries in the city. The figure is composed of three pictures that show the mining process. image (a) shows a typical quarry in the city where the material is mined employing heavy machinery forming terraces. e image (b) shows a sieve employed to separate the sand and stones from the material mined. image (c) shows a shredder employed to reduce big clasts into smaller rocks known as ripio (Author).

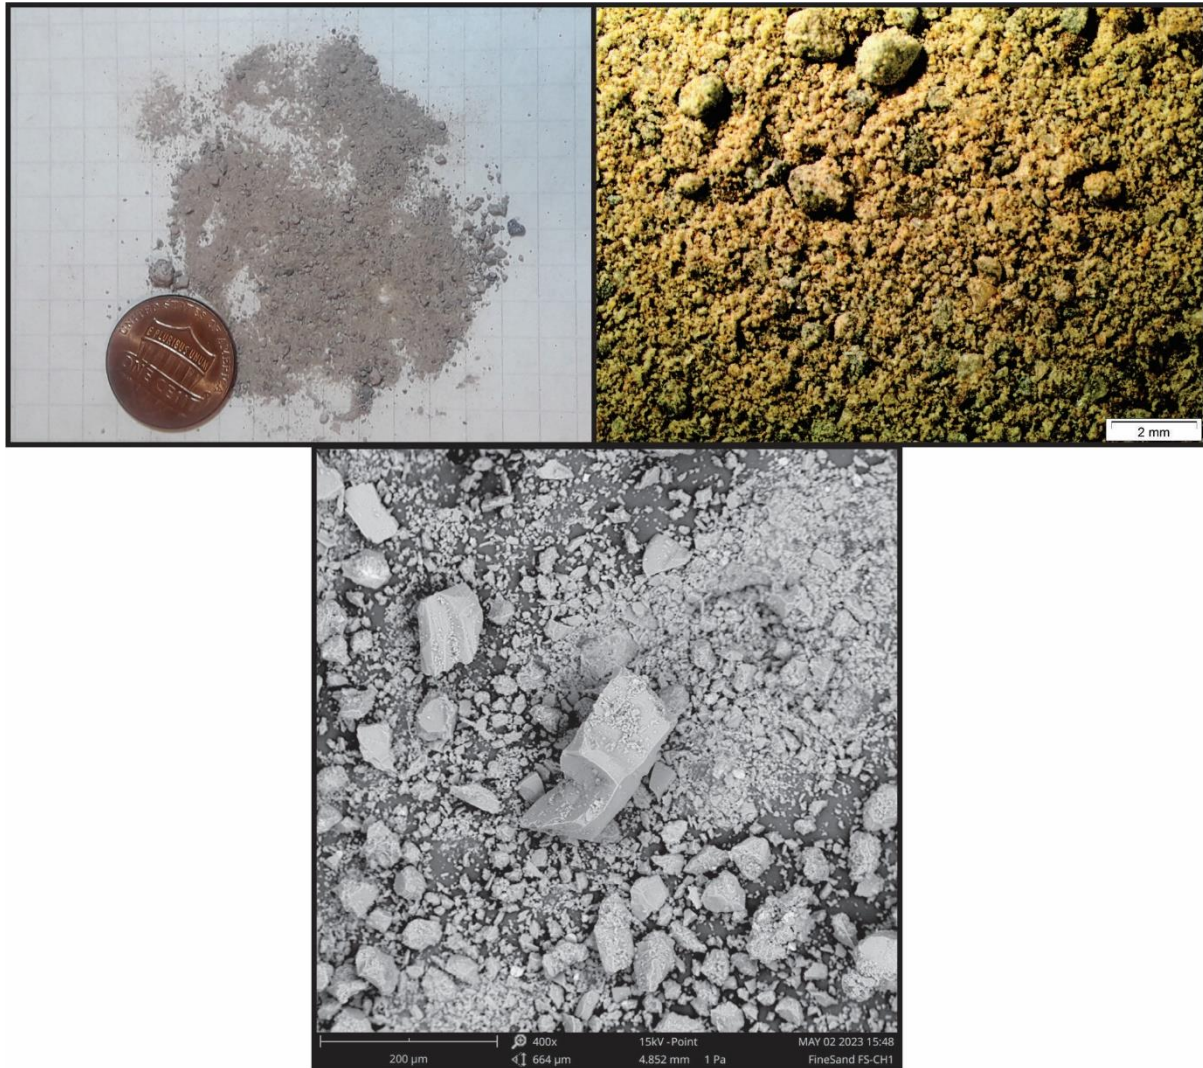
Figure 21. Fine Sand for Plastering mortars. The fine sand marketed independently of the quarry comes from a sifting process. Fine sand is composed of 90% fine sand and a 10% of lithics. The different pictures show the same sand under different levels of zoom amplification (Author).

Fine sand or Sieve sand: This sand is composed of 90% fine sand and a 10% of lithics. The fine sand is of light-beige color. Which is composed especially of glassy crystals and, in minor proportion, black and brown particles. The mineral composition corresponds to plagioclase, amphibole, pyroxene, and quartz. The lithics size is below 3 mm. These are of gray and black color, angular, with medium sphericity (Figure 21).
