**UNIVERSIDAD DE INVESTIGACIÓN DE
TECNOLOGÍA EXPERIMENTAL YACHAY**

**TÍTULO: Incidence of Physical Weathering by Salt Growing
Deterioration Process Associated to the Aggregates Employed in
the Architectural Structures of the Riobamba City**

Trabajo de integración curricular presentado como requisito para la
obtención del título de Geólogo.

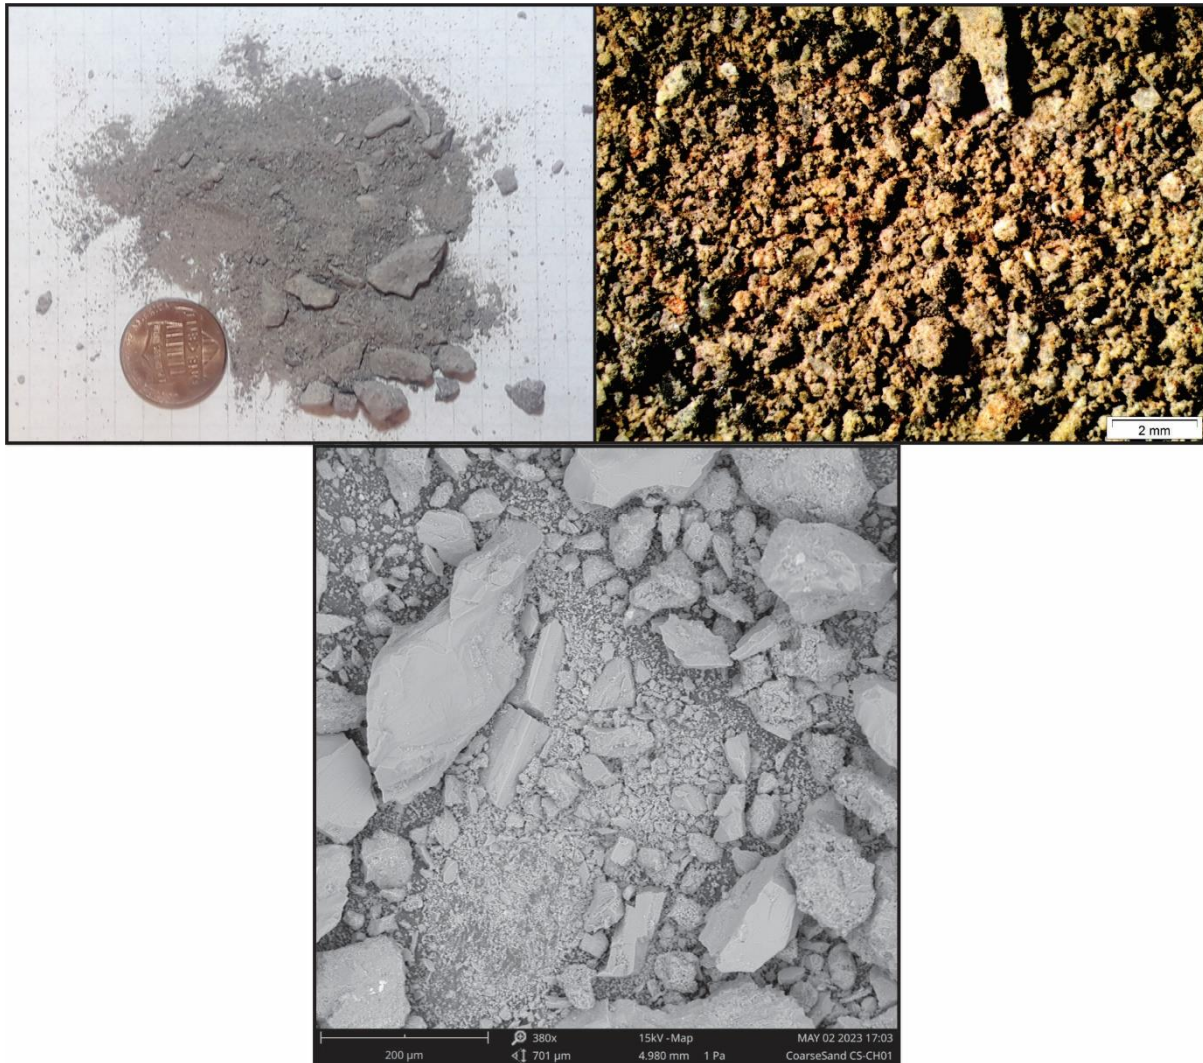
Figure 22. Medium to Coarse Sand. This kind of sand is employed for mortars to join bricks. This sand is composed of 80% medium sand grain size and 20% of lithics. This kind of sand comes in two different ways. The first corresponds to a sifting process and the second is a shredded process. The figure shows shredded sand, taken from Mira Flores quarry, under different levels of zoom amplification (Author).

Medium to Coarse sand: This sand is composed of 80% medium sandgrain size and a 20% of lithics. The sand is of light-gray color, composed of glassy crystals mixed with black and brown particles. The mineral composition corresponds to plagioclase, amphibole, pyroxene and quartz. The lithics corresponds to andesites, dacites and tuffs, which size varies from 2 to 10 mm (Figure 22). These are angular, with low sphericity many of them are planar. Some clasts present fractures this could be the result of the shredded process.

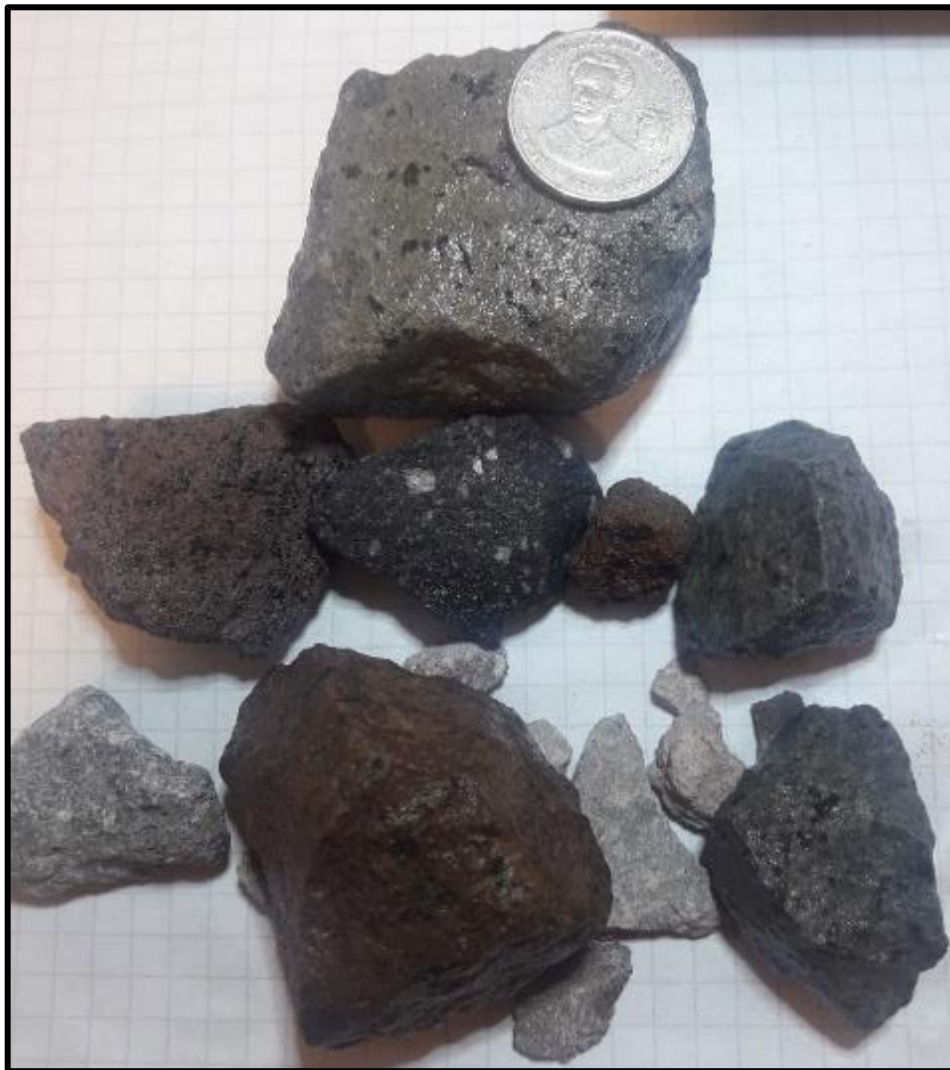
Figure 23. Ripio. Is known as Ripio at the mixture of rocks composed of: andesites, amphibole andesites, amphibole-pyroxene andesites, amphibole-plagioclase andesites and, tuffs, expended as aggregate by the concrete to produce concrete, employed in slabs and columns. To be considered as Ripio the size of rocks must be between 10 to 51 mm (Author).

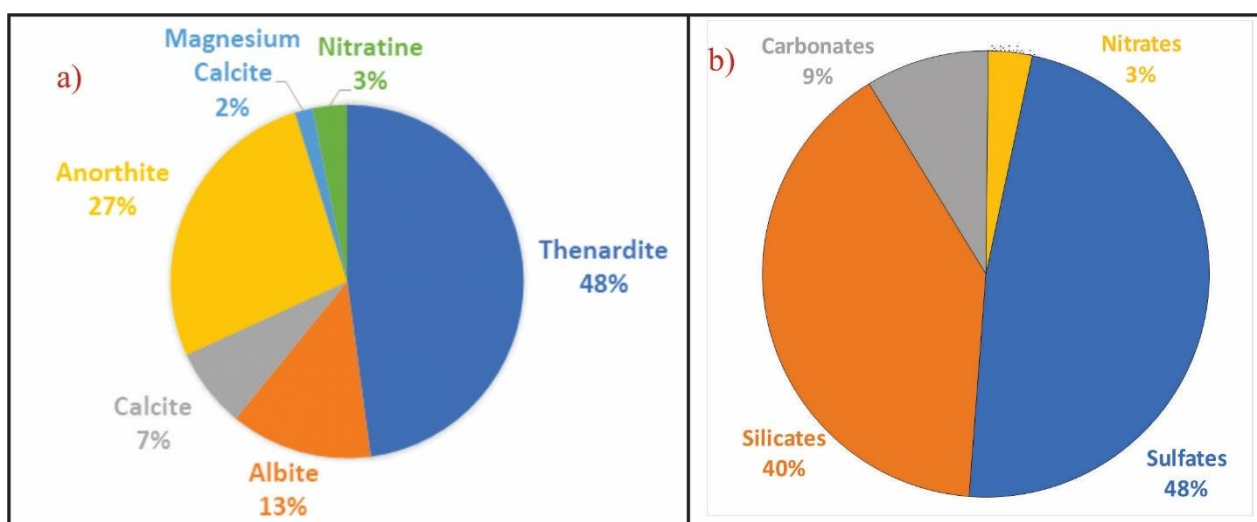
Figure 24. Percentage Distribution of the Different Mineral Phases Responsible in the Deterioration Process. This figure is composed of two graphics that represents the percentage distribution of the different mineral phases and salts responsible for the deterioration process in architectural structures of Riobamba city. The part a) represents the mineral phases and the part b) the salts species. Both graphs summarized the data exposed in Table 6, where the results from XRD are shown (Author).

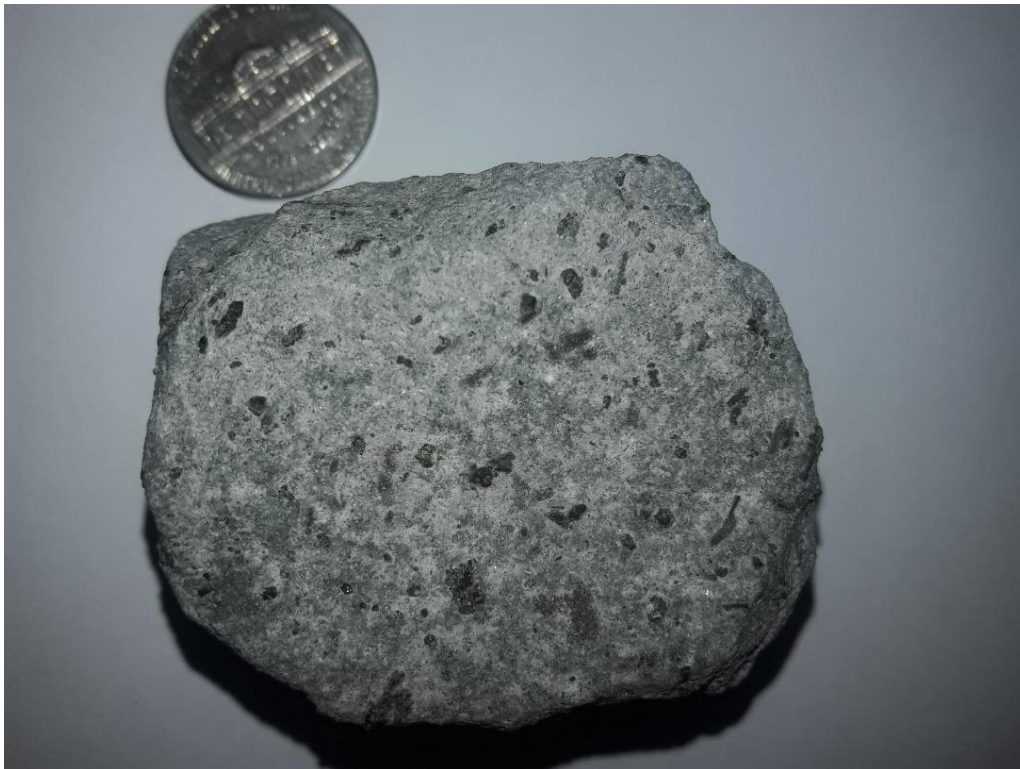
PETROGRAPHIC DESCRIPTION	
Component Features	
Color	Brow
Texture	Porphyritic
Structure	Massive
Crystal Size	1 mm
Crystal shape	Euhedral to subhedral
% Phenocrysts:	40
% Matrix:	60
Mineral Content	
Main Minerals	Amphibole, pyroxene, plagioclase.
Secondary Minerals	-
Minerals Accessories	Quartz
Mineralization	-
Degree of weathering	Low
Type of alteration	-
Rock's name	Amphibole-pyroxene andesites

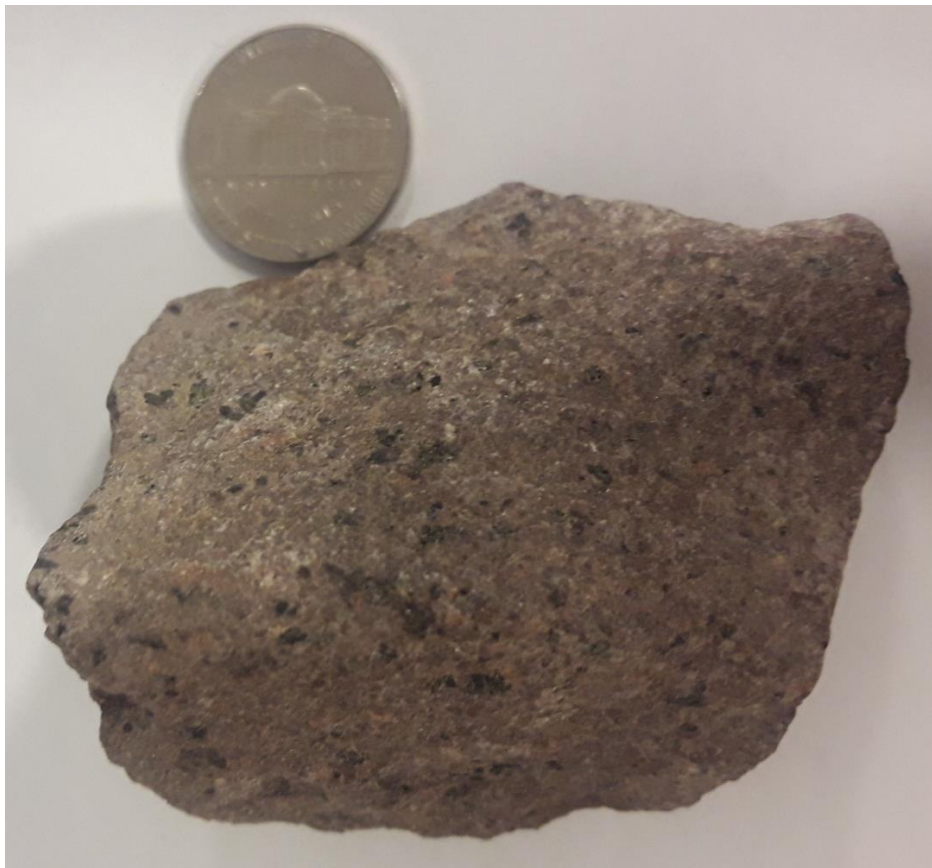
PETROGRAPHIC DESCRIPTION	
Component Features	
Color	Reddish
Texture	Porphyritic
Structure	Massive
Crystal Size	1 mm
Crystal shape	Euhedral to subhedral
% Phenocrysts:	15
% Matrix:	80
Mineral Content	
Main Minerals	Pyroxene, amphibole, plagioclase.
Secondary Minerals	-
Minerals Accessories	Quartz
Mineralization	-
Degree of weathering	Low
Type of alteration	-
Rock's name	Amphibole-plagioclase andesites

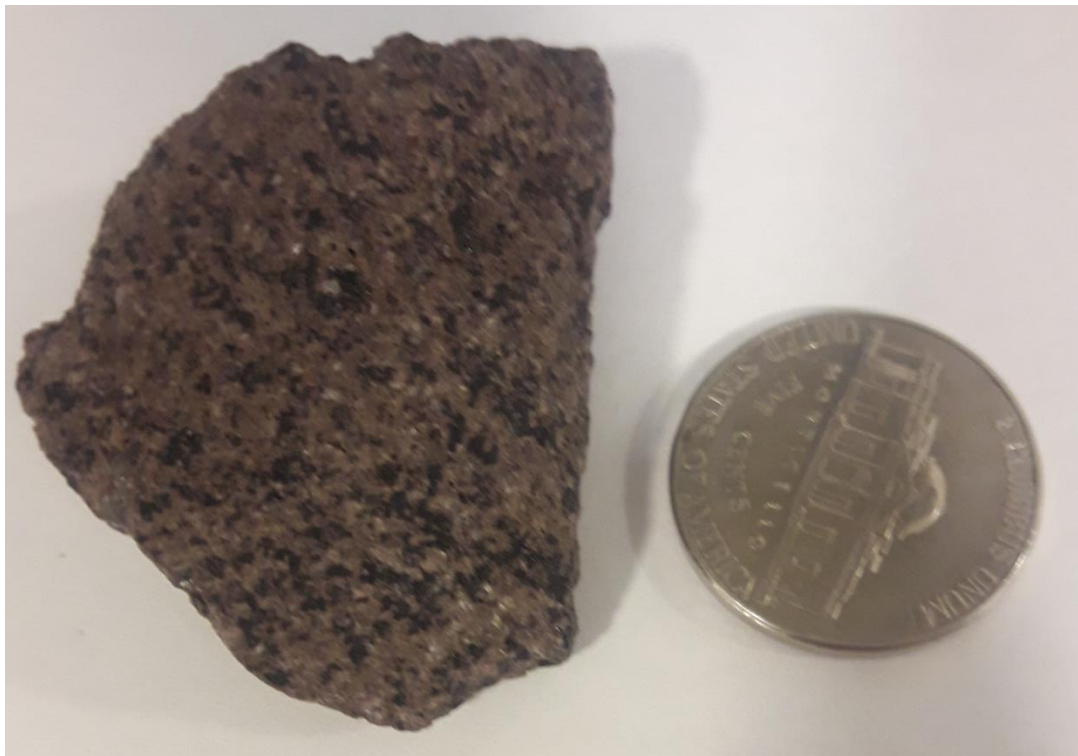
PETROGRAPHIC DESCRIPTION	
Component Features	
Color	Gray
Texture	Porphyritic
Structure	Massive
Crystal Size	1-3 mm
Crystal shape	Euhedral to subhedral
% Phenocrysts:	45
% Matrix:	55
Mineral Content	
Main Minerals	Pyroxene, amphibole, plagioclase.
Secondary Minerals	-
Minerals Accessories	Quartz
Mineralization	-
Degree of weathering	Low
Type of alteration	-
Rock's name	Andesite
