UNIVERSIDAD DE INVESTIGACIÓN DE TECNOLOGÍA EXPERIMENTAL YACHAY

TÍTULO: SUBSURFACE WATER FLOW ASSESSED WITH ELECTRICAL RESISTIVITY AND GROUND-PENETRATING RADAR IN YACHAY TECH, ECUADOR

Trabajo de integración curricular presentado como requisito
para la obtención del título de Geóloga

Urcuquí, Agosto del 2019

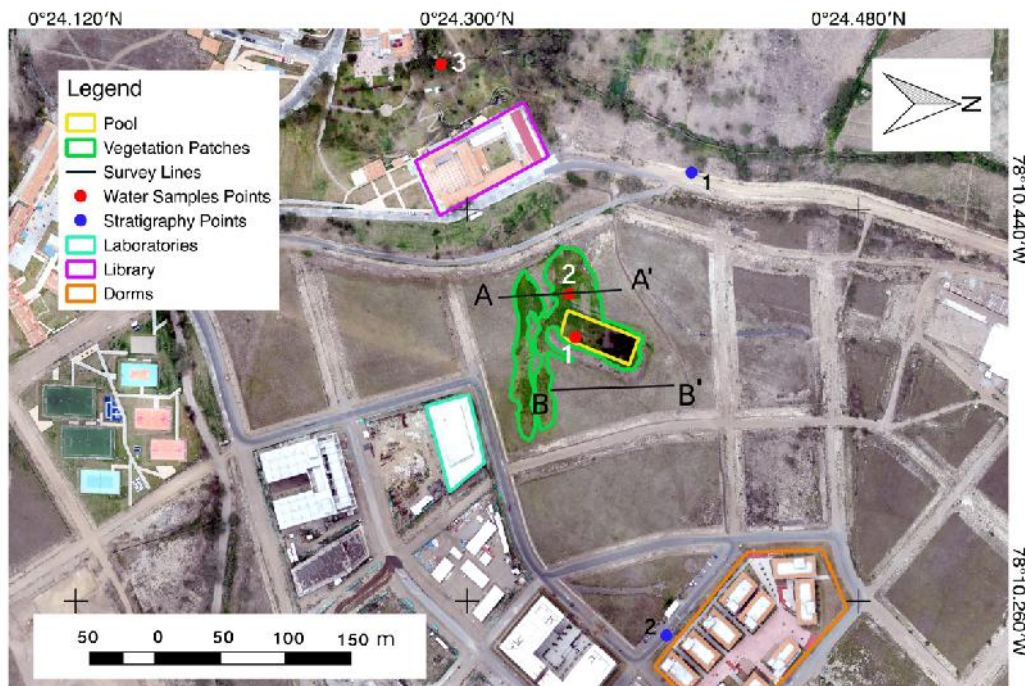
Figure 2. Map of the study area. The patch of vegetation around the pool is shown in green, the pool in yellow, the A-A' and B-B' survey lines in black. Also, the location for stratigraphy sections (purple dots) and water sampling locations (red dots) are shown.

We decided to study the area in December 2017 by implementing ERT and GPR geophysical methods across two survey lines: one located upslope and west above the pool (A - A', Figure 2) and the other downslope and east below the pool (B - B', Figure 2). Our study of two ERT pseudosections with a depth of approximately three meters and two radargrams with a depth of approximately six meters, revealed that: (1) there probably is no water table present in the upper zone; (2) the zones with less resistivity match with the zones with green vegetation; (3) there possibly is a blocked or broken pipeline, that is not transporting water to the pool at all, but instead is leaking and forming these big patches of vegetation on both sides around the pool.

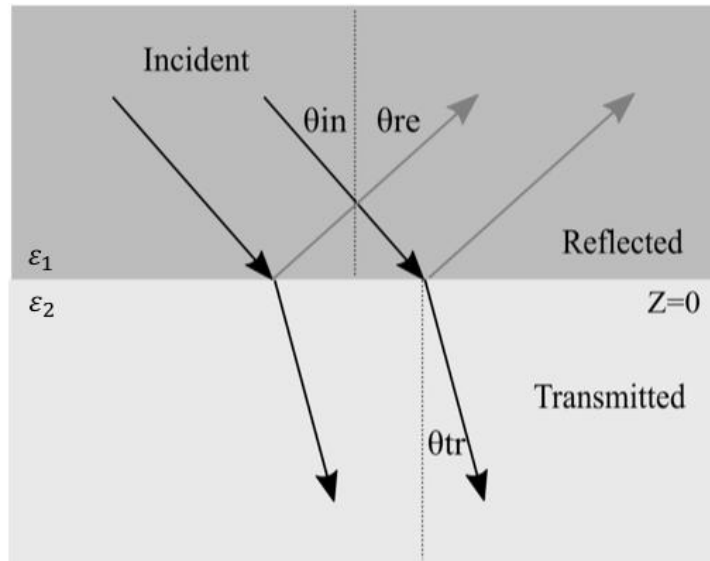
Figure 3. Simple sketch of the propagation of electromagnetic waves at an interface. A horizontally polarized plane electromagnetic wave encounters obliquely a planar interface separating two lossless dielectric media where E is the electric field, H is the magnetic field vector, \hat{p} is the propagation vector, \hat{q} the reflection vector, θ_i is the incident angle, θ_r is the reflected angle, θ_t is the transmitted angle, ϵ_1 is the dielectric constant. Modified after Everett (2013).

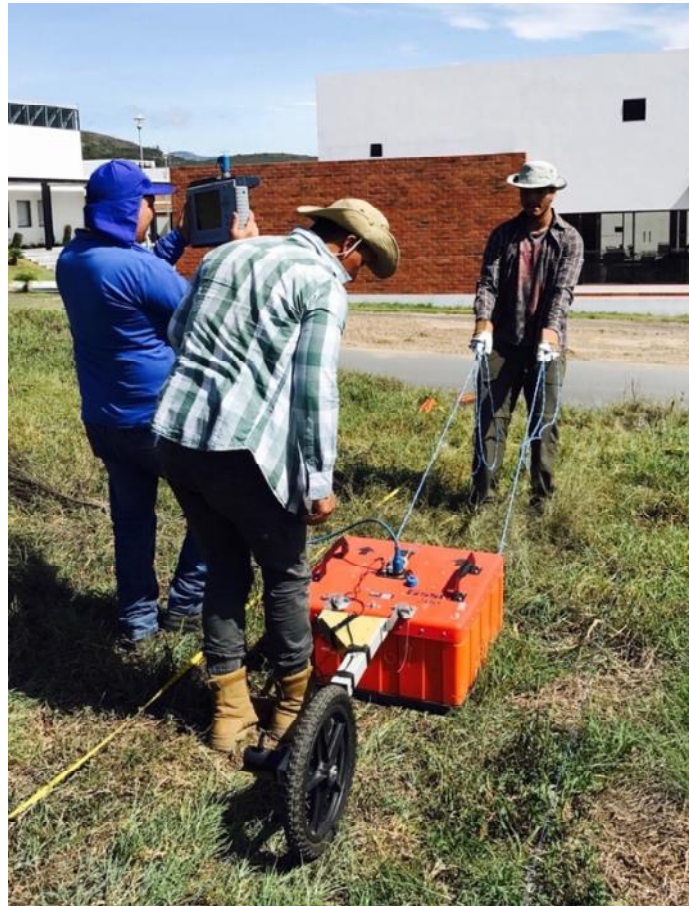
Figure 4. GPR equipment of EPMAPS in the field. Diego Guanotuña is holding the control unit in his hands on the left of the photo. The main sending/receiving antenna is in the orange box being pulled by Gustavo Béjar (right). The box is connected to a survey wheel which simultaneously measures the distance.

We preferred the lower frequency antenna due to better penetration depth, however due to technical difficulties in 2017 all but survey line B-B' was measured with the 400 MHz antenna (Table 2). In the field, we use the control unit to configure the antenna, calibrate the survey wheel for distance, and set the viewing depth, soil type and unit of measurement (Geophysical Survey Systems, 2014). Then, we pass over the established survey line by dragging the antenna and the control unit across it (Figure 4).

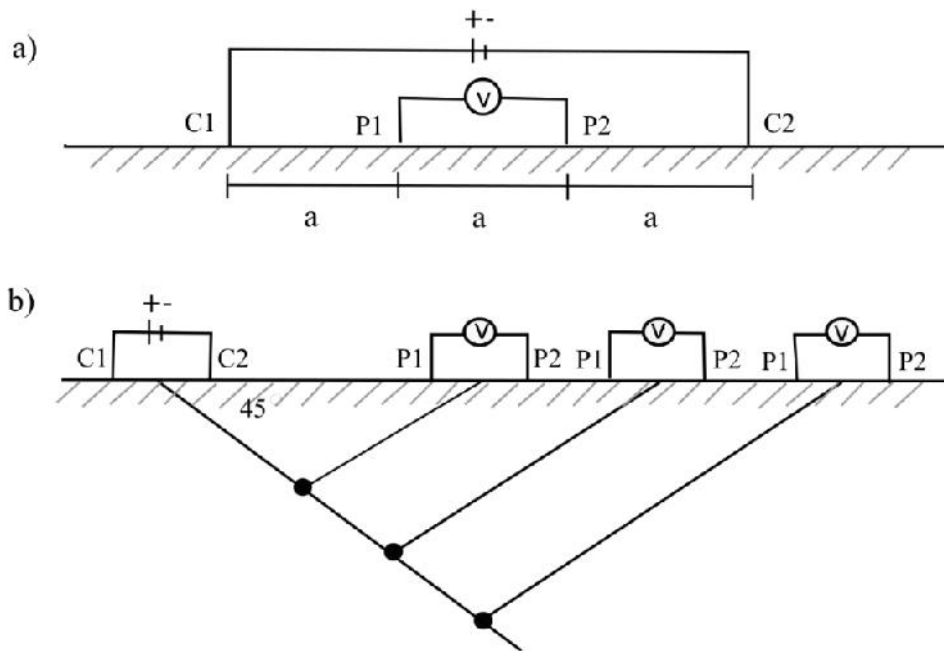
Figure 5. Sketches of the two electrode configurations used in this study. a) Wenner electrode configuration. C1 and C2 are the electrodes connected to the battery that creates the current. P1 and P2 are the electrodes reading the voltage in Volts. b) Dipole-dipole electrode configuration. Furthermore, this sketch shows how the consequently deeper depth (apparent depth) is gained for the apparent resistivity estimate by measuring the potential stepwise further and further away from the current electrodes.

where V is the voltage drop between the potential electrodes (P1 and P2), I the current and a the spacing between each electrode. The two outer electrodes (C1 and C2) are connected to an ammeter, which measures the current. The two inner electrodes are connected to a voltmeter which measures the voltage [V or mV]. The vertical depth profile of the different resistivities of the subsoil is found by increasing the value a and conserving the location of the center point of the array. By moving the electrodes to one side across the surface and maintaining a constant, we obtain the horizontal profile (Herman, 2001).

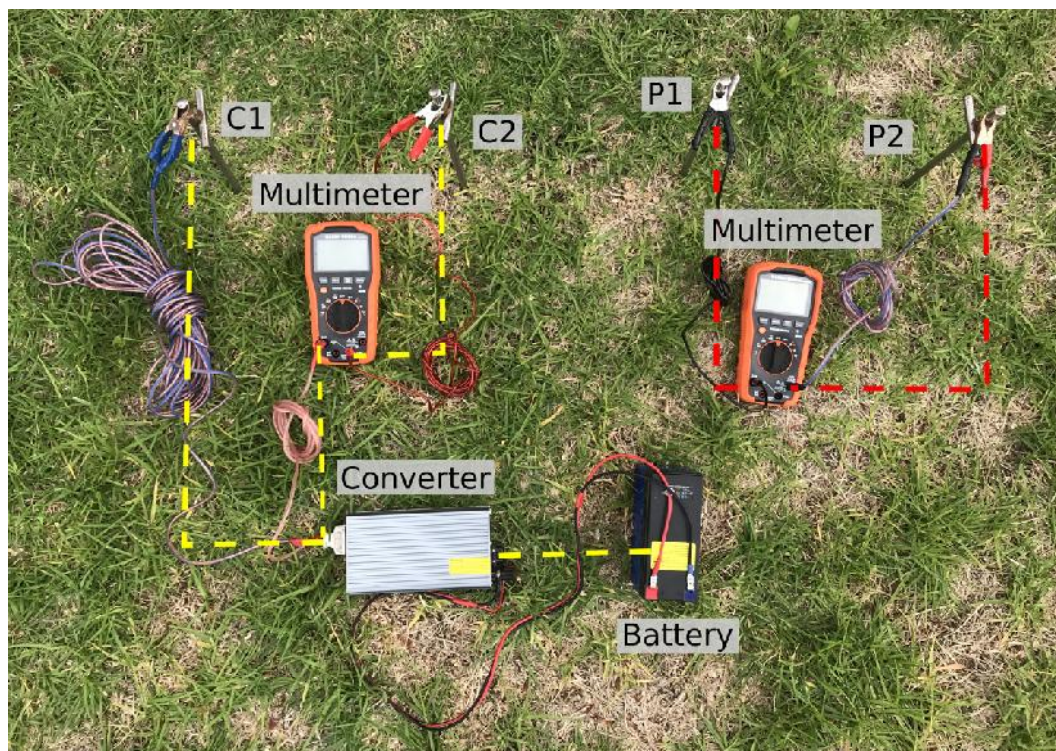
Figure 6. Photo of the ERT equipment used for obtaining the data following dipole-dipole electrode configuration. The electrodes C1 and C2 are connected to a multimeter (measuring the current) and through an electricity converter to a battery. The electrodes P1 and P2 are connected to another multimeter to read the potential.

In order to acquire the data, we built electrical resistivity tomography equipment based on the works of Herman (2001) and Clark & Page (2011) (Figure 6). Electrical resistivity surveys were planned to determine the resistivity distribution in the subsurface of the area near the pool. In November 2017, using the Wenner array, we did two geoelectrical profiles perpendicular to the slope, exactly where the GPR profiles were recorded. They are also called A-A' and B-B' and have an initial electrode spacing of 1m. The approximate reached depth for these surveys is about 3.5 m.

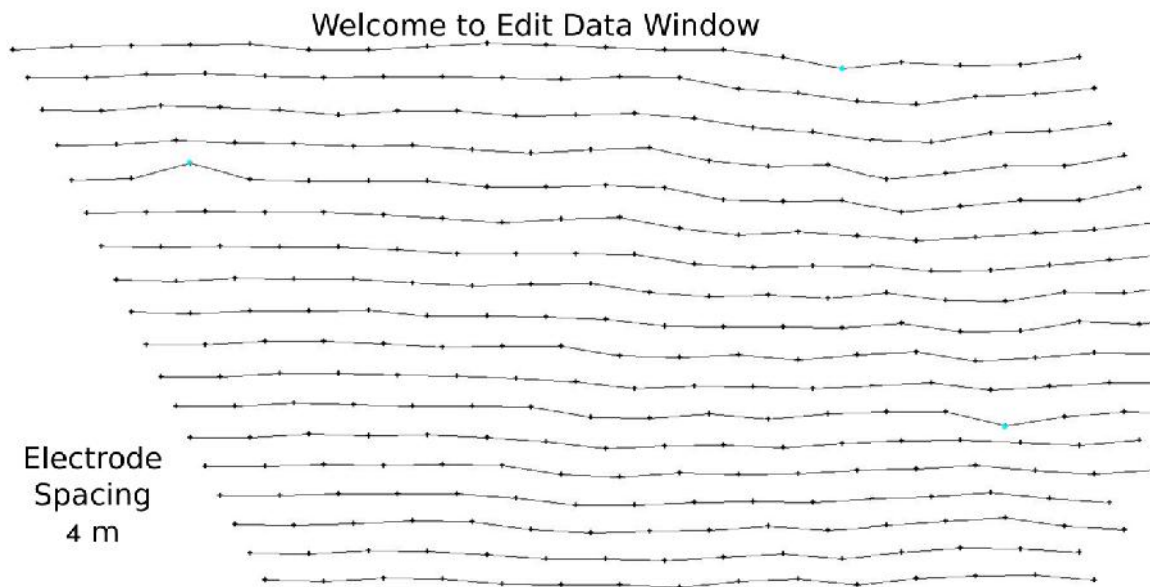
Figure 7. Data points acquired in the field viewed by the RES2DINV computer program for erroneous data points analysis. Each point represents a subsurface measurement point (see Figure 5b). The sky-blue dots are the points selected to be eliminated.

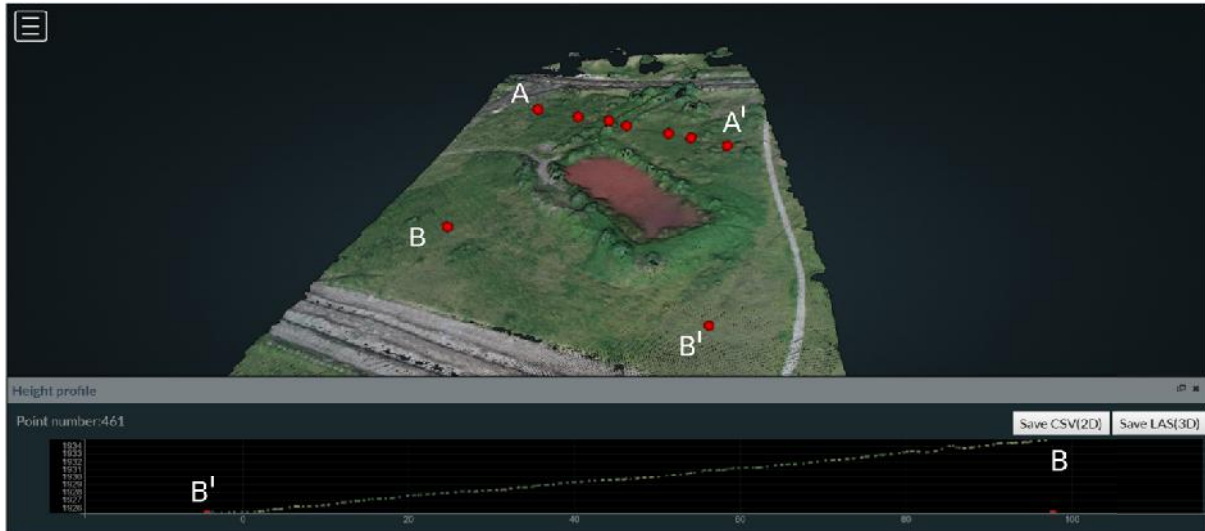
Figure 10. Photos of the WebODM desktop program for obtaining the topography of the survey lines. The top image is the 3D point cloud, that is a set of data points in space that measure the distance to external surfaces of objects, and represents a digital elevation model. On the bottom is the height profile of the survey line B'-B, that was used for obtaining topography of that survey line.

spaced (minimum of 70% of overlap), which allowed us to create a high-resolution 3D model of the survey area in the free WebODM Drone Software (Figure 10). The topography of each survey line was then estimated from this 3D model and are included in each ERT model.

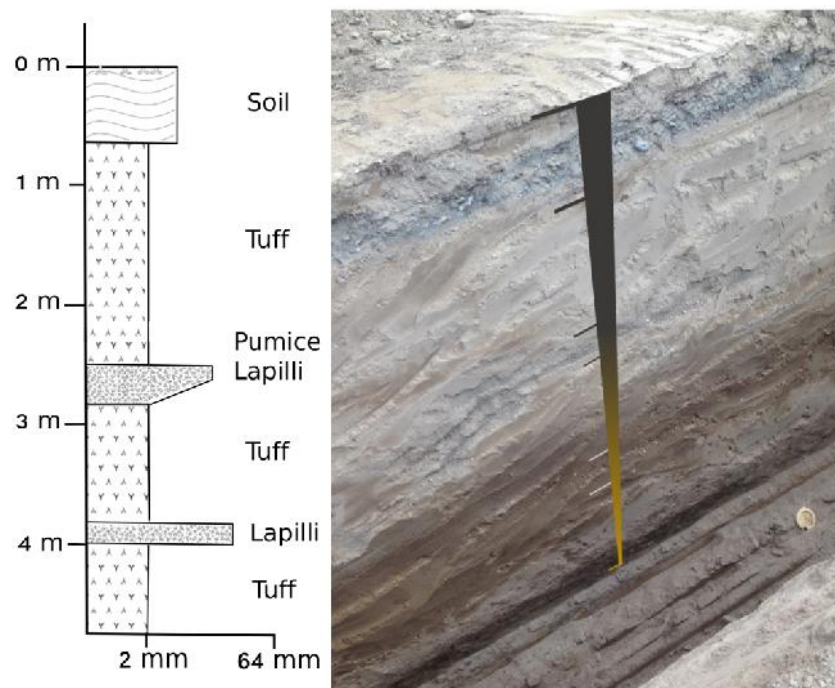
Figure 11. Representative stratigraphy of the first ~5 m of the subsoil in the study area at Point 1. On the left is a stratigraphic column of the outcrop, shown on the photo on the right. For locations see Figure 1.

Figure 23. Electrical resistivity survey (bottom) from A-A' November 2018 and radargram (top). The dashed lines separate the areas of high reflectance from the areas with low reflectance. The former indicates the presence of moisture while the latter, dry areas respectively. High reflectance areas match with the vegetation at the surface and with the humid layer present in Figure 11.

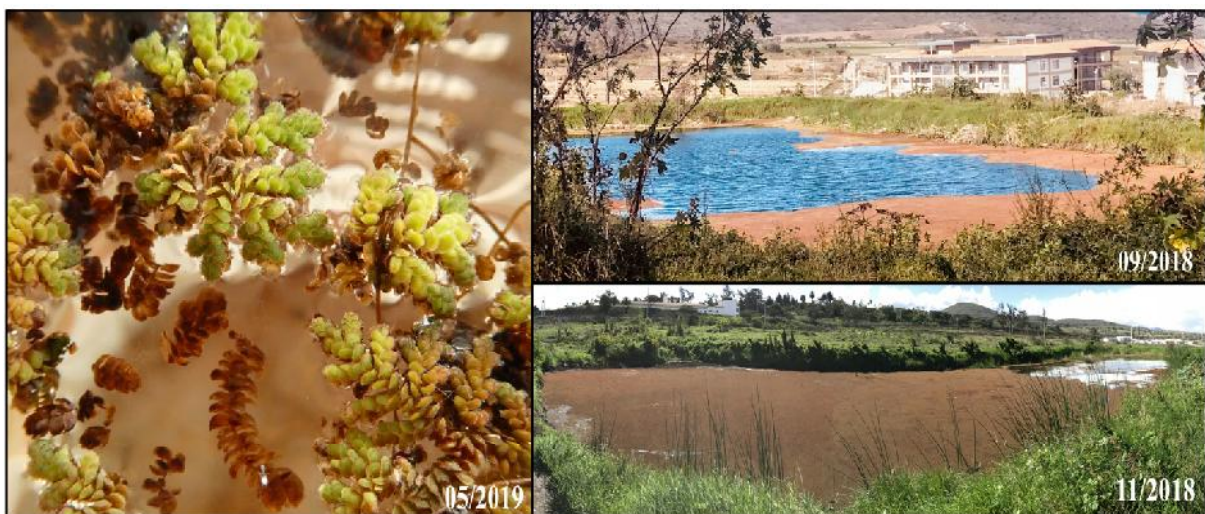
Figure 12. Collage of photos showing the pool and the algae. The photo on the left shows the details of the physical characteristics of the algae present on the surface of the pool, similar in appearance with commonly found *Azolla*. The photo on the top right represents how the pool looked like in 09/2018. The photo on the bottom right shows how the algae grew by 11/2018.

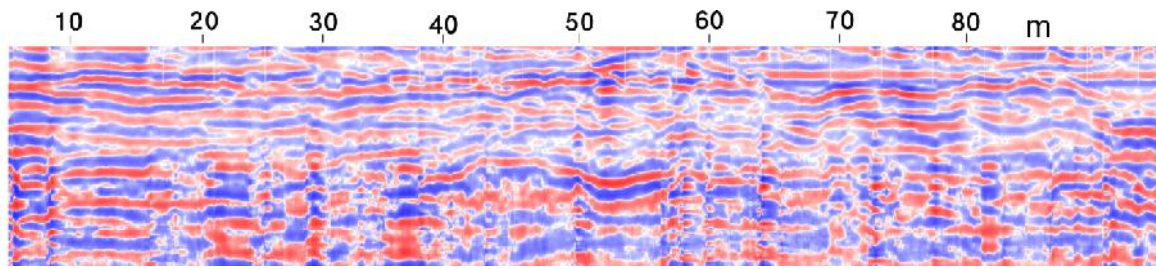
Figure 14. Radargram showing B-B' survey line (See Figure 2 for location). The zones where the colors are intense show more content of water or moisture. The zones where the colors are weak are dryer. The apparent depth is 5 m approximately.

Data were acquired on both survey lines twice: from S to N and vice versa for comparison and in order to assure the data is reliable. The radargrams from 2018 for A-A' (Figure 13) are 100 m long. It shows zones with more reflectance at the bottom, which can be compared with the beginning of moisture present in Figure 11. High reflectance is also observed at the top where the infiltration of superficial water and sub-superficial water is flowing. The vegetation at the surface is apparent where humidity is higher. Around 44 m distance, a significant discharge of water occurred during the month of GPR data collection, November 2018. Consequently, the radargram shows a high reflectance along a vertical area. The radargram of survey line B-B' is shown in Figure 14. It is 100 m long. Unlike the first radargram, this survey line shows a more defined subsurface. It means that there is not much variation in the soil which allows us to more easily recognize the humid areas. We can see that in general, this area is dryer at the top and only deeper zones have high reflectance.

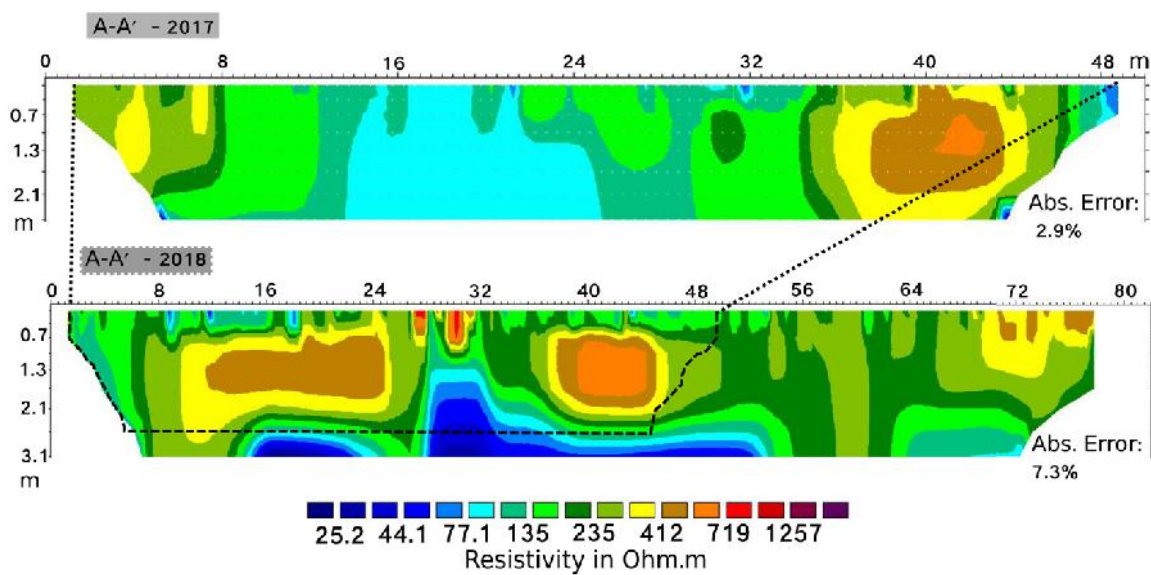
Figure 15. ERT inverse models for A -A' (See Figure 2 for location). Both survey lines were taken with the Wenner array. The top image is from 12/2017. The bottom image corresponds to 09/2018. The dashed lines are the area covered by the inverse model of 2017. The survey line of 2018 is longer and deeper.

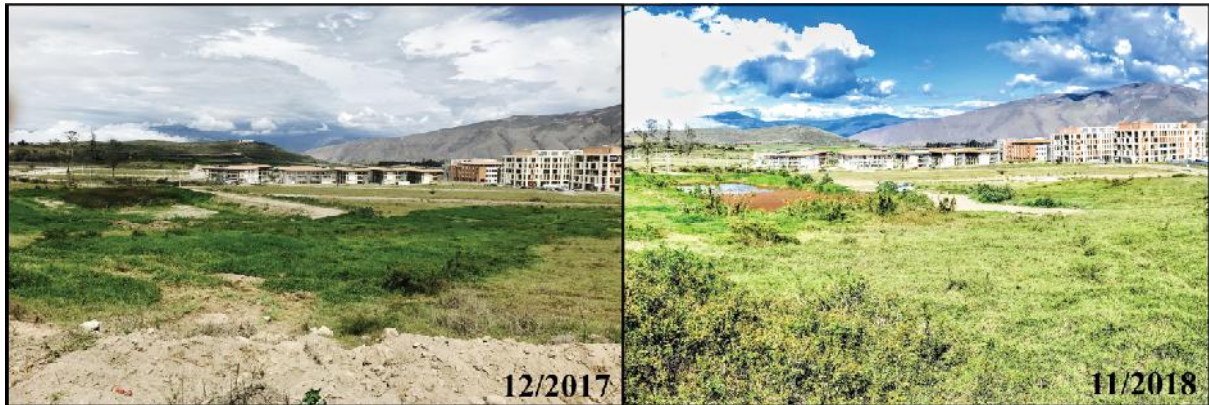
Figure 16. Changes in vegetation over time in the study area. The photo of the left is from 2017 and the photo of the right is from 2018.

(2019), August 2018 was also a dry season with ~ 1.3 mm of precipitation and 4 mm as maximum precipitation in September 2018 in the middle of the month for one week (Figure 17). This confirms the similarity between the Wenner array pseudosections and inverse models even though the vegetation in 2018 has covered the dusty areas of 2017 (Figure 16).

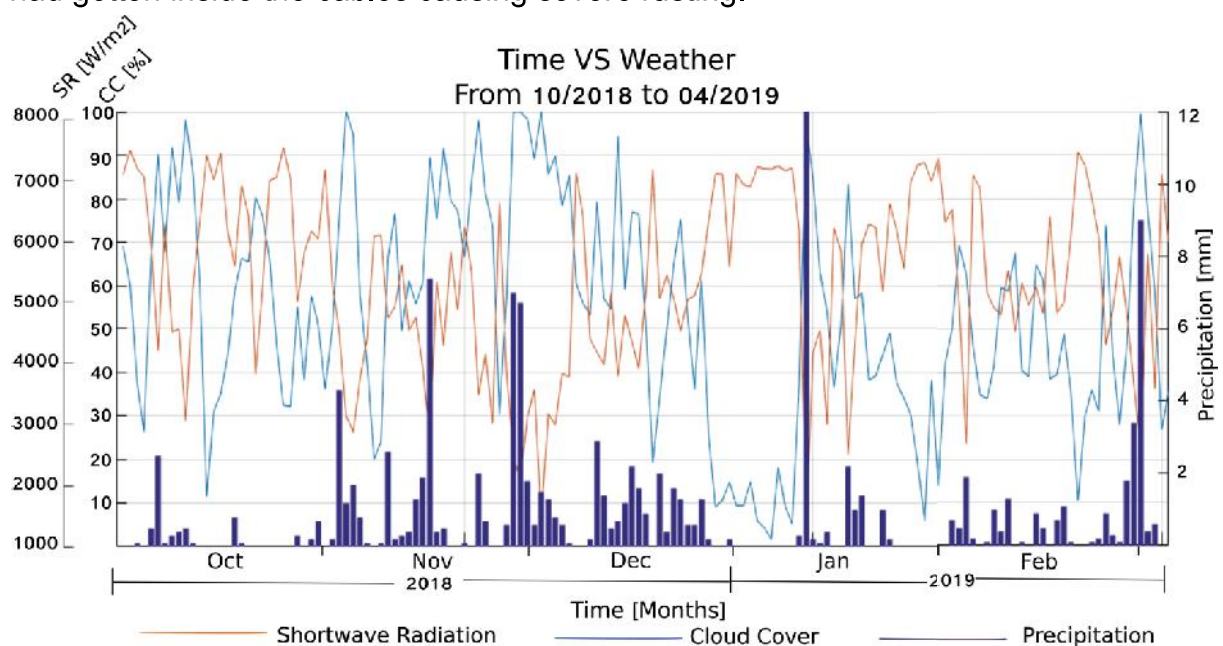
Figure 17. Plot time [months] versus precipitation [mm], cloud cover [%], and shortwave radiation [W/m²] from 08/2018 to 04/2019. Data obtained with the kind permission of Meteoblue (2019).

For this reason, this set of data will not be considered in the discussion. The downstream line B-B' (Figure 19) shows resistivity values from 25.2 Ω m to 1257 Ω m. The first 4 m below from the surface are characterized by high resistance especially on the left side. Between 5 and 11.5 m there is a zone with high values of conductivity especially at the bottom left and center. By this month, the maximum value of precipitation (Figure 17) is 2.5 mm but overall, it is also a dry month.

obvious at the surface where the vegetation becomes thicker (Figure 18). The precipitation in this month is high (Figure 17). Out of 30 days about 23 were rainy days with values from 1 mm to 3 mm of water. The second half of the month presented some sunny days. The increase in resistivity for A-A' can be related with the fact that the values were taken in this period of time. The resistivity for B-B' can be related with the percolation of water from the top of the hill which appears in survey line A-A' in November 2019.

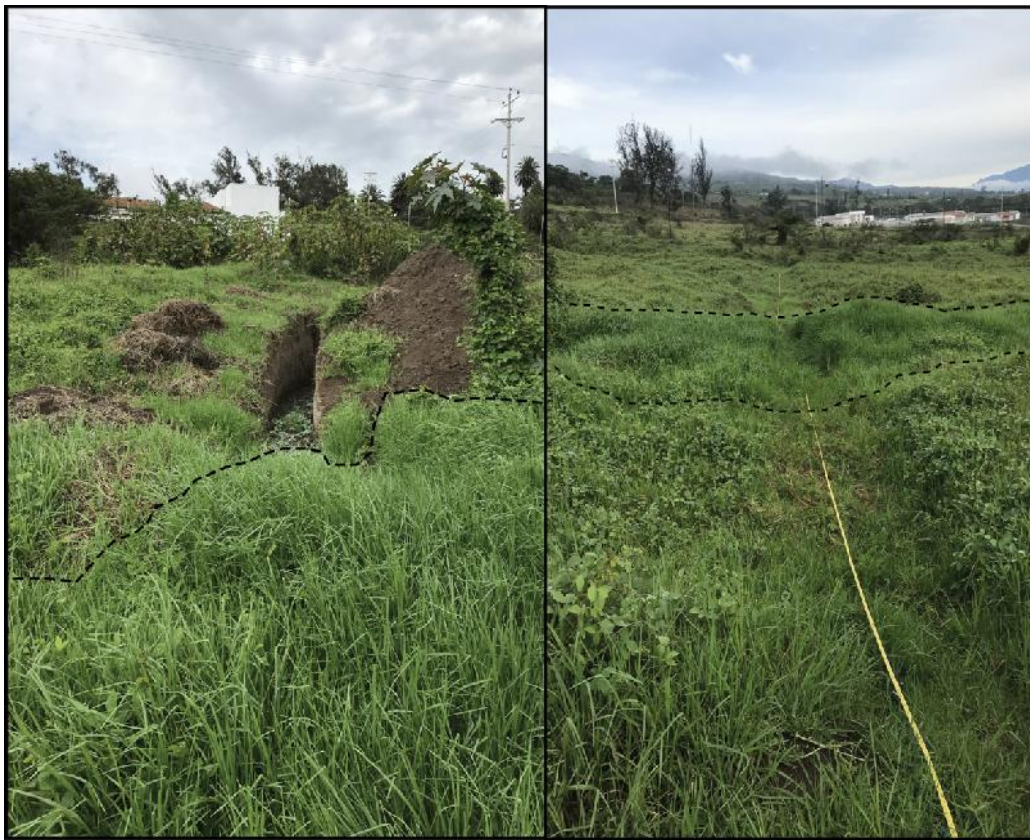
Figure 18. Photos showing the difference in vegetation due to the channel dug in November 2018. The photo on the left shows the half-way dug channel. The area below the dashed lines denote the abundant vegetation caused by this process. The photo on the right is in perpendicular direction with respect to the first photo. The area between the dashed lines also represents the abundant vegetation caused by the water that flowed from the channel.

We can affirm that the water content in the soil has changed with time in both lines A-A' and B-B'. We relate this to the channel dug that transports the water to the pool, the incomplete channel dug (Figure 18) and to weather conditions such as rainfall, cloudy sky and sunny days. We can clearly see in Figure 19 and in Figure 20 how the absence of rain and the increase of shortwave radiation changes the resistivity values and vice versa in at least the first couple meters depth. The extra input of water in November 2018 (Figure 20), makes the soil more conductive especially at the surface where the water flowed. This runoff plus the runoff of the precipitation traveling downhill appear in the model of December 2018 (Figure 19).

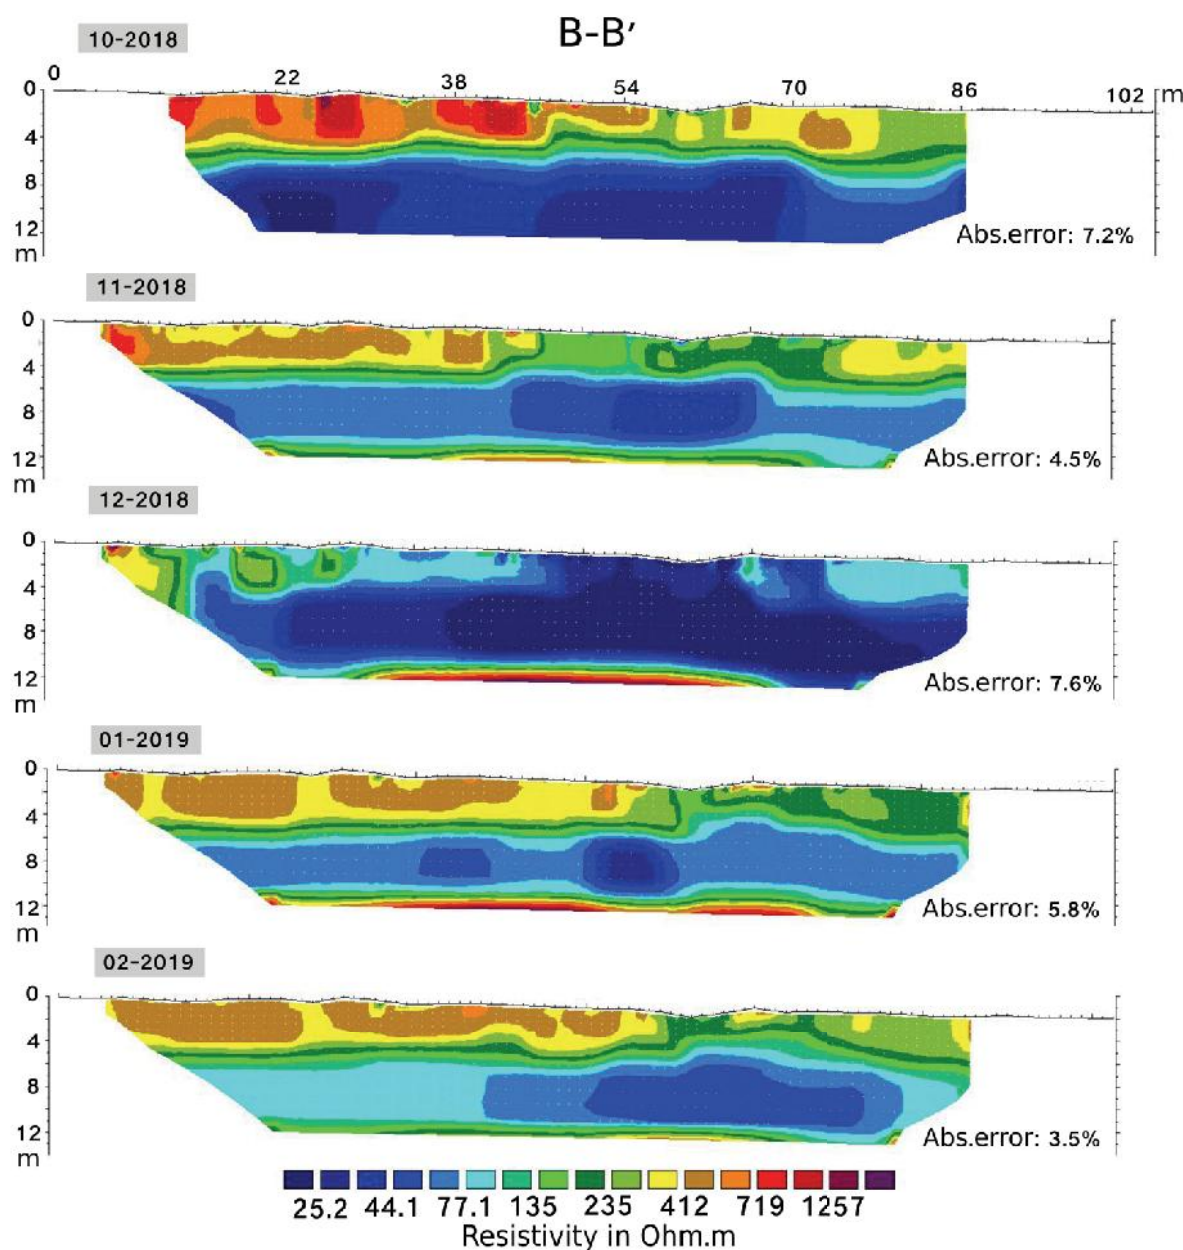
Figure 19. Scheme showing the changes in apparent resistivity from B-B' survey line (See Figure 2 for location) from October 2018 (top) to February 2019 (bottom). Low values of resistivity show areas with moisture while high values represent dry zones.

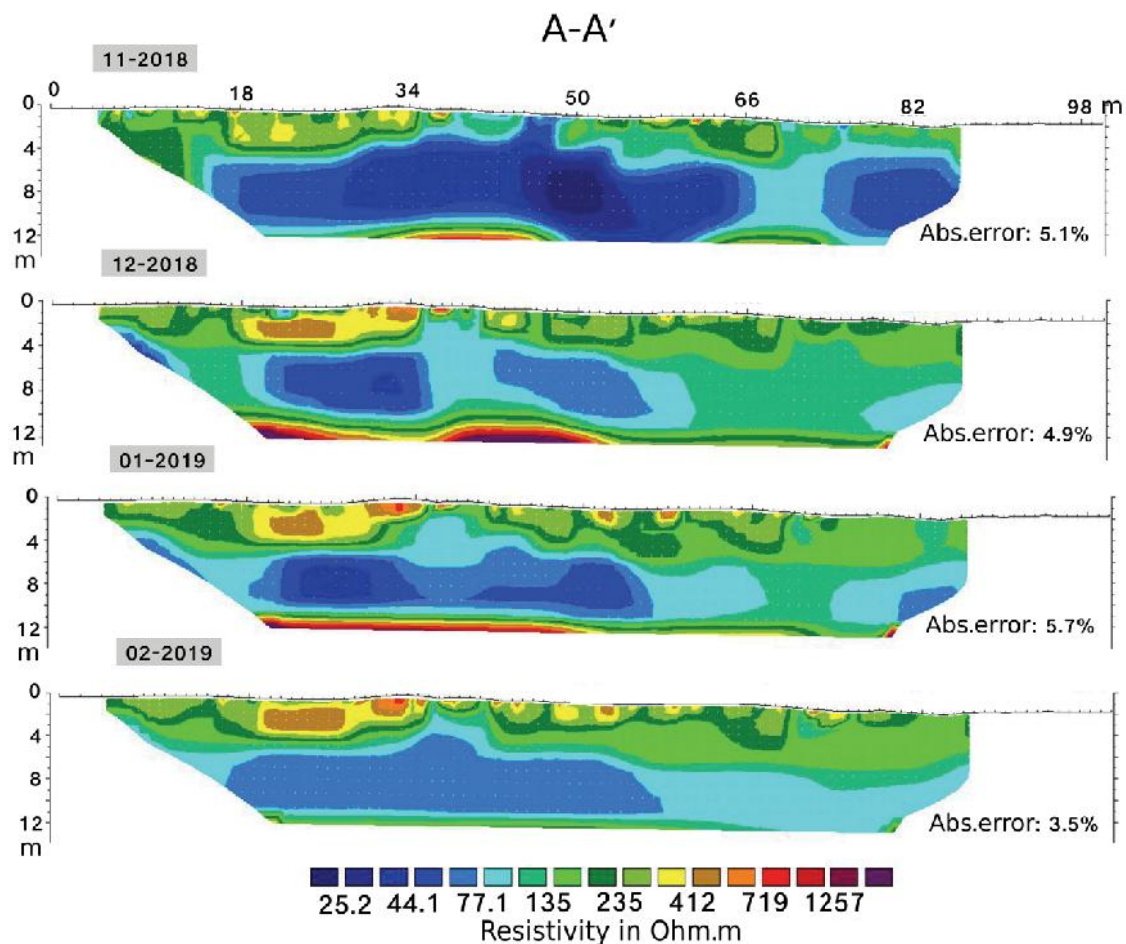
Figure 20. Scheme showing the changes in apparent resistivity from A-A' survey line (See Figure 2 for location) from October 2018 (top) to February 2019 (bottom). Low values of resistivity show areas with moisture while high values represent dry zones.

By January 2019, the profile A-A' shows a little increase in the resistivity especially at the surface. Deeper, the conductive area seems to expand. In contrast B-B', returns to the same values of resistivity (from 44.1 to 412 Ω m) as in November 2019. Precipitation for this month is almost nonexistent except for one day of rain with more than 10 mm of water. This can explain the general diminution of humidity in the subsoil.

Finally, the upstream line A-A' from February 2019 indicates the same behavior as the previous month except for the change in resistivity for the conductive zone from 44.1 Ω m to 77.1 Ω m. The same change is observed for the conductive area of B-B'

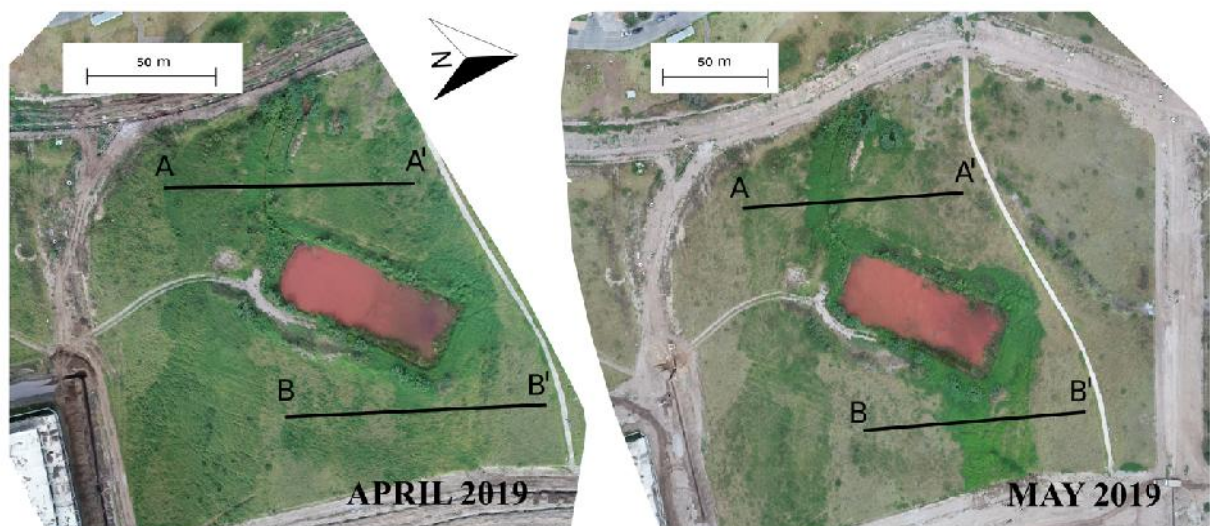
Figure 21. Aerial photos of the study area from April and May 2019. The photos show the change in the extent of the vegetation patch due to change of the water flow. The remain of the vegetation patch present in 2017 is at the left of the actual vegetation patch (May 2019).

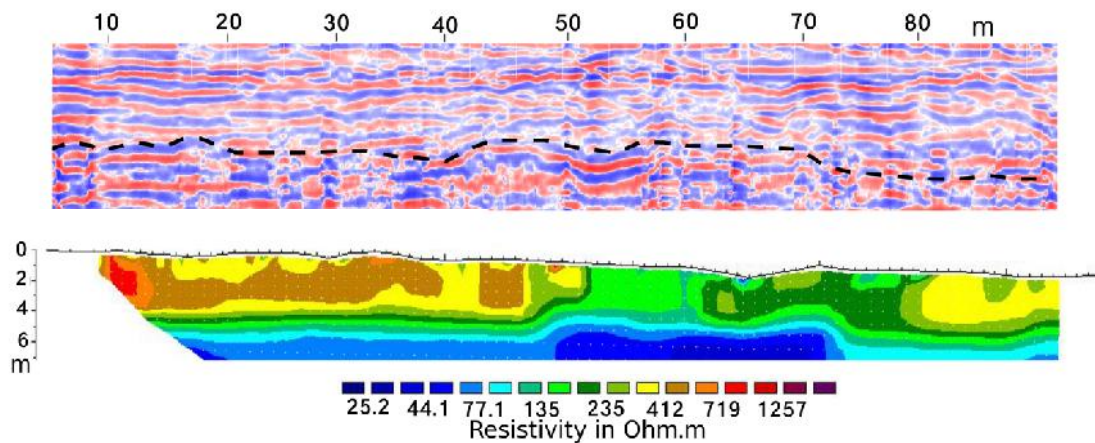
Figure 22. Electrical resistivity survey (bottom) from B-B' November 2018 and radargram (top). The dashed line separates the upper area that has low reflectance (low water content) from the lower area which shows higher reflectance (more water content).

In Figure 22 we can see that the subsoil is vertically well bedded. The dashed line in the radargram separates our interpretation of the dry zone (upper) from the more moisture containing zone (lower) which matches with the resistivity model of the same month. The blue color in the electrical resistivity model points out a conductive area, which in this case, is related with water content. In Figure 23, the areas with high reflectance at the surface matches with the vegetation patches while the areas at the bottom correspond to the humid areas seen in the stratigraphy in Figure 11. The extra superficial water flow in November 2018, due to the channel dug, is also shown in the radargram outlined by the vertical dashed line.
