UNIVERSIDAD DE INVESTIGACIÓN DE TECNOLOGÍA EXPERIMENTAL YACHAY

IS THE DETERIORATION OF CIVIL CONSTRUCTIONS RELATED TO USING NOT ADEQUATE VOLCANIC MATERIALS? CASE STUDY: IBARRA CITY

Trabajo de integración curricular presentado como requisito para
la obtención del título de Geólogo.

Urququí, julio 2023

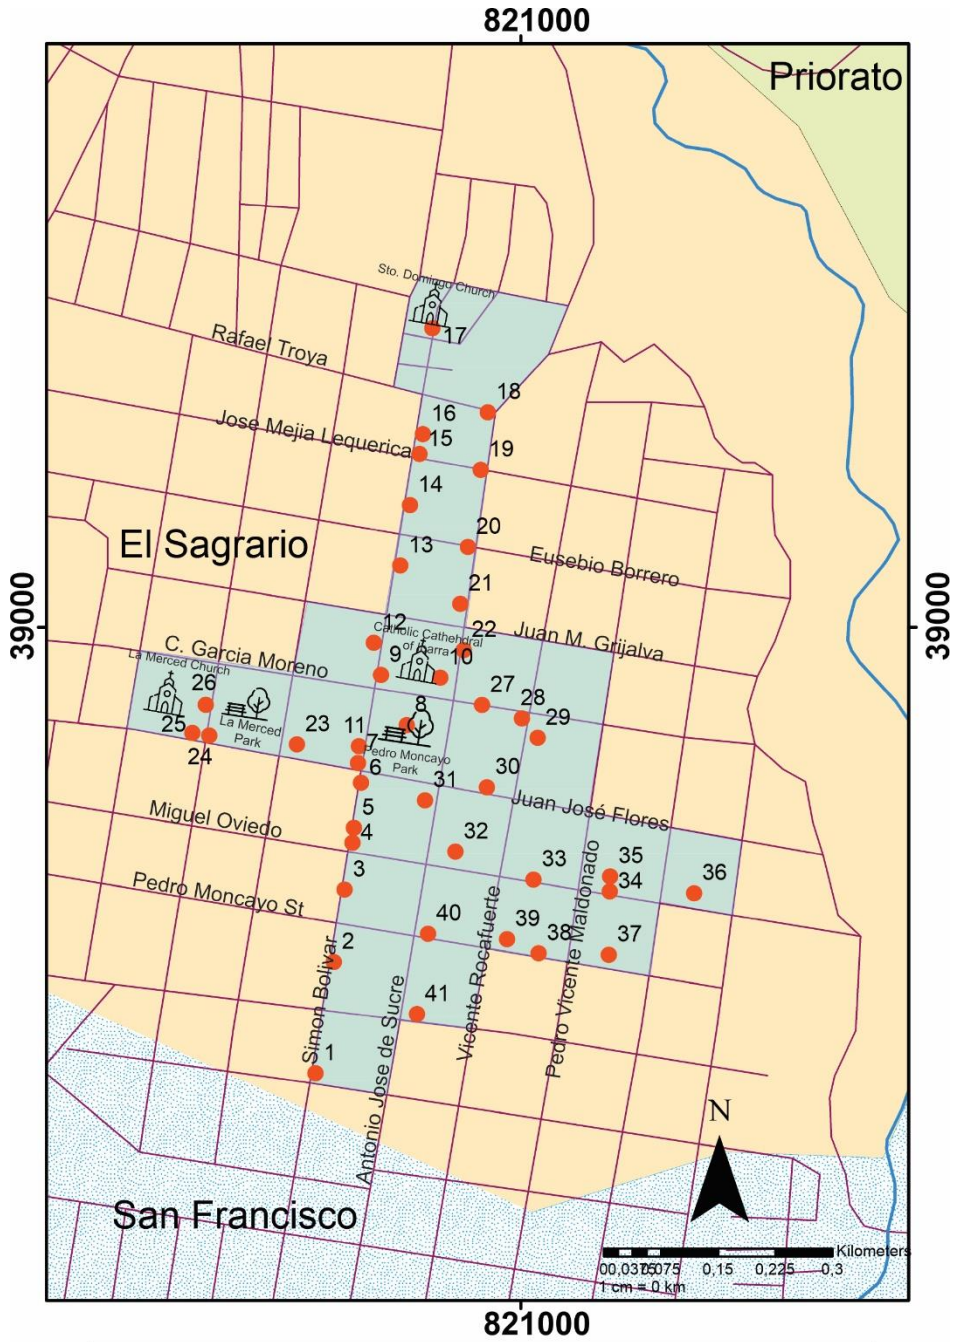
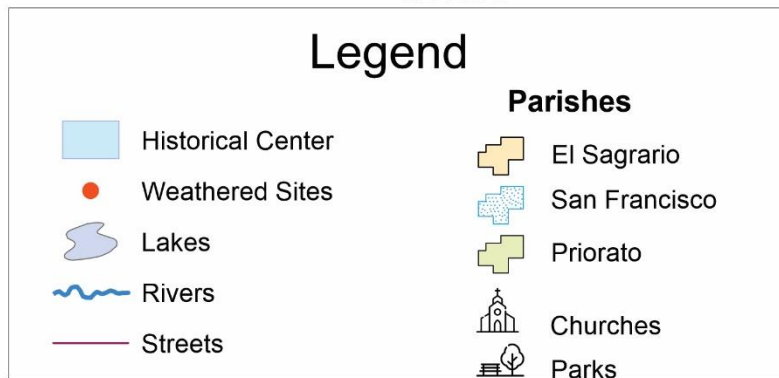
Figure 9. Map showing 41 points corresponding to weathering events along the historical center of Ibarra in the El Sagrario parish, including three historical churches, Santo Domingo, La Merced, and the Catholic center of Ibarra. Datum: WGS84.

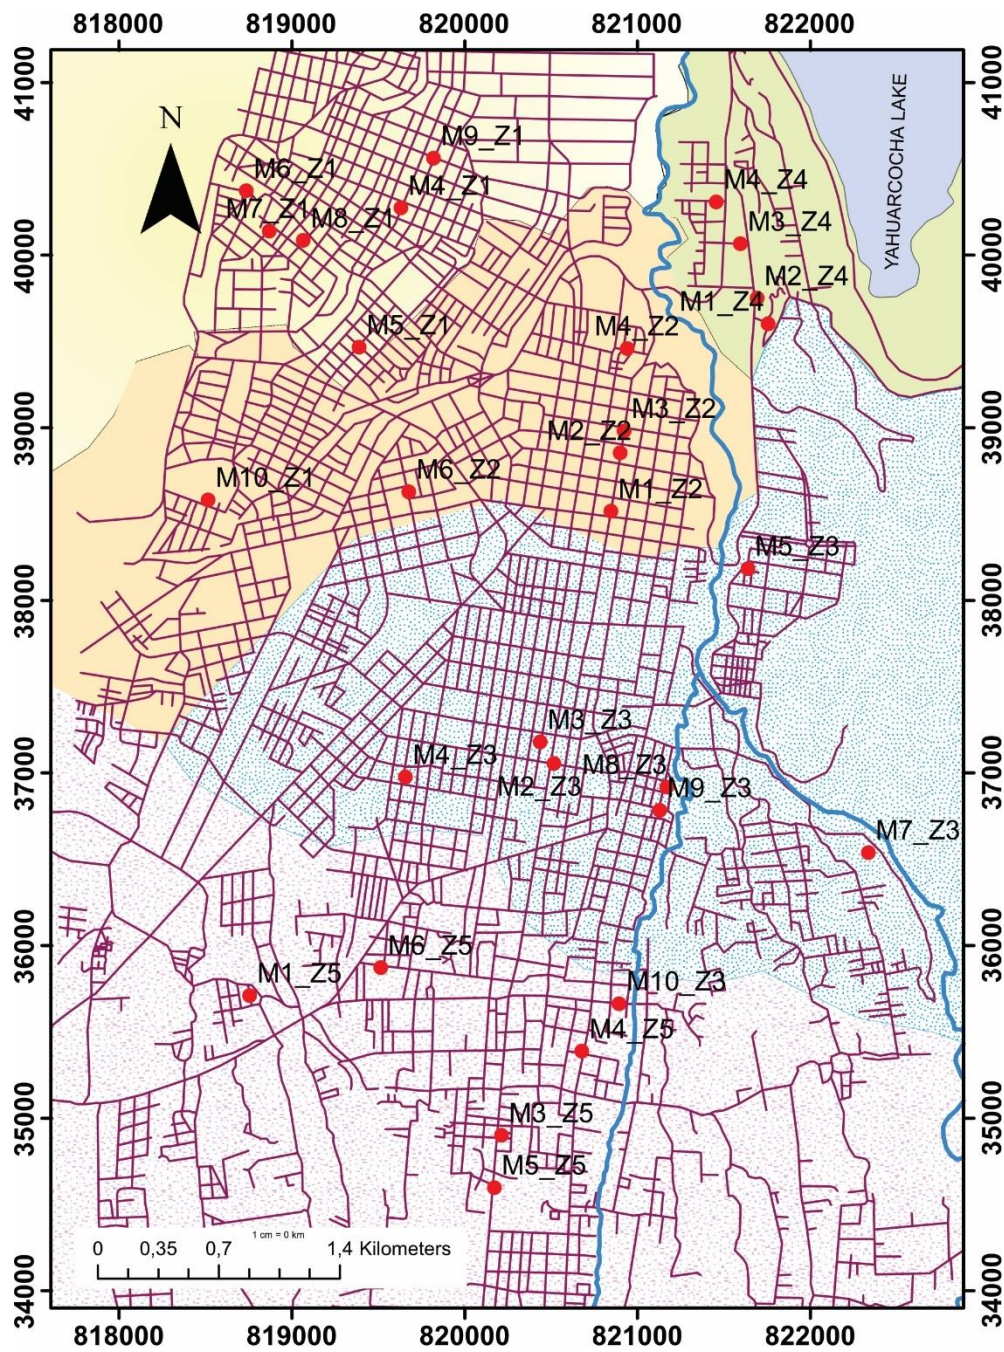
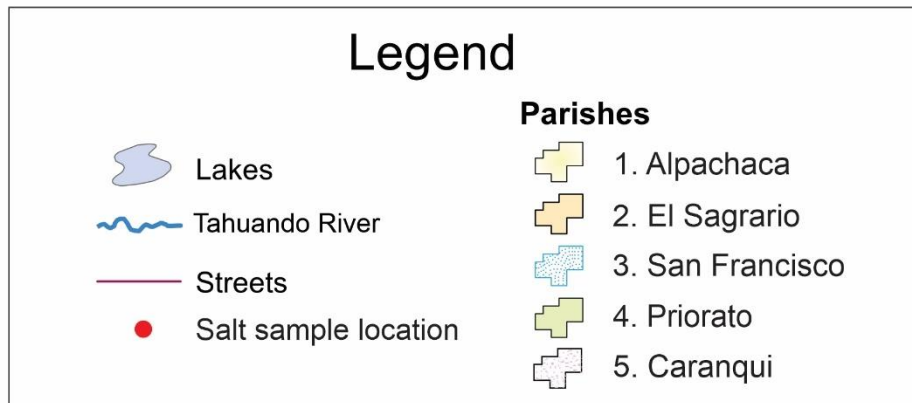
Figure 10. Map showing 29 points which correspond to efflorescence samples taken in the five urban parishes of Ibarra City. Datum: WGS84.

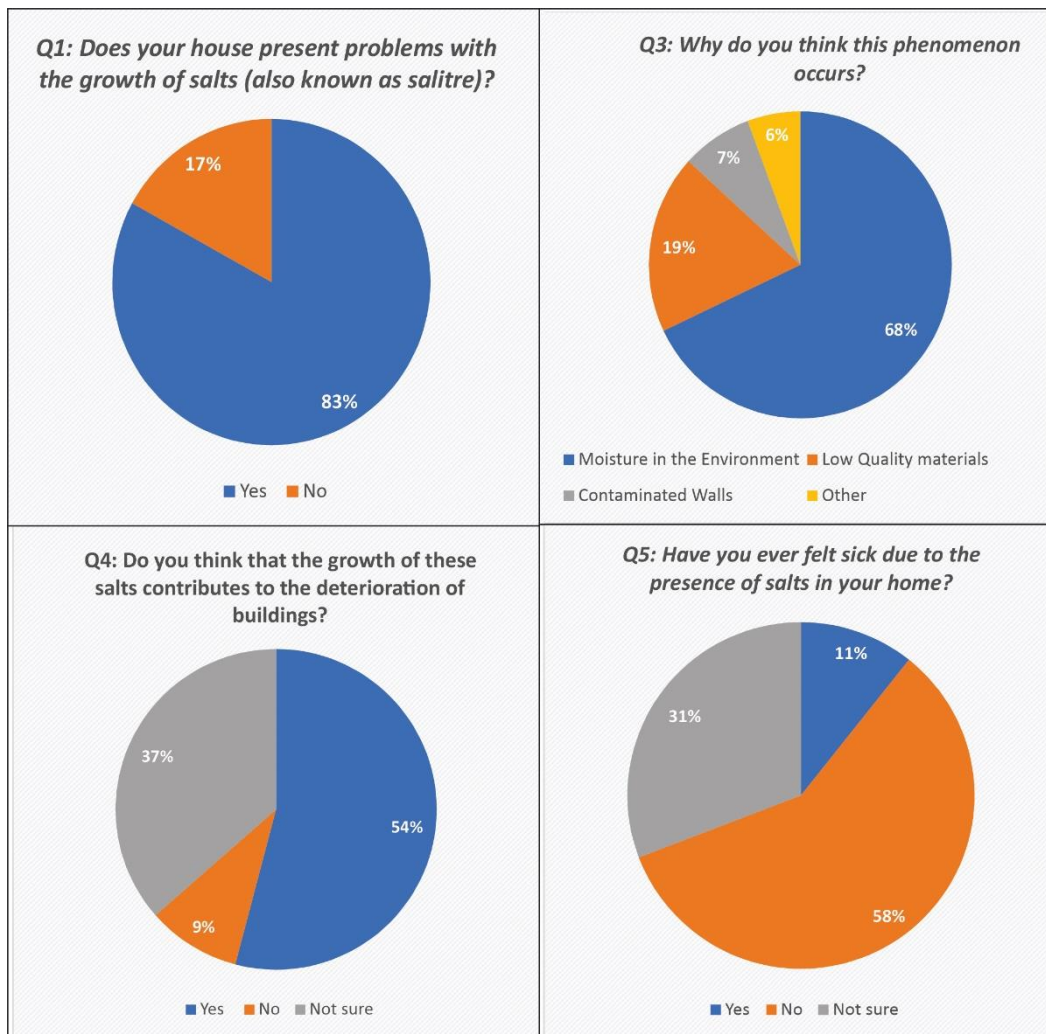
According to the surveys in Ibarra City (see Fig. 15), 83% of the people have stated that their homes show some salt weathering (efflorescence). This corresponds to both inside and outside of their houses. This type of deterioration has caused annual maintenance losses amounting to \$131 U.S. Dollars per household in the city, corresponding to 31% of the basic monthly salary. Putting this in perspective, annual expenses on maintenance and repairs of homes in the city of Ibarra amount to approximately 4,843,856 USD. Despite the concern and attempts of people to mitigate this phenomenon, there are very few options for it other than avoiding the implementation of low-quality cements, reducing the water ratio when mixing concrete, or the isolation of walls and floors using hydrophobic coating, which can cause additional expenses in the construction of buildings.

Moreover, 68% of people believe salt deterioration is due to humidity. Although the other reasons for possible deterioration remain low, 19% of the population thinks salt deterioration is due to the low quality of the materials used in construction. Considering the bibliography consulted, both reasons can be considered valid. This is due to the high amount of sulfates, carbonates and nitrates that are unconsciously used in cement and stone material. We also know that humidity, together with the constant increase in temperature, is one of the triggering mechanisms in the crystallization of salts.

Figure 15. Results of 4 of the 5 questions from the survey about salt weathering carried out to 159 individuals living in particular residences, showing the incidence of salt weathering as a common problem in Ibarra City.

One of the most shocking data in this study is that only 54% of the population is familiar with the harmful effects of salt growth in buildings (Fig. 15Q4). On the other hand, 37% are not sure of the damage that this entails, this may be because the rate of deterioration due to saline growth may be relatively low. Salts do not present a major risk to the population's health in general, since only 11% have reported having felt any symptoms related to salt exposure. In general terms, the population is moderately educated on this problem. However, most of them are exposed to these types of deterioration daily.

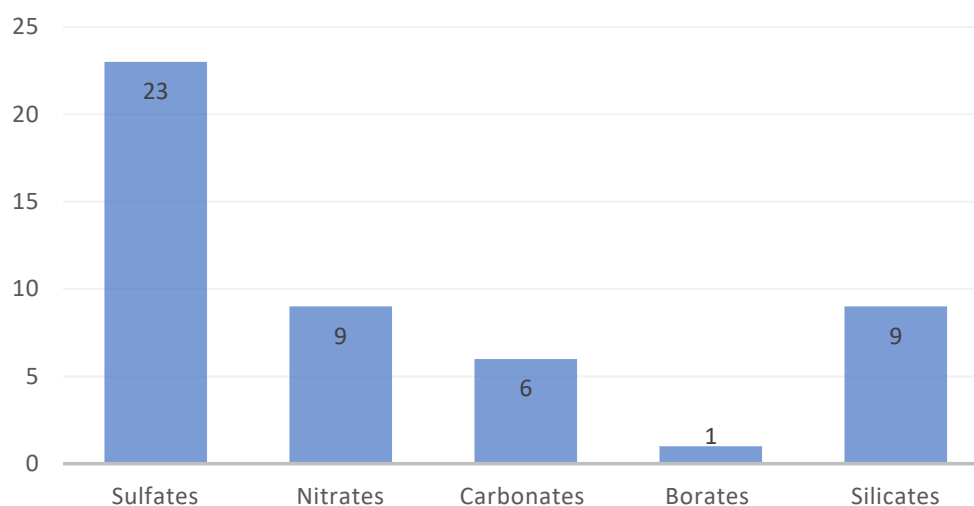
Figure 17. Number of ions of salts that showed dominance in the 29 salt samples studied after being analyzed using the Powder XRD technique. Some samples showed minerals that fall in more than one ion, (e.g. Darapskite $\text{Na}_3(\text{SO}_4)(\text{NO}_3)\cdot\text{H}_2\text{O}$, being both a sulfate and a nitrate)
