**UNIVERSIDAD DE INVESTIGACIÓN DE
TECNOLOGÍA EXPERIMENTAL YACHAY**

**TÍTULO: “Characterization of Haloclasty to reduce the
deterioration of buildings in Urcuquí and near Villages,
Ecuador.”**

Trabajo de integración curricular presentado como requisito para la
obtención del título de Geóloga.

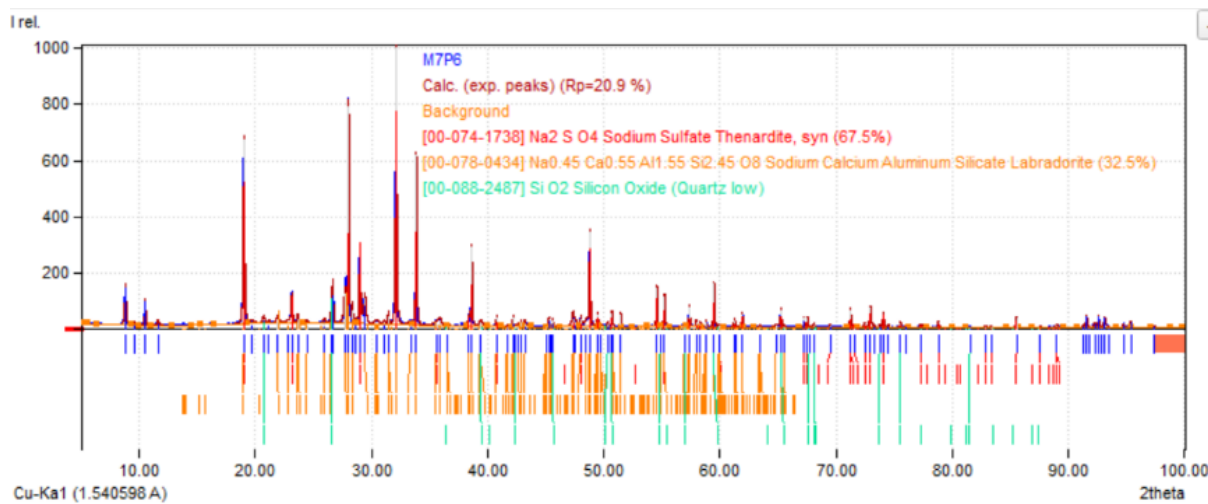
The diffraction profile reflects the outcomes achieved through X-ray diffraction (XRD). It can provide details about the diffraction peaks, the 2-theta interval utilized, and the intensity of each peak. The diffractogram shows the makeup of the construction of the sample M7P6 (Figure 28). The analysis shows the significant existence of sodium sulfate, commonly referred to as Thenardite.

After analyzing the data, it has been observed that the samples contain minerals like labradorite and quartz. These minerals are commonly found in volcanic rocks and are not responsible for deterioration. The cause of damage should be attributed to the salts present in the samples, such as thenardite and mirabilite.

Figure 28. X-ray diffractogram of the sample M7P6 taken from a wall.

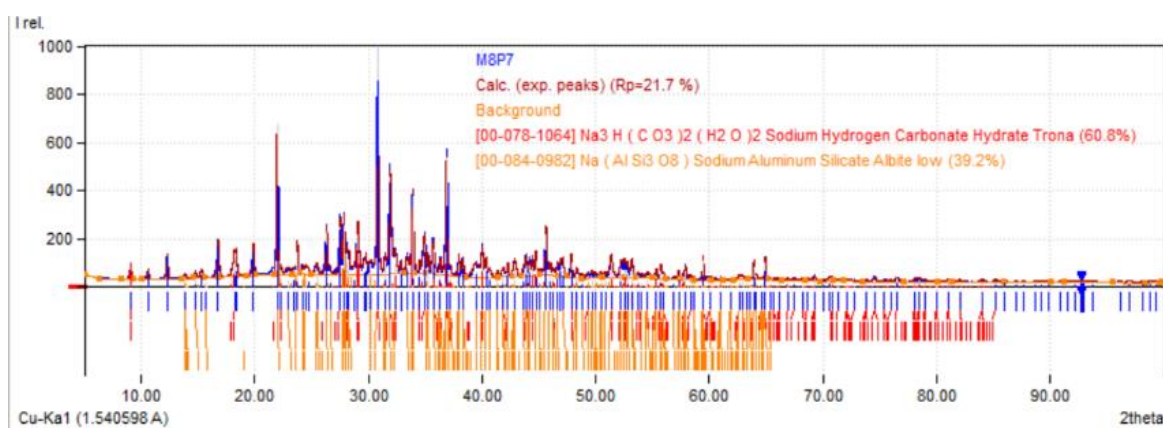
The mineral sample M8P7 is composed of 60% Trona, which is a hydrate of sodium hydrogen carbonate ($\text{Na}_3\text{H}(\text{CO}_3)_2(\text{H}_2\text{O})_2$), and 30% albite, a mineral made up of sodium aluminum silicate ($\text{Na}(\text{AlSi}_3\text{O}_8)$) (Figure 29). According to Dana's classification, Trona mineral is categorized under the carbonate group. On the other hand, Albite is a prominent component of felsic rocks and belongs to the silicates group.

Figure 29. X-ray diffractogram of the sample M8P7 taken from a natural environment.

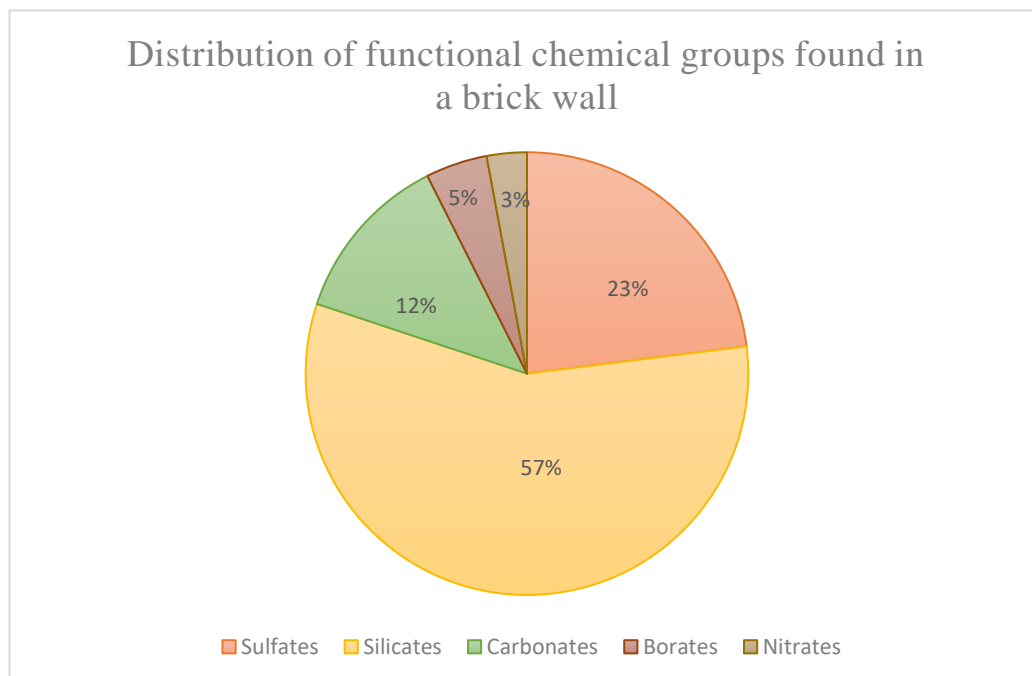
The analysis of a specific brick wall aims to identify the minerals responsible for its deterioration, as the decay levels differ from one level to another. This particular wall contains sulfates, silicates, carbonates, and nitrates.

After an analysis, it was discovered that most samples contained a mineral component called thenardite (Na_2SO_4). The most commonly detected element was sodium sulfate, followed by hydrated calcium sulfate (gypsum) and sodium-potassium copper oxide sulfate (Euchlorine). Although most of the samples examined had thenardite, it was found in low amounts. Silicates were also present in most samples, with a higher percentage than sulfates. The silicate group detected in the XRD analysis showed that sodium aluminum silicate was the most prevalent type. It is important to note that silicates such as quartz and labradorites are not causing any damage to the walls. Additionally, structural changes were observed with ordered and disordered Al-Si distributions at low and high temperatures, referred to as "low albite" and "high albite," respectively. Other substances in this category included magnesium carbonate, calcium aluminum hydroxide carbonate, chloride aqua hydrate (hydrocalumite), and sodium magnesium carbonate (Eitelite), all obtained from near the wall's base. It was also discovered that borates were involved in the brick manufacturing process (Figure 30).

Figure 30. Percentage of each functional chemical group found in a brick wall from Urcuquí.

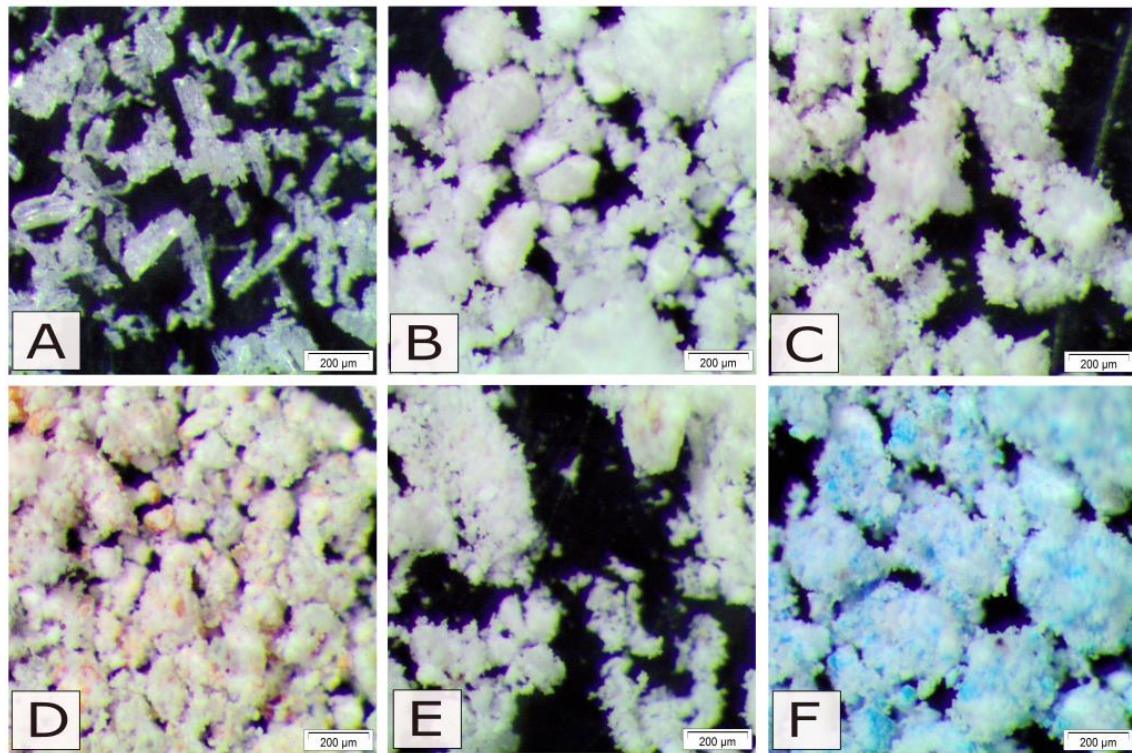
The initial illustration showcases Epsomite, which belongs to the sulfate category and has a chemical formula of $\text{MgSO}_4 \cdot 7\text{H}_2\text{O}$. Its structure is characterized by elongated and white crystalline shapes, as depicted in Figure 30A. Only M1P1 was identifiable under the microscope during the sample collection process due to its distinct dry crystal formation and transparent look. Nonetheless, to confirm its real identity, it is necessary to conduct XRD processing.

Figure 31. Mineral samples under stereomicroscopic view. Sample M1P1(A). Sample M6P5(B). Sample M7P6(C). Sample M12P11(D). Sample M2P2(E). Sample M16P15(F).

The remaining pictures showcase different examples with similar physical attributes, as depicted in Figures 30B, C, and E. These samples are all white, and their crystalline structure is not readily visible. Identifying the specific crystalline structure of each mineral sample can be pretty challenging since most minerals are interconnected. Although the majority of samples are white, some of them exhibited traces of building materials. This was particularly noticeable in the orange color in the image, which was identified as clay. Additionally, the blue substance observed in the picture is the painting on the wall during sampling, as shown in Figures 30D and F.

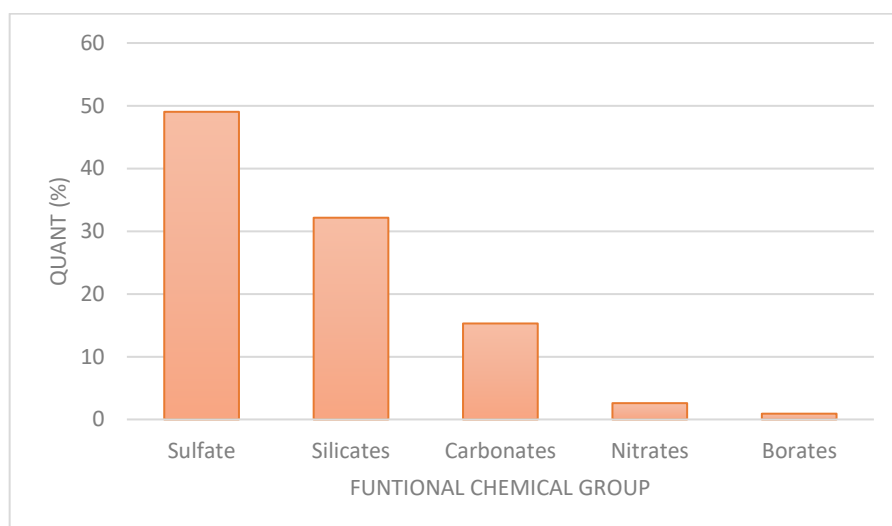
The XRD data analysis determined that all samples contain sulfates, including thenardite, typically found in dry evaporite environments. This particular salt is known for causing structural damage due to its crystallization. The samples also contain functional chemical groups such as nitrates, chlorides, carbonates, and silicates (Figure 31). Typically, cement repairs and urban atmospheric deposition are the sources of sulfates, sulfites, nitrates, and nitrites. Aside from being present in bird droppings, which can contaminate urban structures, nitrates are frequently found in agricultural structures (Delgado et al., 2016).

According to the results, sulfates ($(\text{SO}_4)^{2-}$) are among the most plentiful substances in the study samples. Salts usually cause problems if they can reach water, move around a building, and crystallize. According to bibliographic research, most of the experiments conducted by several researchers in this field used sulfates. As the reason for the deterioration of the walls, they cite sulfates.

Figure 32. *The specimens gathered encompass a range of functional chemical groups with distinct functional properties.*

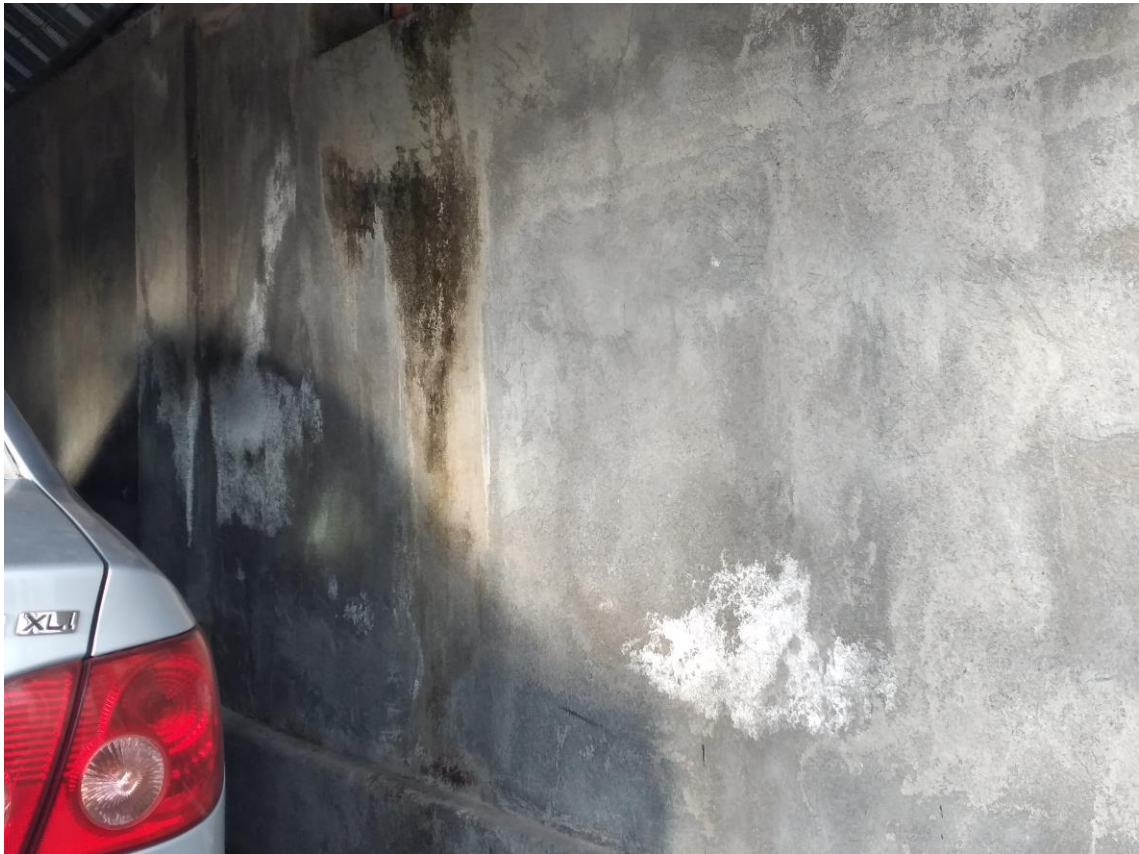
Image 9. The white and black spots on the wall indicate the presence of water filtration, wetness, and CO2.
